Mangaonuku results

What's going on Mangaonuku sub-catchment?

The Mangaonuku is one of 17 sub-catchments in the Tukituki catchment.

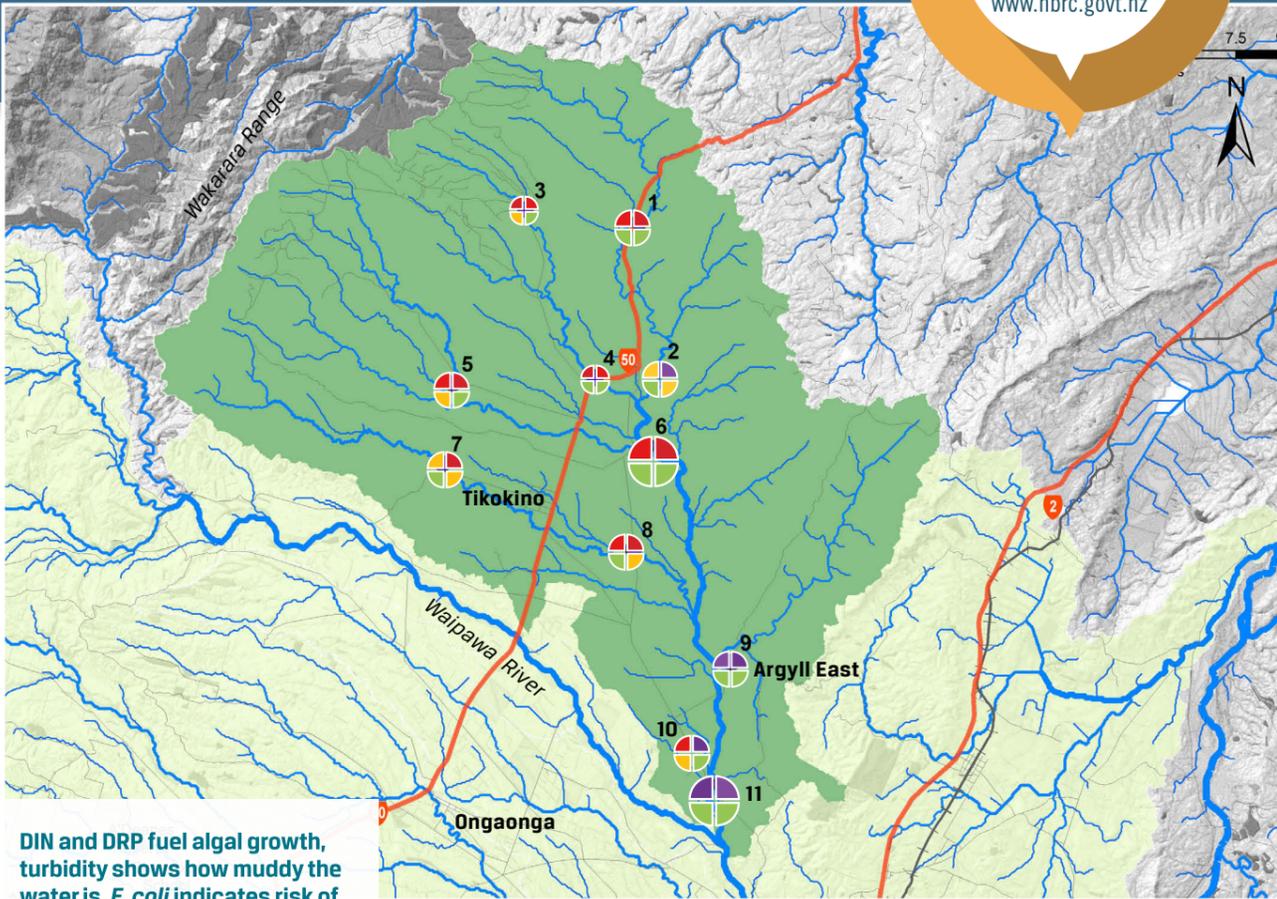
DIN and DRP fuel algal growth, turbidity shows how muddy the water is, E. coli indicates risk of pathogenic infection

SITE	NITROGEN	PHOSPHORUS	SEDIMENT	FAECAL	FLOW	SAMPLES
1. Mangaonuku Stream at Highway 50 Site 2	0.89	0.018	0.60	110	104	7
2. Mangaonuku Stream at Shed Access	0.68	0.025	0.60	220	312	7
3. Mangamate Stream at Downstream of Weir	1.00	0.012	1.38	30	40	7
4. Mangamate Stream at State Highway 50	1.45	0.018	0.23	70	31	7
5. Opokararo Stream at Matheson Rd	1.40	0.016	1.16	20	119	6
6. Mangaonuku Stream D/S Mangamauku	1.14	0.019	0.63	30	632	7
7. Mangaoho Stream at Holden Road	0.66	0.011	0.73	130	159	7
8. Mangaoho Stream at Butler Road	1.60	0.011	0.60	160	148	7
9. Mangaonuku Trib at The Brow Rd Br 8029290	2.09	0.029	0.56	90	367	6
10. Mangaonuku Trib at Tributary 19	1.10	0.067	1.09	90	189	7
11. Mangaonuku Stream at Waipawa Tikokino Rd	2.00	0.025	0.58	80	1797	7

All sites sampled had elevated levels of at least one of the four main contaminants of concern.

The phosphorus target was exceeded at all sites, and the nitrogen target was exceeded at all but two sites. The highest nitrogen and phosphorus levels were mainly recorded in the most downstream sites.

For most sites, neither sediment nor faecal contamination were at concerning levels. These results are based on limited data however, and further sampling would be needed to confidently assess water quality patterns.

The flow at site 6 (mainstem Mangaonuku half-way down sub-catchment) was only about a third of the flow at Waipawa-Tikokino Rd (most downstream site). Many springs emerge in the lower catchment, which means that water quality influences from properties in the upper catchment may not materialise in the streams until groundwater resurfaces at the bottom of the sub-catchment.

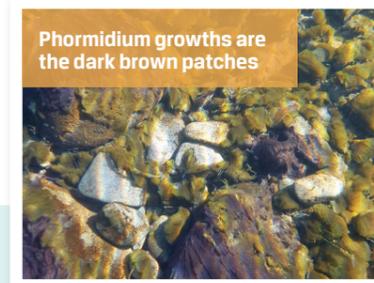
Phormidium growths are the dark brown patches

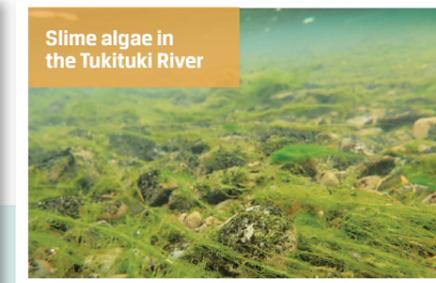
Slime algae in the Tukituki River

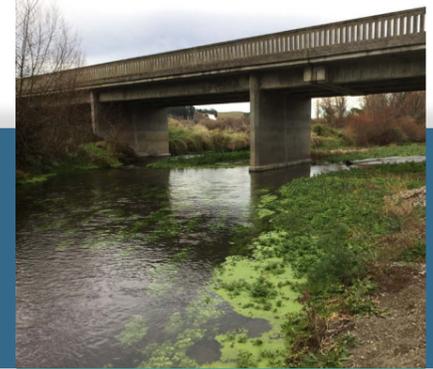
Above: Mangaonuku Stream at Tikokino Road. Below: Mangatahi Stream at The Brow Road.

Going forward, the Mangaonuku Stream at Waipawa-Tikokino Rd will be the long-term water quality compliance monitoring site.

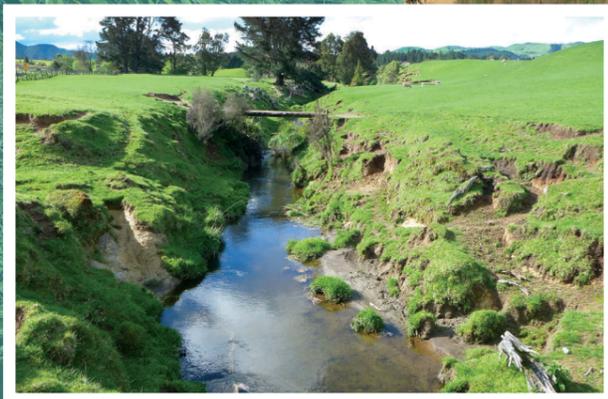
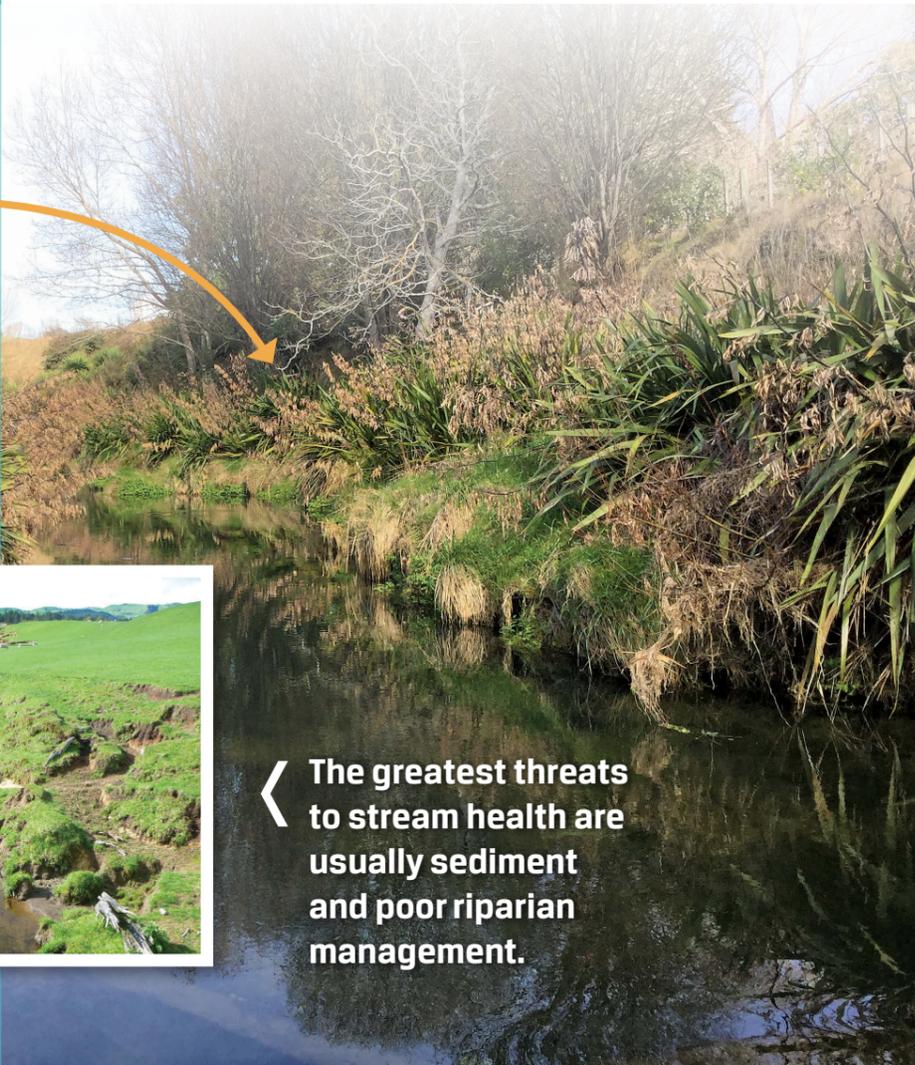
Poor riparian habitat (inset below), and an example of good riparian planting (main photo right).

Riparian areas along the Mangaonuku showed plenty of room for improvement, with 35% of small streams having moderate to highly disturbed banks*.

Wide buffer areas near streams and substantial planting will benefit these waterways by reducing phosphorus, sediment and bacteria levels.

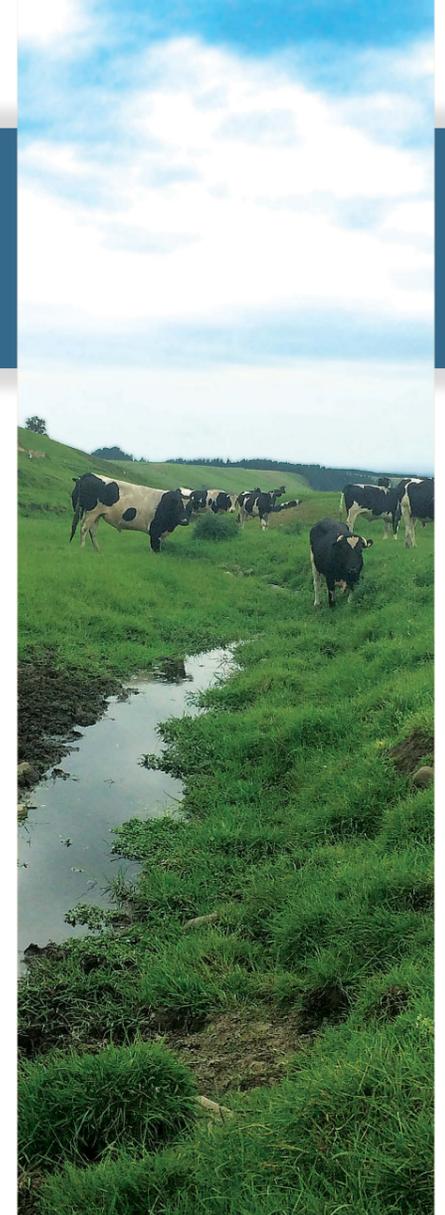
Stock exclusion (not happening above) and pole planting (below) are two ways to help improve water quality.

Stock exclusion will contribute to improving stream health.
