Irrigation Check-Up Programme 2017

An assessment of irrigation efficiency to
promote responsible water use

May 2018
HBRC Report No. RM18-25 – 5010

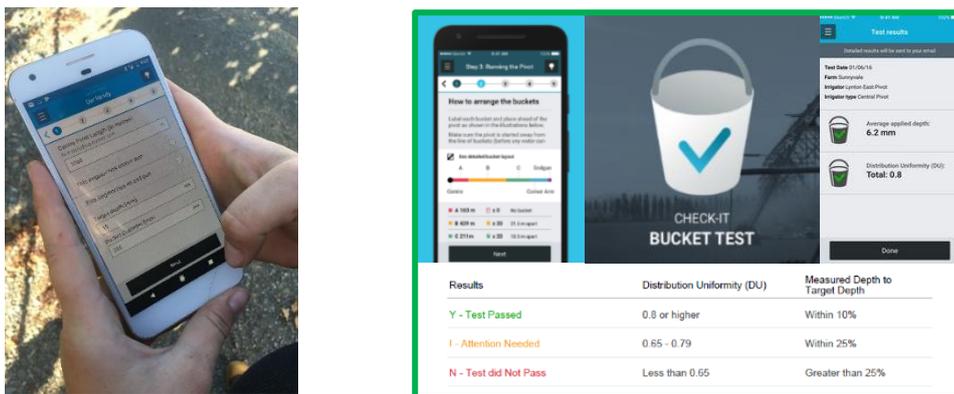
Figure 2-1: Example of the Check-It Bucket Test App.

The efficiency ‘bucket test’ for these system types involves setting buckets out either parallel or perpendicular to the irrigator, at spacing specified by the App (see Figure 2-1 below). Information such as length of pivot or boom, target application and system operating pressure is required. Once the irrigator has completely passed over the buckets the water volumes can then be collected and entered into the ‘App’. From this the Distribution uniformity (DU) is calculated to show how efficiently the system is operating. The DU results can be interpreted as per Table 2-1.

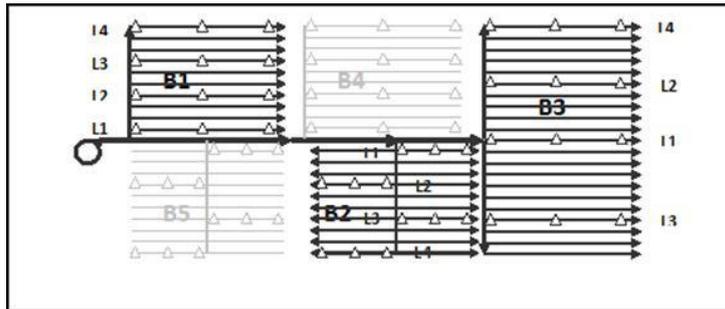
Figure 2-2: Example of which blocks to efficiency test.

For each system (that is, all blocks operated by one pump set-up) 3 different blocks are chosen to represent the whole system. The block closest and furthest from the pump and one in the middle are assessed for emitter uniformity (EU) and target depth versus actually applied irrigation depth (mm). Emitter uniformity is a measure of how even the water is applied from each dripper tested. This shows how the blocks perform in relation to each test position along the mainline. Figure 2-2 below shows the bucket layout for each block, with the triangles representing the buckets within the block, which covers 4 lateral rows at the beginning, middle and end of the block. Water is collected at each bucket location. The system is tested mid operation to ensure water is collected at the usual operating pressure.

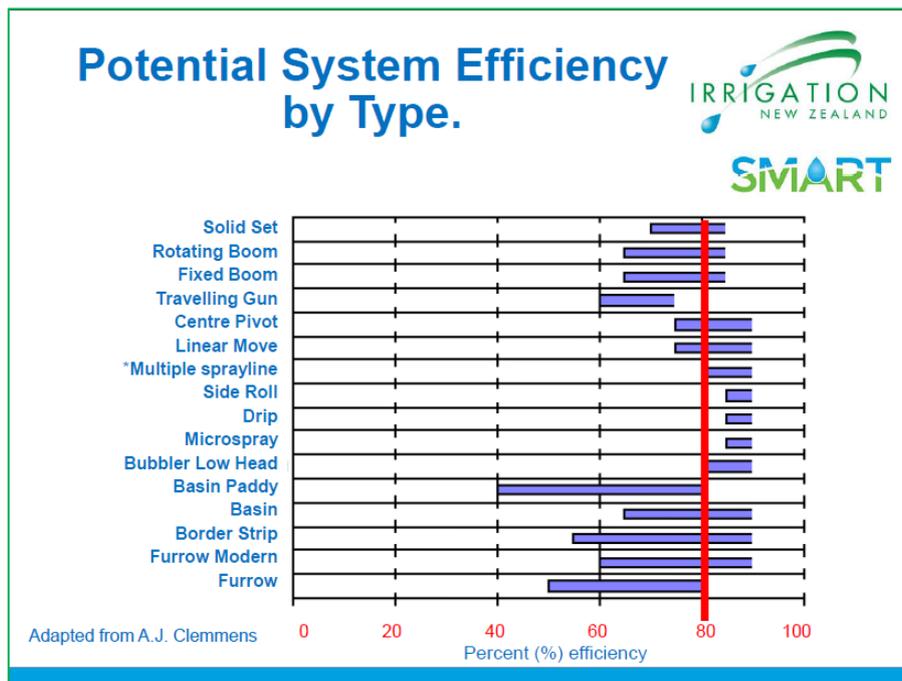
Figure 4-1: Irrigation NZ - Potential System Efficiency by Type. Note many of these system types ('side roll', 'bubbler low head' and below) are generally not present in Hawke's Bay.

It is important to understand the potential level of efficiency that can be achieved by a given system type. Irrigation New Zealand have assessed where most irrigation systems fit in relation to the industry standard (80% efficiency or higher) (Figure 4-1).

Some Regional Resource Management Plans now specify an irrigation system efficiency percentage. However, it is noted that some system types will struggle to reach higher uniformities such as Rotorainers and travelling guns due to their design and susceptibility to wind.

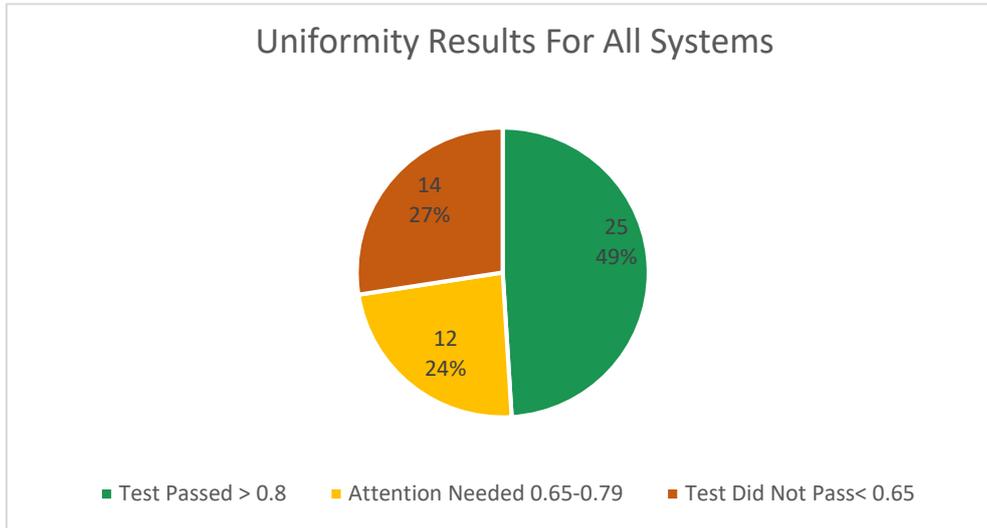
Figure 4-2: Emitter Uniformity (EU) and Distribution Uniformity (DU) Results for All Systems (51). Using an average of the drip micro blocks for each system & converted to Check It Bucket Test App categories.

The uniformity for all system types showed 49% achieved a 'Test Passed' DU/EU result of 0.80 or higher. While 24% achieved an 'Attention Needed' result with the remainder of 27% showing a 'Poor' result (Figure 4-2).

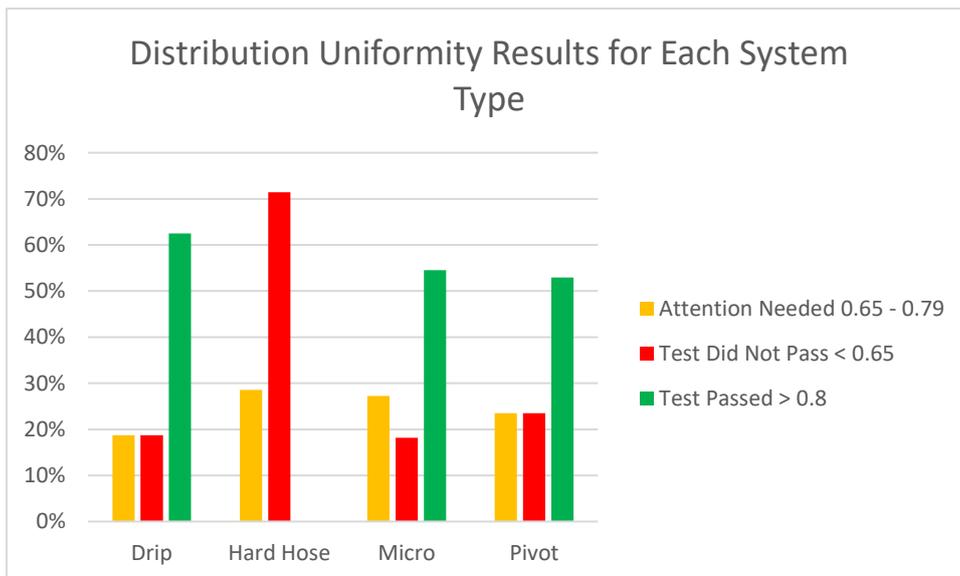
Figure 4-3: Distribution Uniformity (DU & EU) Results for all System Types (Percentage; 51). Using an average of the drip micro blocks for each system & converted to Check It Bucket Test App categories.

Within the different irrigation types Drip systems had the highest percentage of 'Test Passed' results at 63%. This was followed by Micro at 55% and Pivot systems at 53% (Figure 4-3). Hard hose systems struggled with 71% achieving a 'did not pass' category.

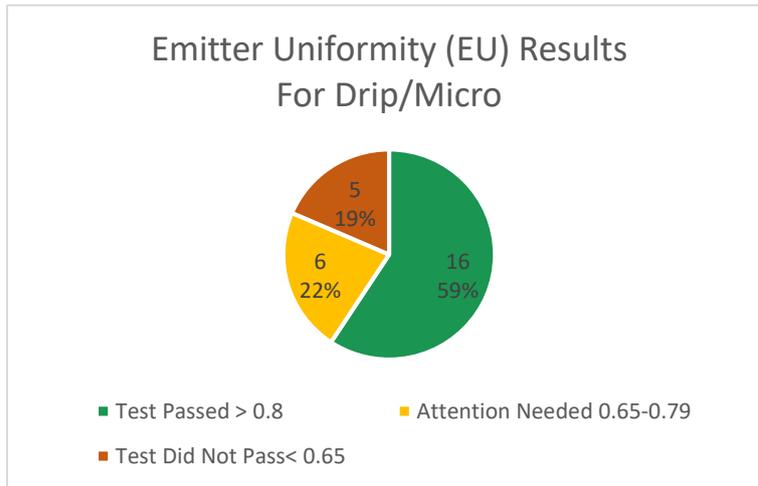
Figure 4-4: Emitter Uniformity (EU) Results for Drip/Micro (27).

It is reassuring to see that of the drip micro systems tested, well over half were operating at a ‘Test Passed’ level (59%). Whereas 19% were at a ‘Test did not Pass’ level (Figure 4-4). The majority of those that did not pass were older systems that appeared to be at the end of their life or had been subject to ad hoc maintenance over the years. *Note: Drip/Micro results have been calculated from an average of the individual block results for each property. The result categories have also been converted from Irrig8lite to the Check-It Bucket Test categories’ for analysis purposes.*

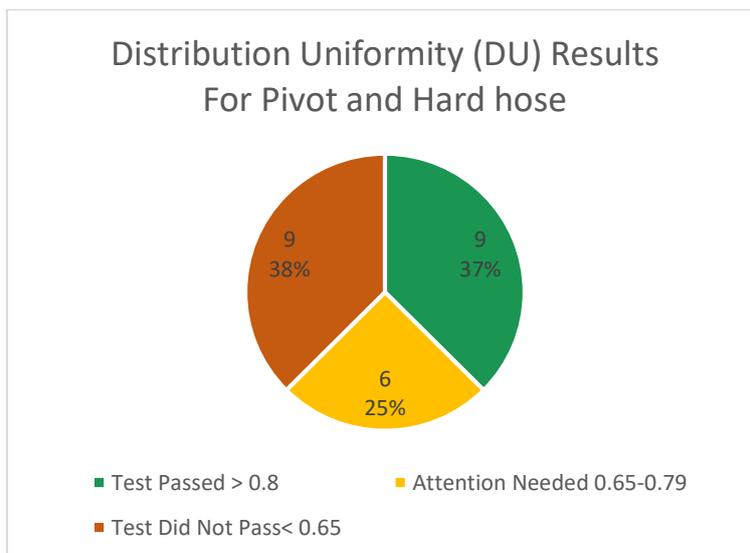
Figure 4-5: Distribution Uniformity (DU) Results for Pivot and Hard hose irrigators (24). Includes irrigators categorised as 'other'.

The DU results for Pivot and Hard hose irrigators showed that 63% needed attention or did not pass (Figure 4-5). Guns had poor performance with no gun type system achieving a DU of 0.8 or higher (Figure 4-3). This was largely due to wind susceptibility and operational issues. The pivots that were poor performing tended to have issues with pressure or aging infrastructure resulting in worn nozzles and failed pressure reducing valves (PRVs). *Note: ‘Other’ systems have been categorised as Hard hose.*

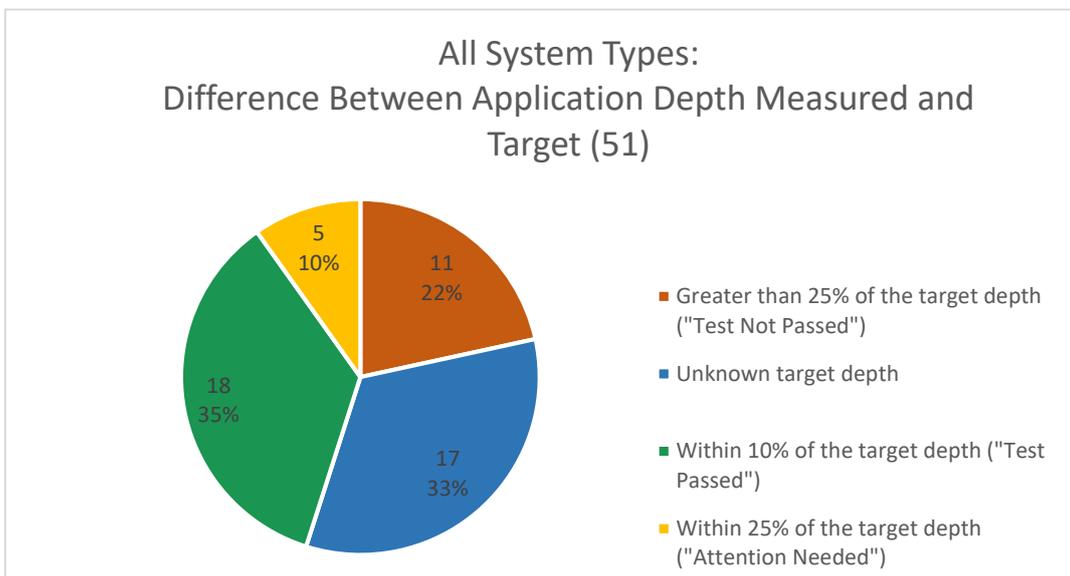
Figure 5-1: All System Types: percentage difference between Application Depth Measured vs Target (51). Using an average of the drip micro blocks for each system.

This part of the assessment checked if the actual irrigation application depth (mm) was the same as the participant believed it to be. Though overall 35% of systems achieved a 'Test Passed', nearly the same proportion did not know their target depth (Figure 5-1) (discussed further below).

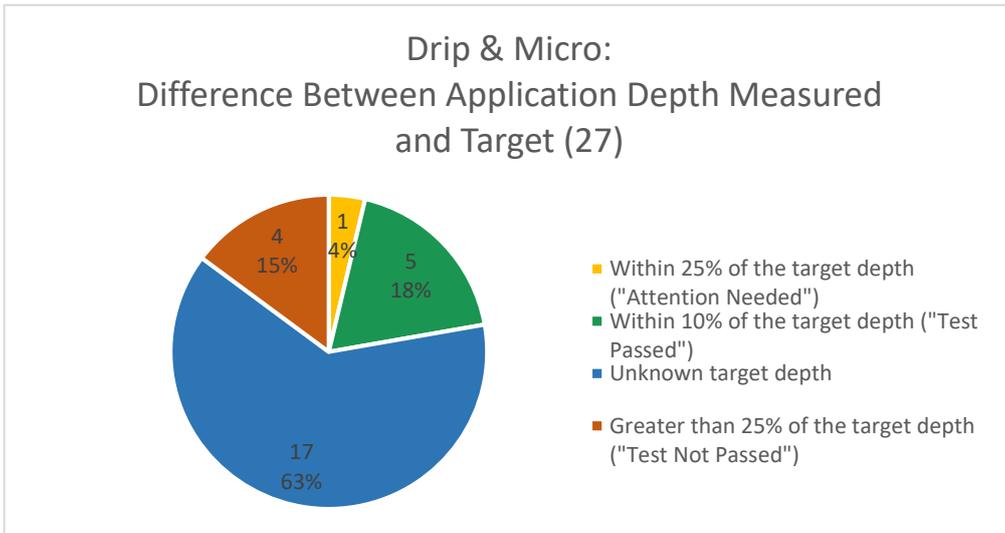
Figure 5-2: Drip & Micro: Percentage difference between Application Depth Measured Vs Target (27). Using an average of the drip micro blocks tested per system.

All of the 'Unknown' target depths had Drip/Micro systems (Figure 5-2). When this data is assessed further it shows that for most of this group, irrigation scheduling is based on one or a combination of soil moisture metering, monitoring software and/or consultant advice (Figure 5-3). Also some participants may not have been able to answer the survey question as they work in litres per hour or litres per plant. The survey questions can be altered to address should the programme run again.

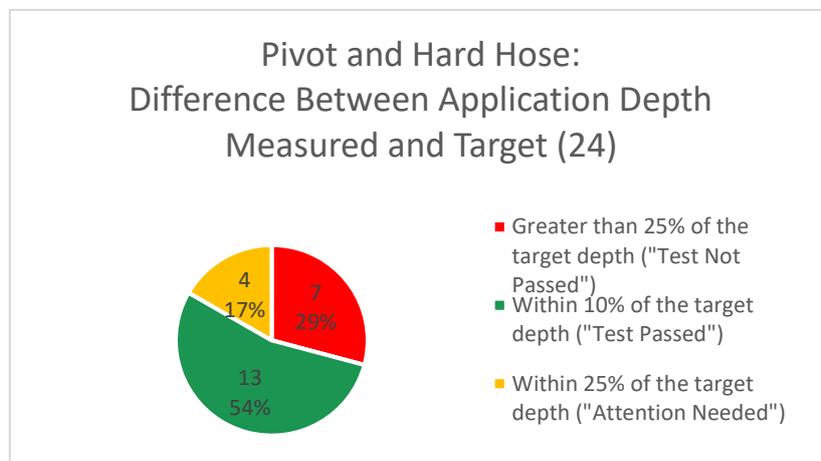
Figure 5-4: Pivot and Hard hose: Percentage difference between Application Depth Measured vs Target (24).

Over half of the Pivot and Hard hose systems assessed had a 'Test Passed' result (Figure 5-4). Irrigation applied rate (mm) (or depth per unit time) can be altered by changing the speed of the machine. Pivots and linear irrigators display the applied rate (mm) on the control panel screen. Therefore, all users of these systems were aware of their intended application rate. Basic efficiency testing such as this can identify if there has been an issue when the system was set up or if something has affected the machines calibration.

In some cases, a DU "pass" was achieved but application depth achieved an "Attention Needed" result. For pivots this means the machines speed is not calibrated correctly which affects the depth (mm) applied on the control panel. If this occurs for Hard hose guns or booms the speed settings on the machine need to be reviewed and adjusted accordingly.

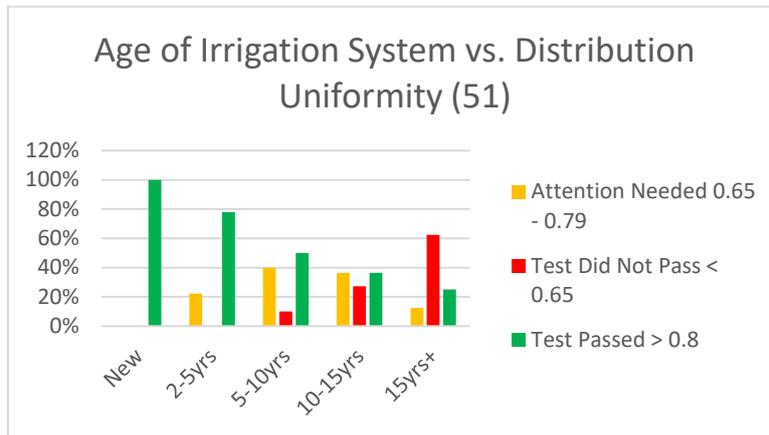
Figure 6-4: Age of Irrigation System vs. Distribution Uniformity (51).

By comparing the age of irrigation systems to the uniformity results, it shows a trend of performance declining as the systems age (Figure 6-4). This is seen through the decreased percentage of uniformity 'Test Passed' as we move from 'New' to '15years+', at the same time there is an increase in tests not passing. A similar trend can also be seen when comparing system age with applied depth results, with a dramatic increase in 'Test not Passed' results as systems age (Figure 6-5).

Unsurprisingly this suggests that as irrigation systems get older and are subject to greater wear and tear, the demand on system maintenance increases. Alternatively, these older systems would have been the 'early adopters' and without having comparative testing it is difficult to know what their starting DU/EU, or application depth was at design and installation.

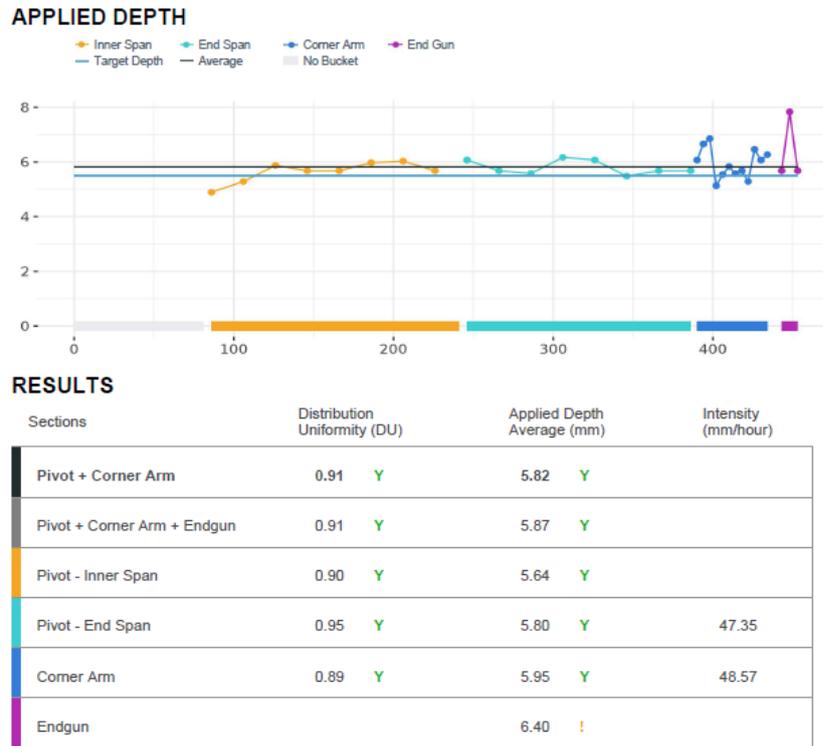
Irrigation system: 390m Centre Pivot with corner arm.

The centre pivot was tested in ideal conditions. The bucket test data, showed good performance across the machine with a distribution uniformity (DU) of 0.91 ('Test Passed'). The application depth was measured at 5.82mm which is within 10% of the target depth ('Test Passed').

- Replacing failed equipment e.g. new pump installed.
- Comprehensive servicing of pivot every season (by preferred service provider)
- Weekly visual checks.

- Reviewing soil moisture sensor results and report of recommendations.
- Irrigate at night.
- Forward planning for irrigation scheduling.
- Comprehensive pre-season maintenance checks by preferred service provider.

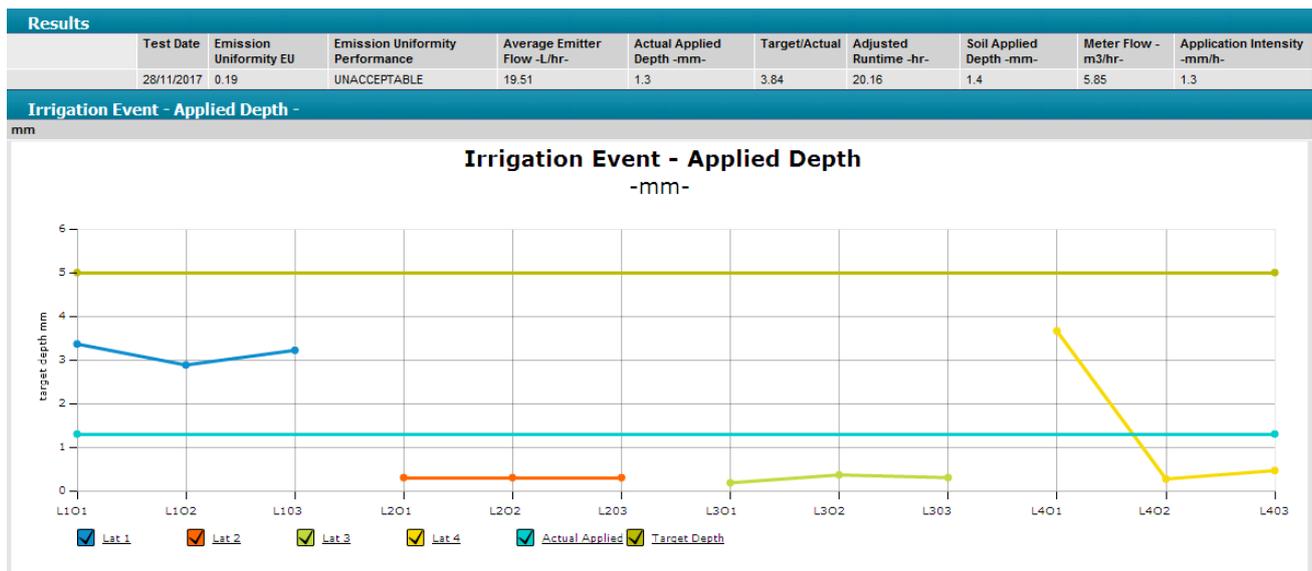
The system was tested in ideal conditions at an application target depth of 5.0mm/hr. The applied depth was measured at 1.3mm/hr. This was greater than 25% of the target application, giving a "Test not Passed" result.

The irrigation uniformity for the block tested was measured at 0.19 (EU), which is considered an "Unacceptable" result by Irri8lite categories. This is equivalent to a "Test Did Not Pass" result when converted to the Bucket Test App.

There were a range of issues observed with this system. The most obvious was the variety of sprinkler heads, emitting different volumes and some with significant leaks. The orchard manager runs ongoing maintenance on the system e.g. fixing leaks and replacing sprinklers etc. Issues beyond this were not identified and could not be ruled out as contributing to the poor result. The participant acknowledged that the system is due for replacement and is working towards this.

Multiple sprinkler types within an orchard micro system is not uncommon. Often this can be as a result of retailers changing stocked items, stock temporarily unavailable, manufacturers ceasing production, changing to a cheaper option etc. Multiple emitter types with varying outputs and spray patterns should be avoided if possible.

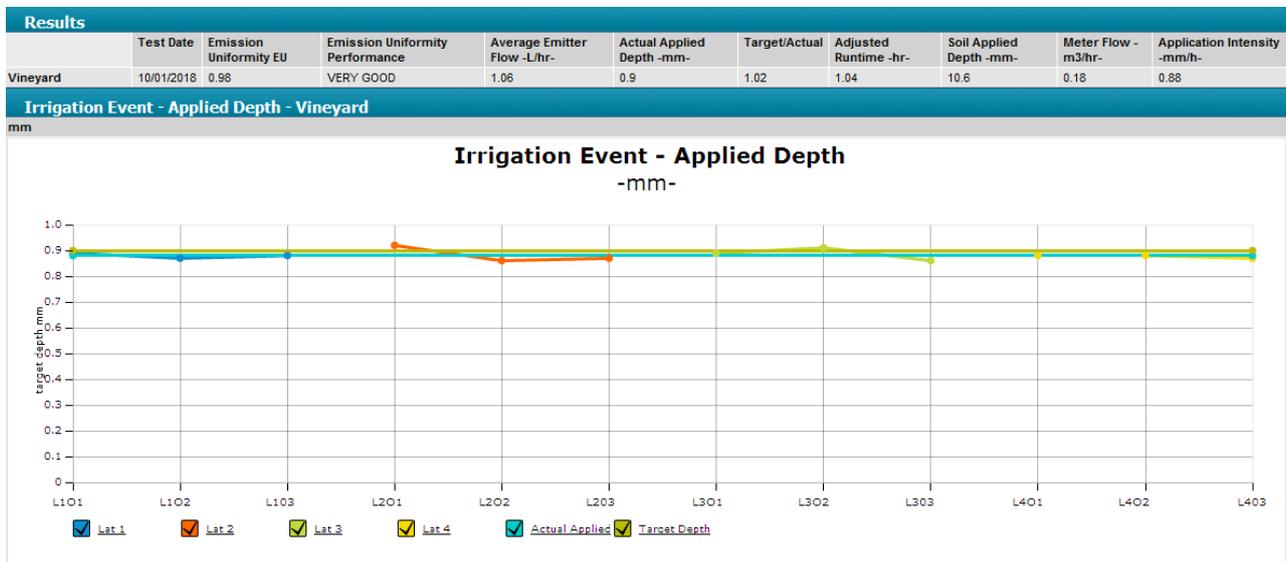
The system was tested in ideal conditions with an application target depth of 0.9mm/hr. Data created from Irrig8lite shows the system was operating at a high level of efficiency. The system applied depth was 0.9mm/hr this was within 10% of the target depth ("Test Passed"). Overall the block tested was measured at 0.98 emitter uniformity, which is considered a "very good" result by Irrig8lite, or a "Test Pass" when converted to Check It Bucket Test categories.

The right design is important to address site specific issues or prevent potential issues from arising e.g. potential water quality issues. This has been addressed by installing disk filters.

Regular maintenance from when the system is newly installed is important. It will help to identify and correct issues early and keep the system operating at optimum efficiency for as long as possible. For this irrigation system maintenance includes:

- General maintenance (fixing leaks etc.)
- Pre – season flushing of lines.
- Every 5 years a system acid flush is scheduled

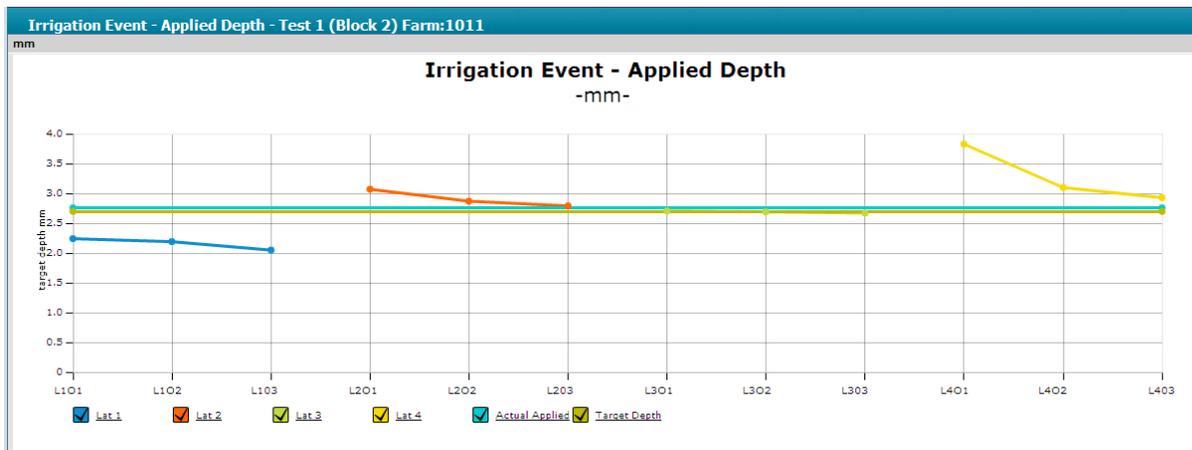
Figure C-1: Case Study 3: Irrig8lite results graph.

A drip or micro system should be performing in the range of 0.8-0.95 EU. The system performed well overall with Test 2 and Test 3 results within the expected range. Surprisingly, the first block (typically the best block) had ‘average’ results with an EU of 0.78 (“Fair”). The calculated target depth was correct at 2.8 mm/hr. Initially this looks alright but further analysis shows that there are inconsistencies with the results.

The raw data helps to decipher what is going on within the block (Table C-2). It was found that this block had dripline with two different emitter rates installed, which was not visually obvious. Because of the mix of emitter rates, this caused variations in the collected volumes for each row, this resulted in the lower EU of 0.78. The applied depth is on target for the desired depth. However, from the graph you can see some of the under and over watering on laterals 1 and 4 (

There is also an outlier on lateral 4b, this is likely caused by either, water tracking along the lateral from another dripper and being caught in the collection container, or during maintenance potentially a new length of lateral was inserted with the higher emitter rate. No matter the cause, the owner now plans to change the drip line to ensure uniform application throughout the block.
