Transport Rebuild East Coast

Historic Heritage Management Advice

To: Nick Beattie
From: Andy Brown
Cc:
Date: 09/09/2025
Project Area: BR217 River Berm Works
Fault ID: BR217

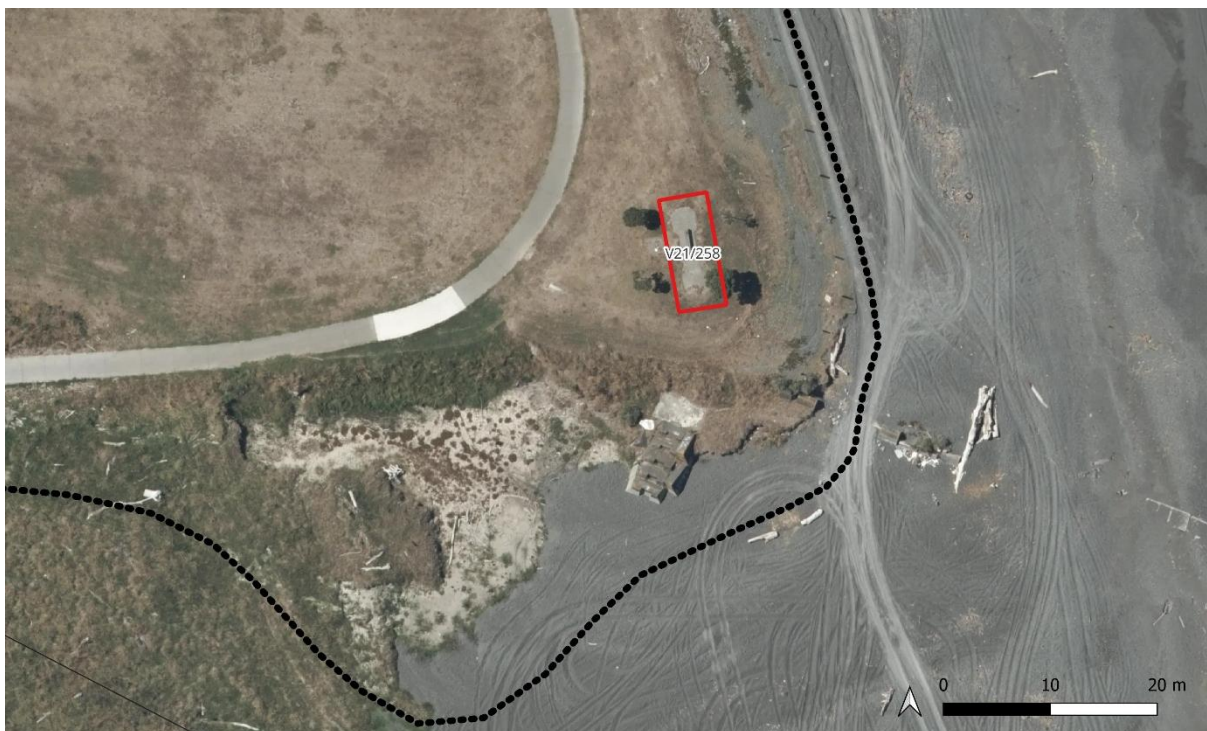
Figure 1 – Location of proposed access near V21/258 (LINZ, ArchSite).

No recorded historic heritage places or memorials are recorded within 50m of works. However, the eastern access track will pass within 50m of V21/258 (Figure 1, 2), a buried pill box associated with coastal defence efforts in the twentieth century. The structure is not protected by the Heritage New Zealand Pouhere Taonga Act (2014) but has considerable heritage value. The proposed eastern access route will make use of informal beach tracks, which are approximately 20m removed from the site (Figure 1 and 4).

It is recommended that the recorded location of the pillbox is included in pre-work briefings and toolboxes to ensure operators are aware of the site and maintain a safe working distance during machine movements.

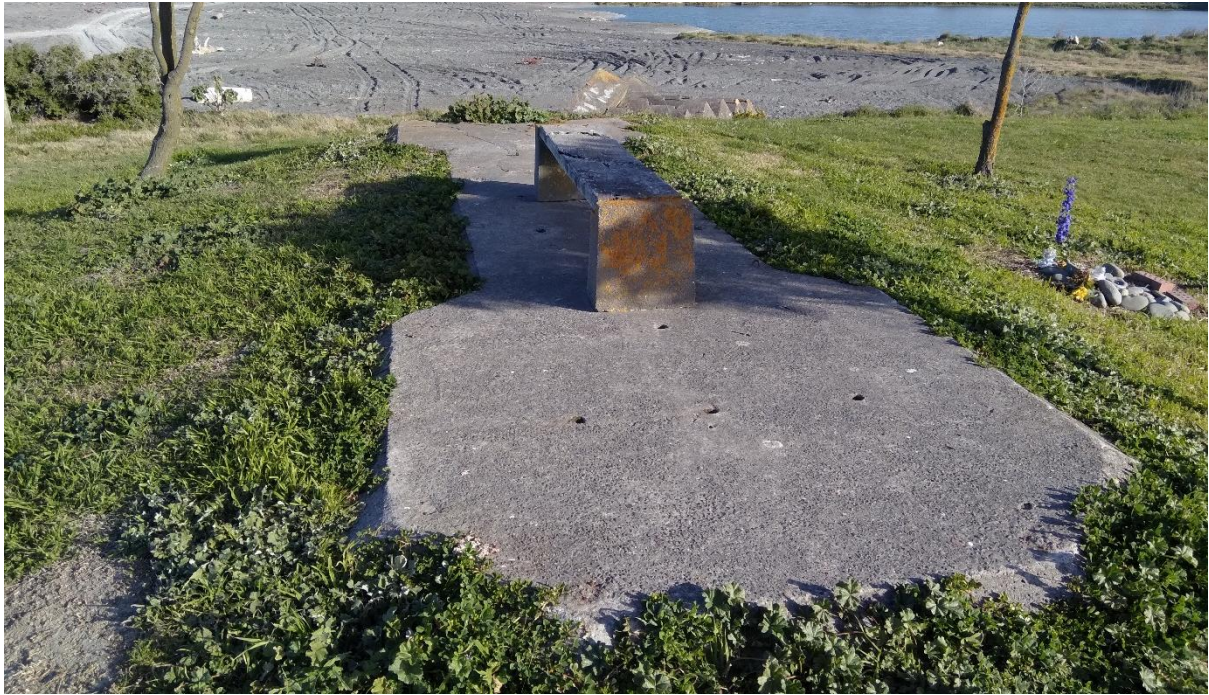
Figure 2 – The top of the pillbox.

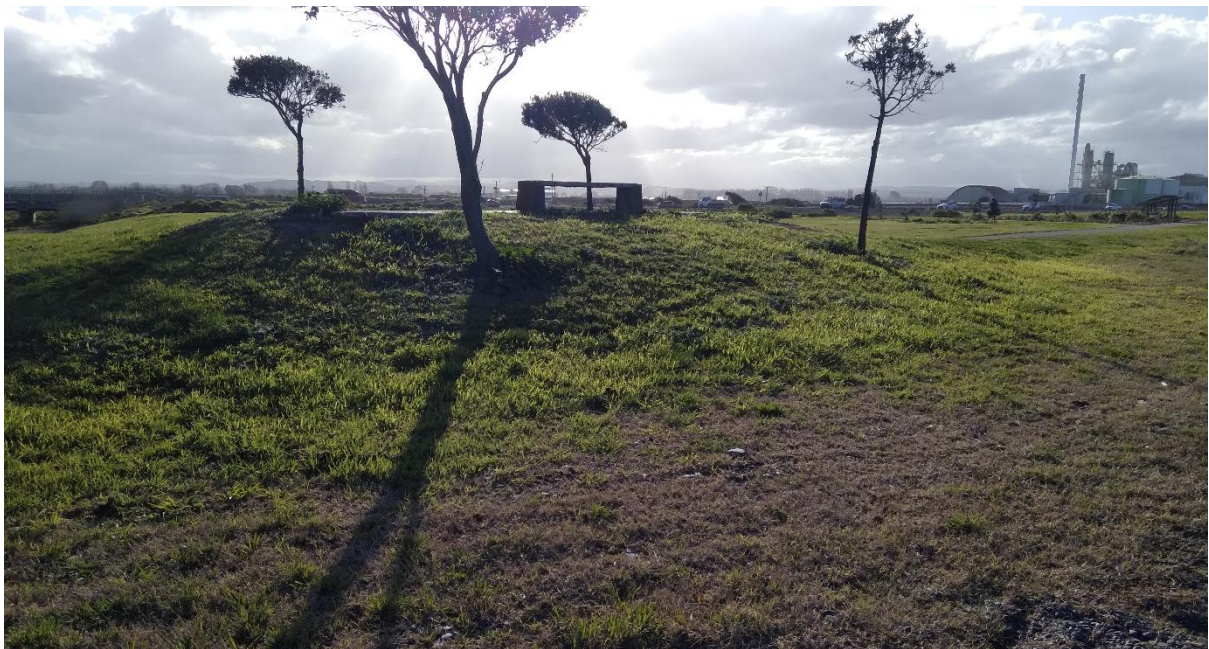
Figure 3 – West-facing image looking inland toward the pillbox (buried). The seat on the top of the pillbox is visible at the top of the mound.

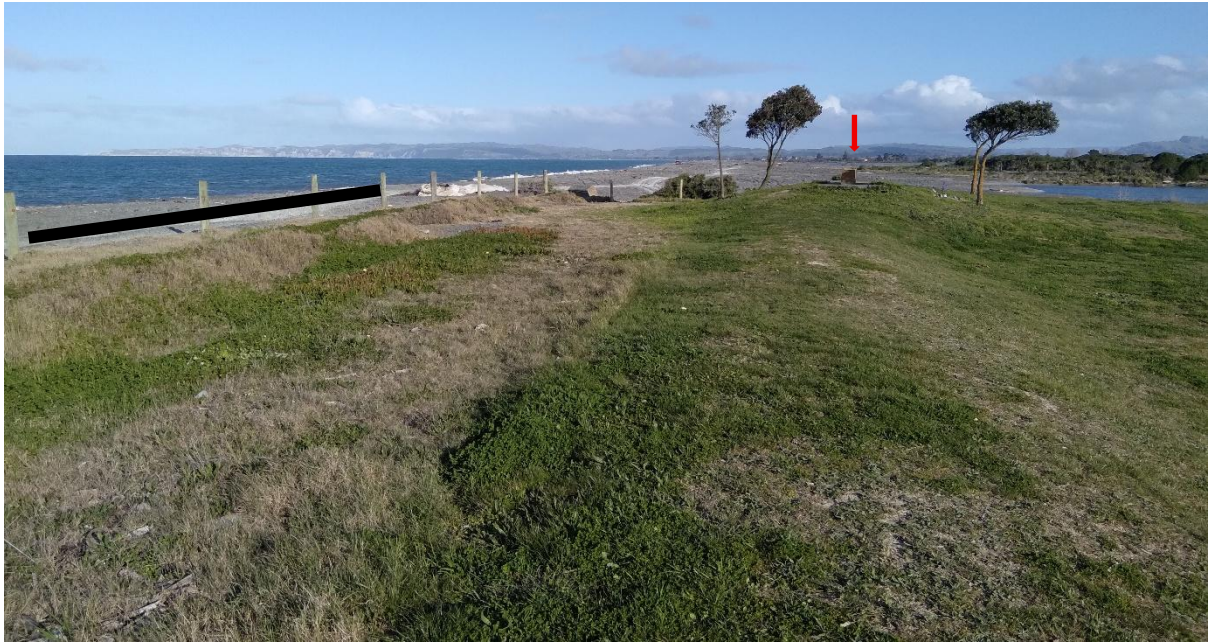
Figure 4 – The propose access track (black line) and the location of the pillbox (red arrow).

The works will take place in a dynamic riverine environment where natural processes are likely to have removed any intact archaeological deposits / features (if ever present). The area has also been heavily modified by bridge construction, including the recent emergency works. There is no evidence of historic heritage sites in the work zones or access tracks. Access along the beach is suitably removed from V21/258 and will have no effect.
