**GEOTECHNICAL ASSESSMENT OF
WATER TREATMENT PONDS,
PART LOT 1 DP 3350 WHAKAMAHIA ROAD, WAIROA**

Project Reference: 13322
17 August 2017

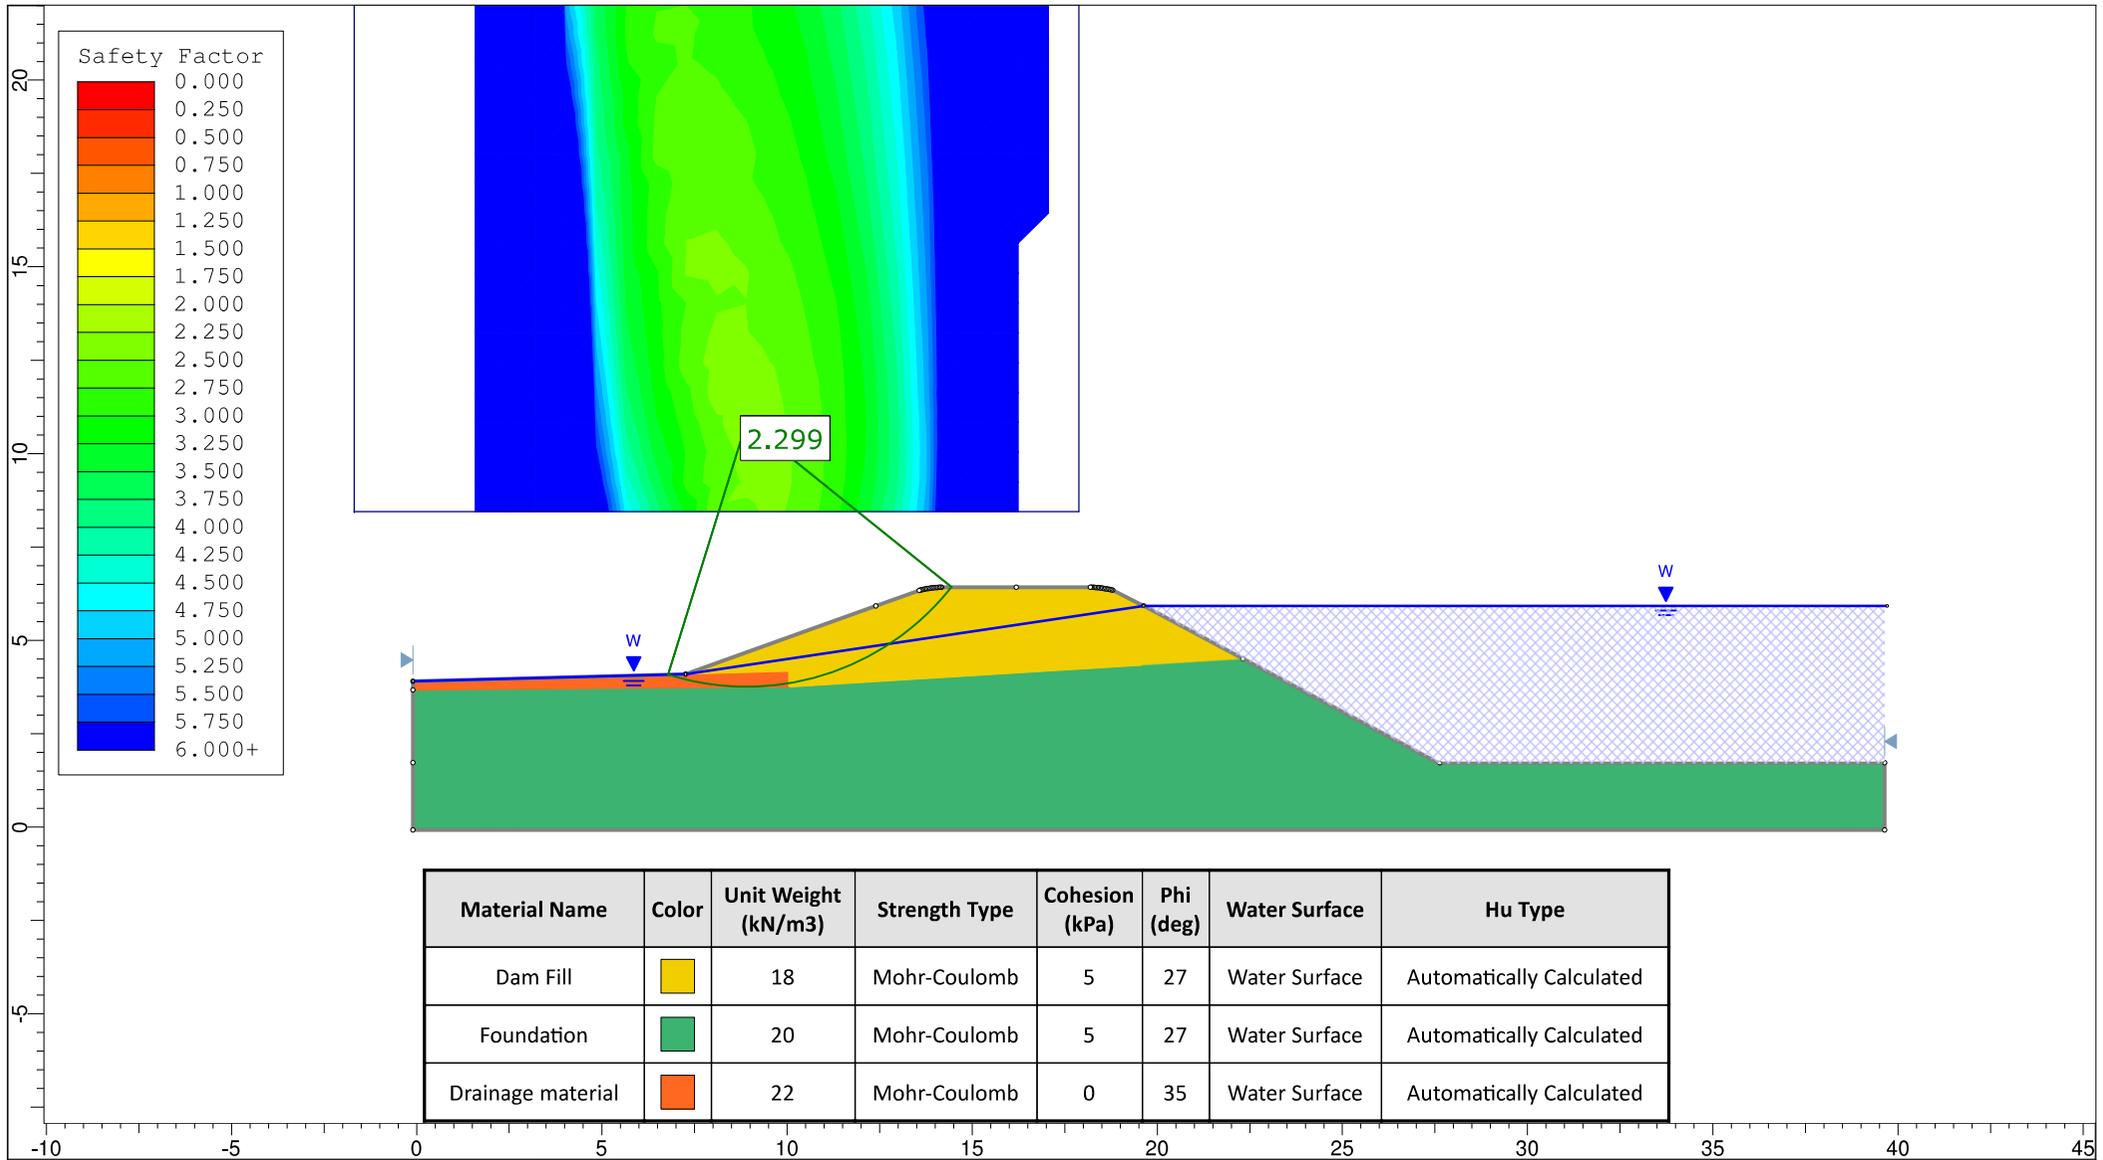
Under design conditions (modelled using maximum pond storage level), numerical analysis identified the raised embankment to have a minimum factor of safety of >1.5 (Figure 12).

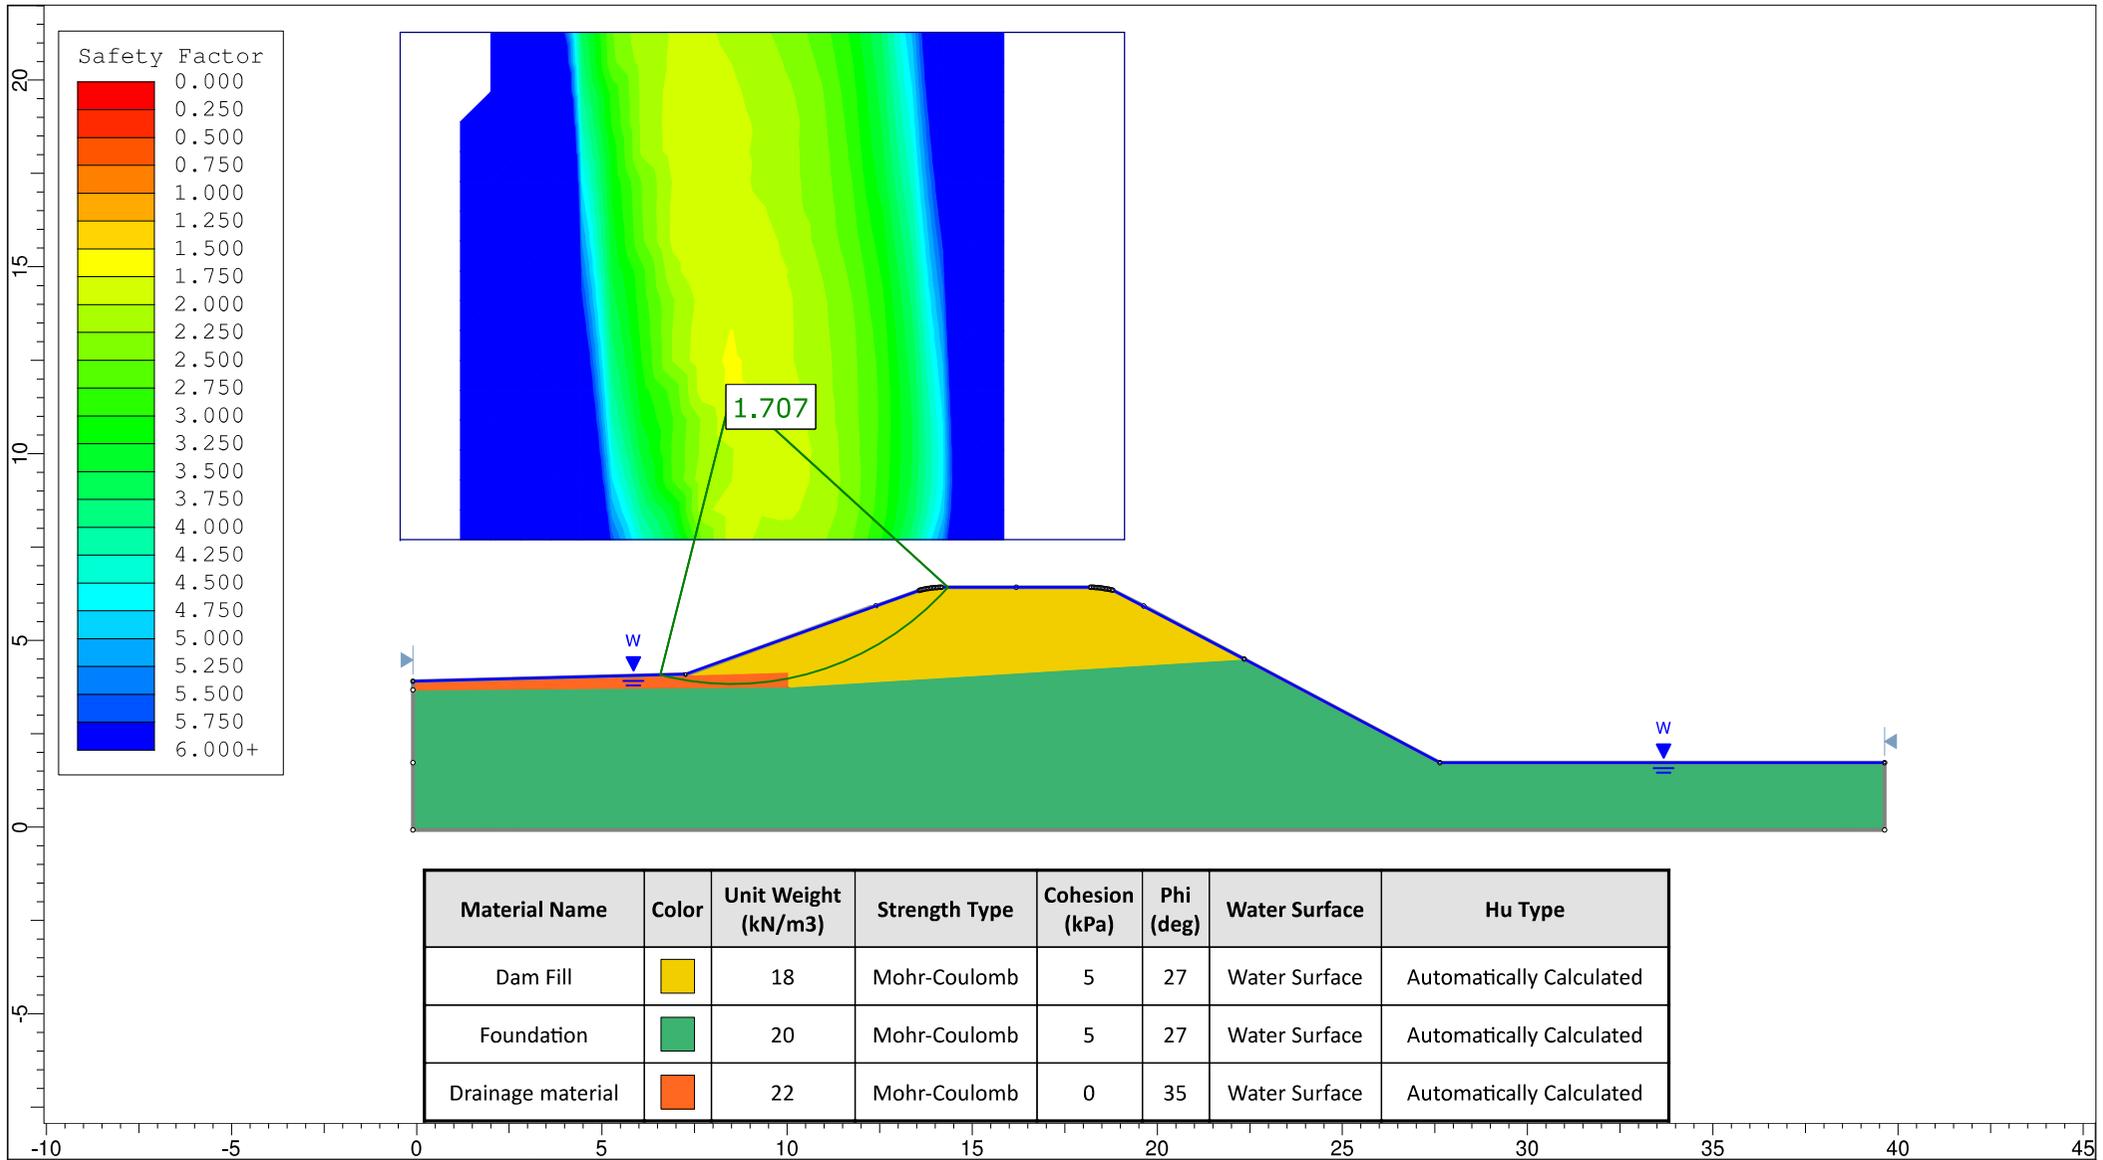
Numerical analysis identified that under the unlikely condition of a fully saturated embankment, (i.e. extreme groundwater conditions with an empty pond and saturated embankments) the internal embankments are shown to have minimum factor of safety values of >1.2 (i.e. meets the minimum criteria for stability under fully saturated conditions).

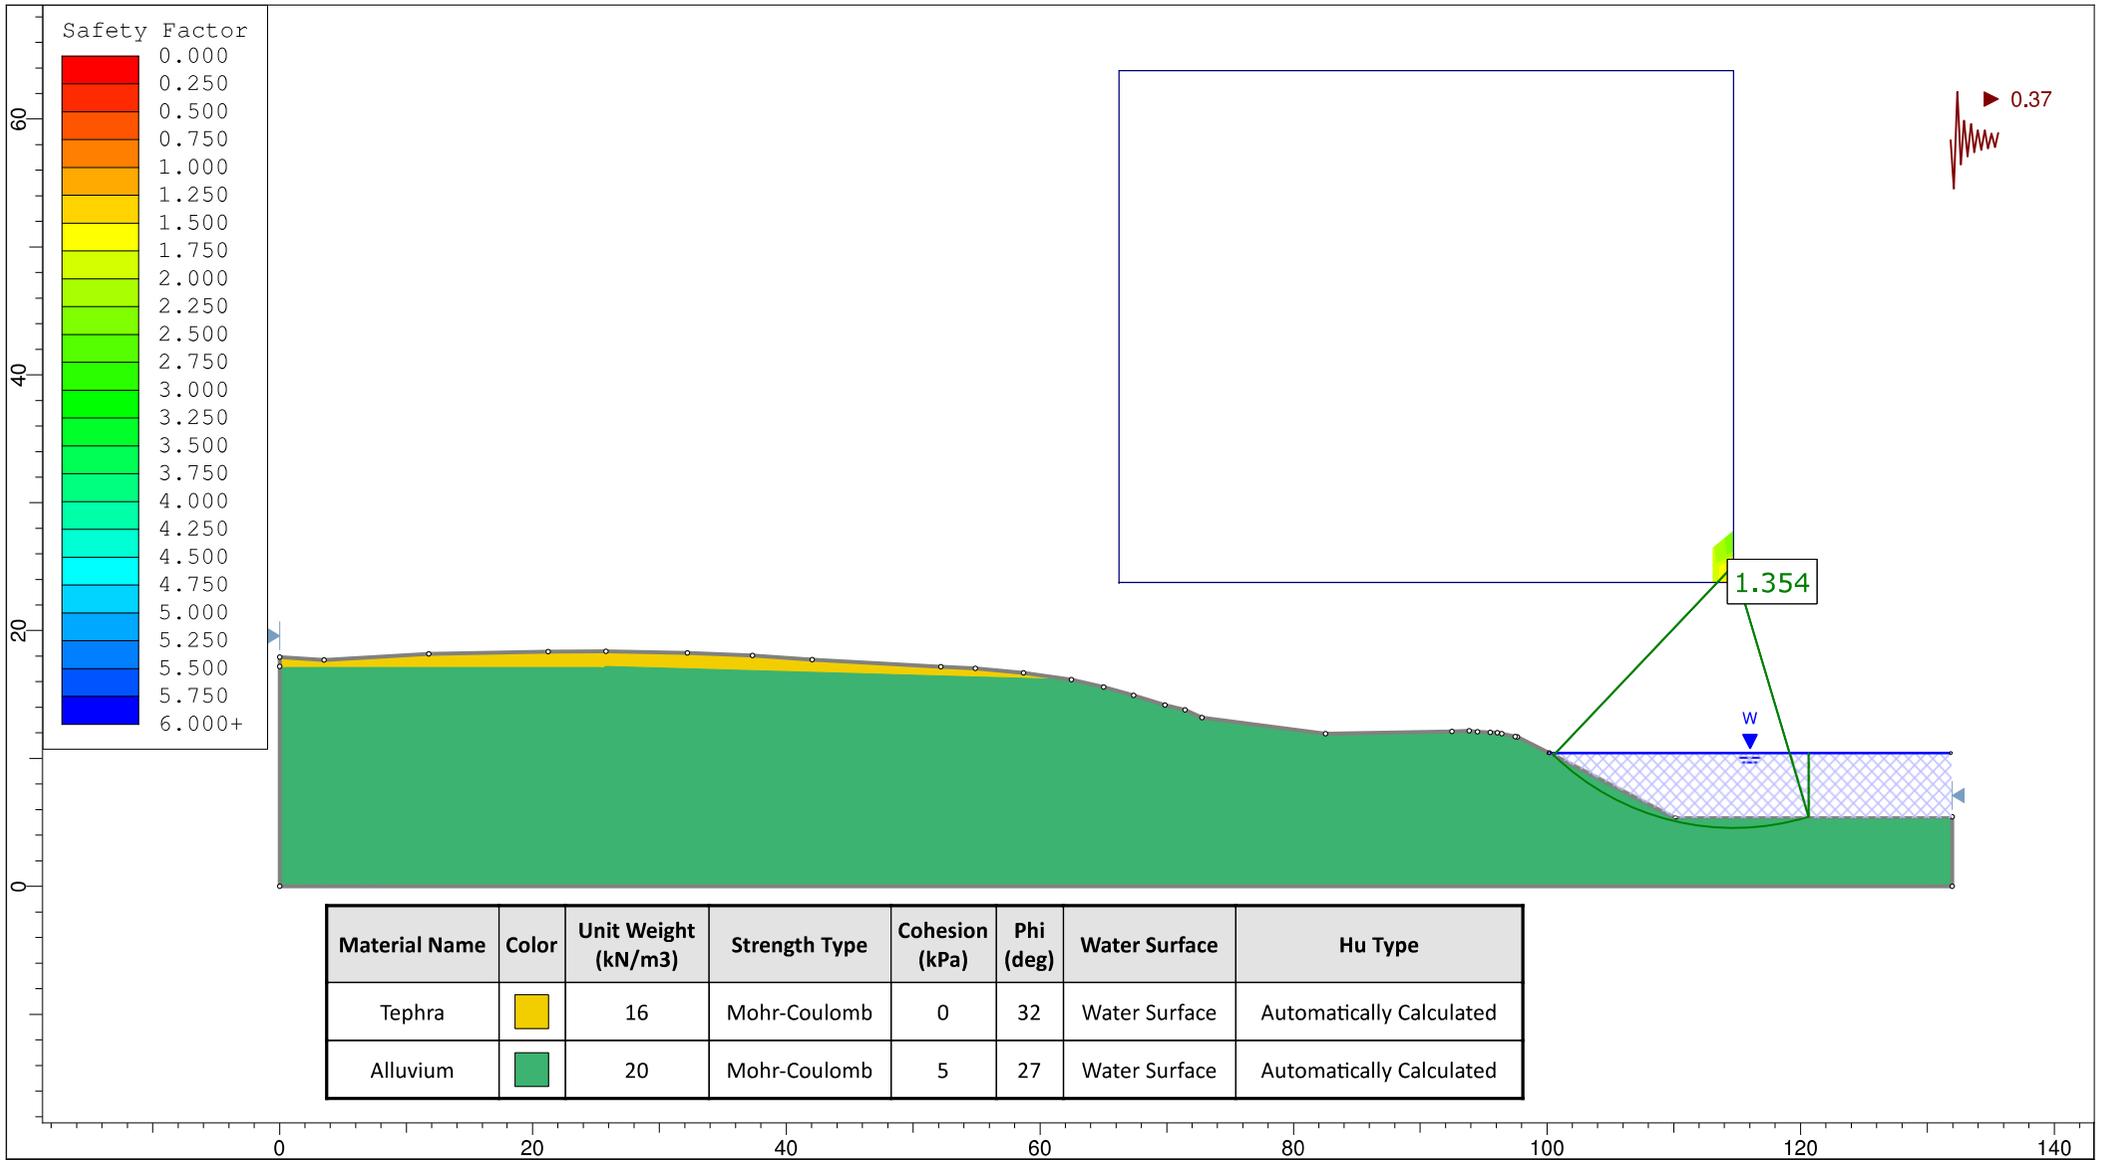
Numerical stability analyses were undertaken for the southern slope taking into consideration the secondary pond extending into the position of the primary aeration pond. The analyses showed that the slopes leading into the secondary pond would have a factor of safety >1.5 under fully saturated conditions and >1.0 under ULS seismic loading, both well above minimum accepted factors of safety.
