**NAPIER INNER HARBOUR  
and  
LOWER AHURIRI ESTUARY AREA  
POINT SOURCE DISCHARGES**

**NOVEMBER 2000**

**Investigation and Report undertaken and Prepared by  
Charles Rycroft  
Harbourmaster  
HAWKES BAY REGIONAL COUNCIL**

HBRC Publication No. 4877  
Report No. RM16-58

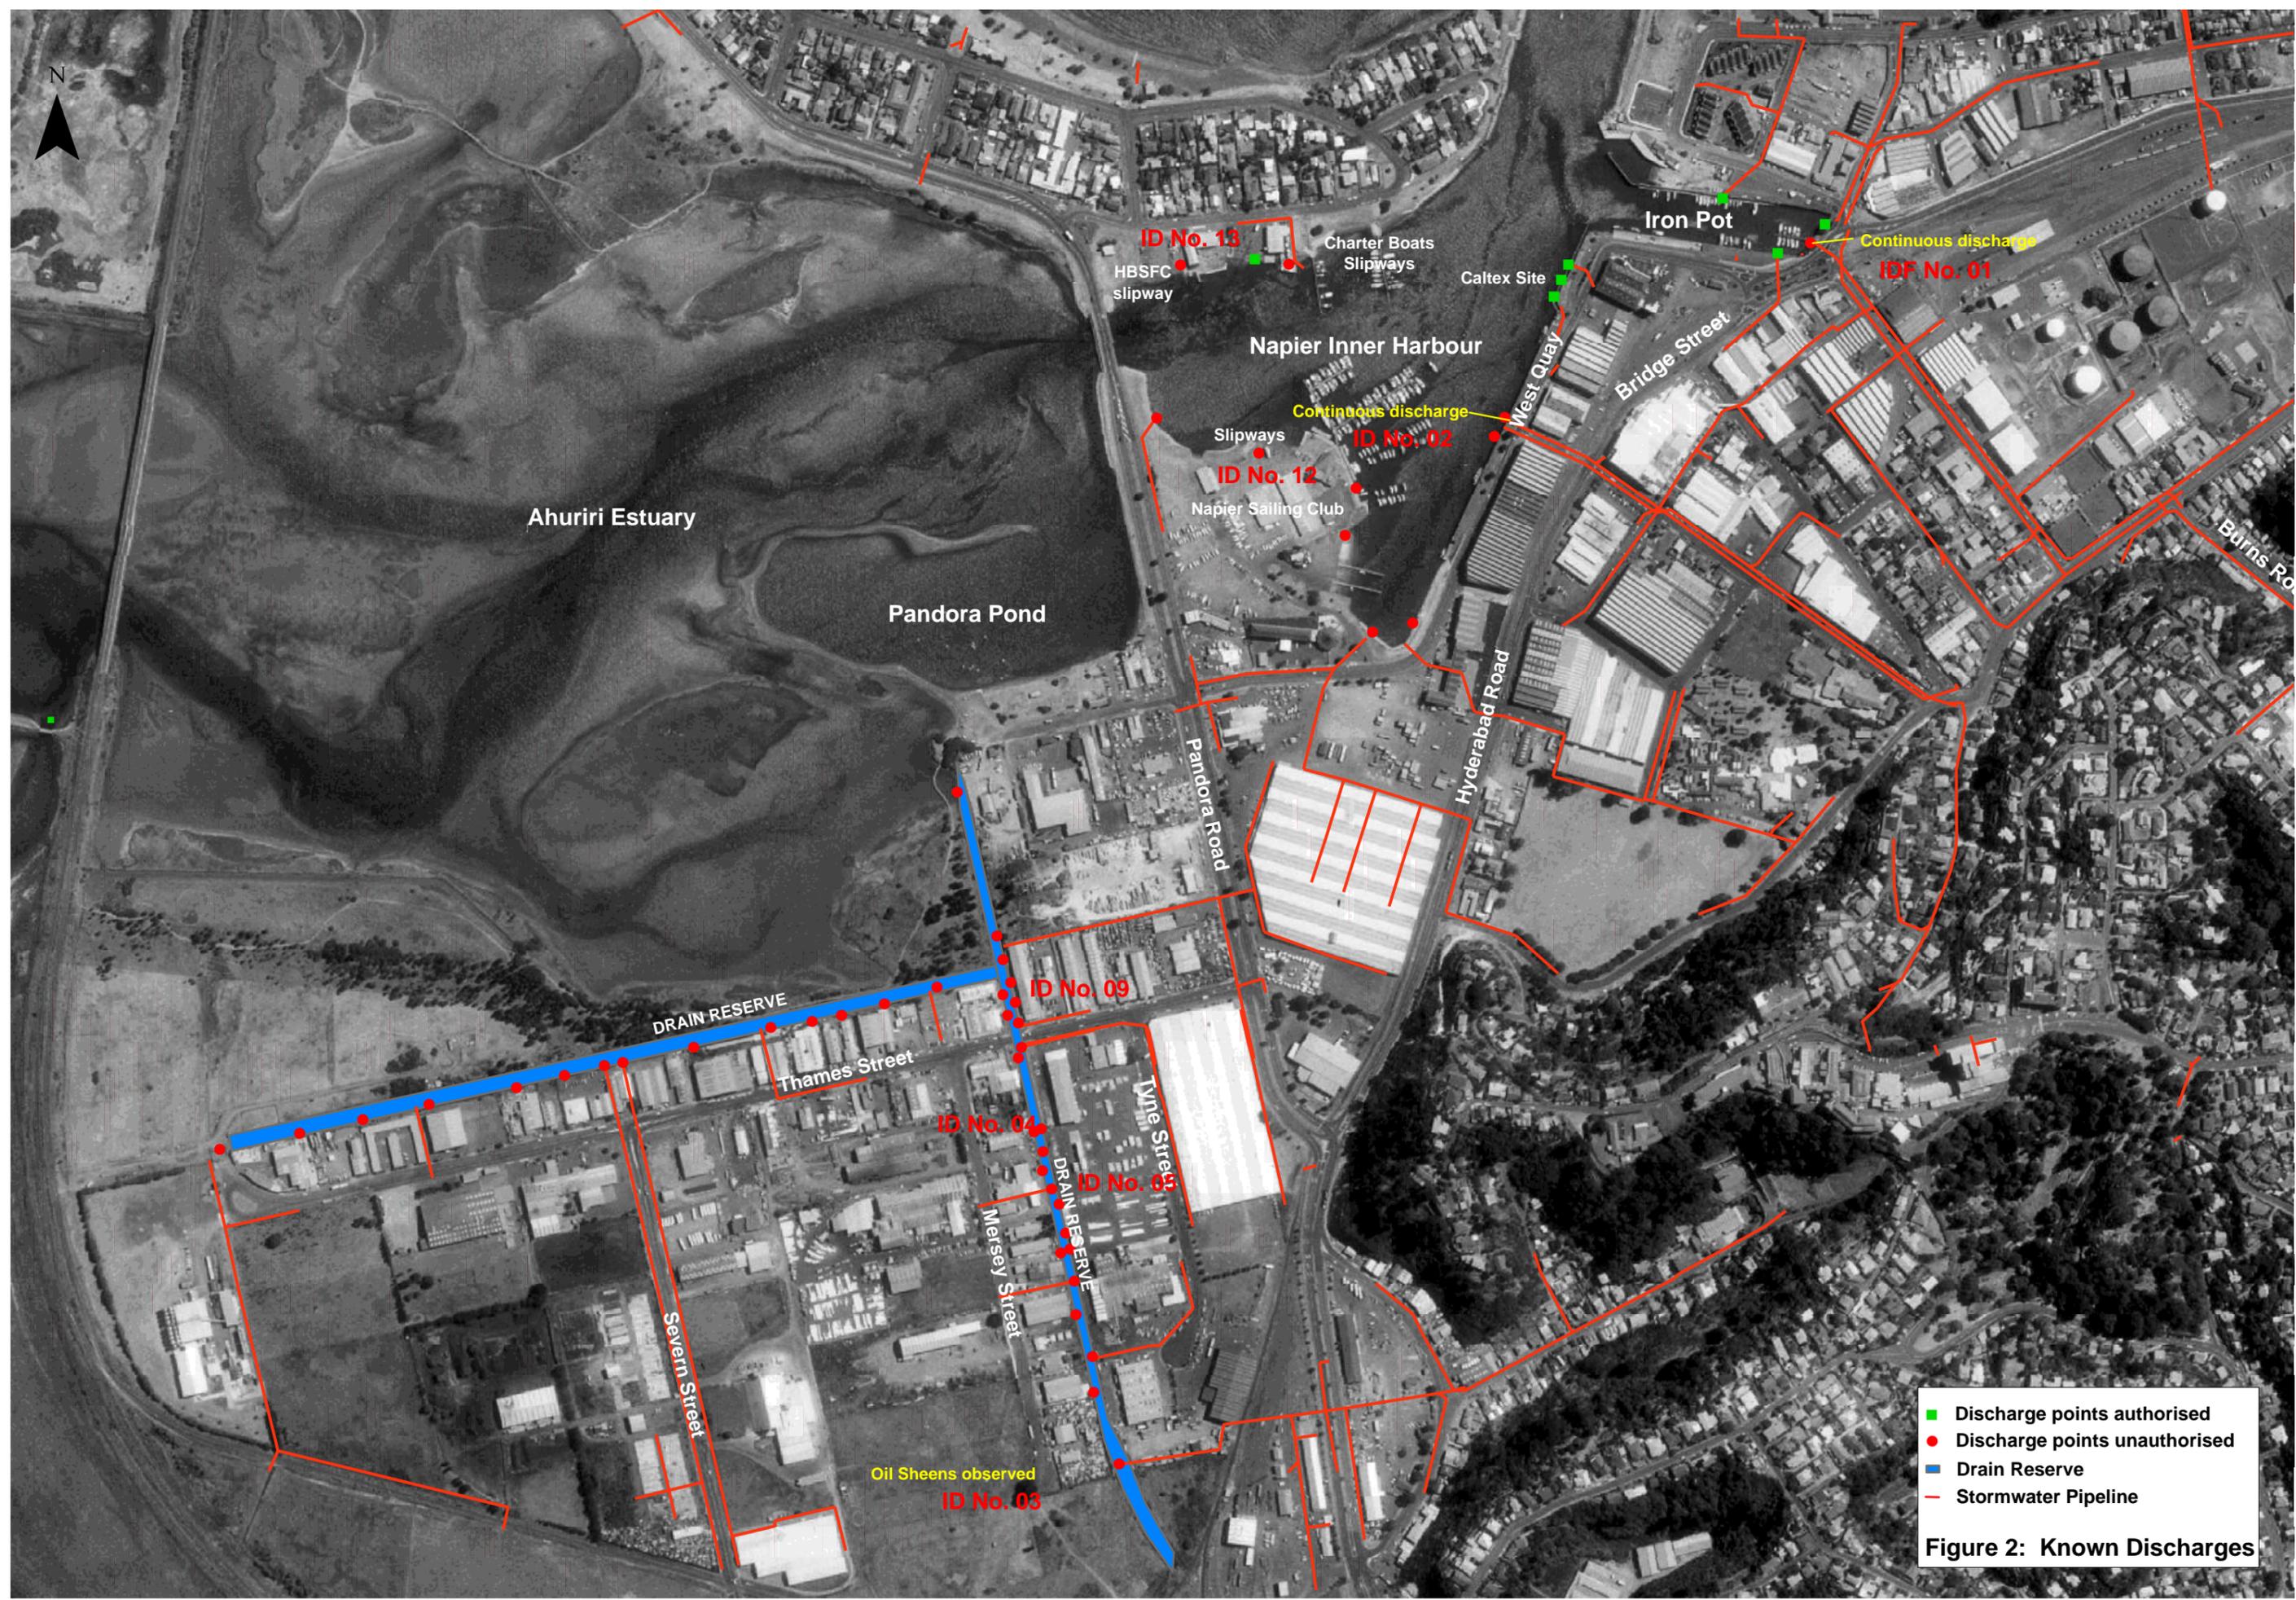
**Figure 2: Known Discharges**

In addition to the seven discharges, which are authorised by current resource consents, at least 37 unauthorised discharges were identified. The authorised discharges are detailed in Table 1, and unauthorised discharges are shown in Table 2. The locations of the authorised and unauthorised discharges are shown in Figure 2. Photos of unauthorised discharges are contained in Appendix 1.

Two stormwater discharge pipes are discharging water continuously – one at the eastern end of Iron Pot (ID No. 01) and the other at West Quay (ID No. 02, approx. 150 metres north of the Maintenance Berth). Both discharges appear to be clear water discharging at rates of < 1 litre/sec and > 5 litres/sec respectively. Investigations indicate that they may be discharging as a result of leaking water mains and reticulation pipes.
