Hawkes Bay Regional Council

Ruataniwha Water Augmentation
Scheme

Advanced Prefeasibility Geotechnical
Investigation Report

T&T Ref: 27195/V04

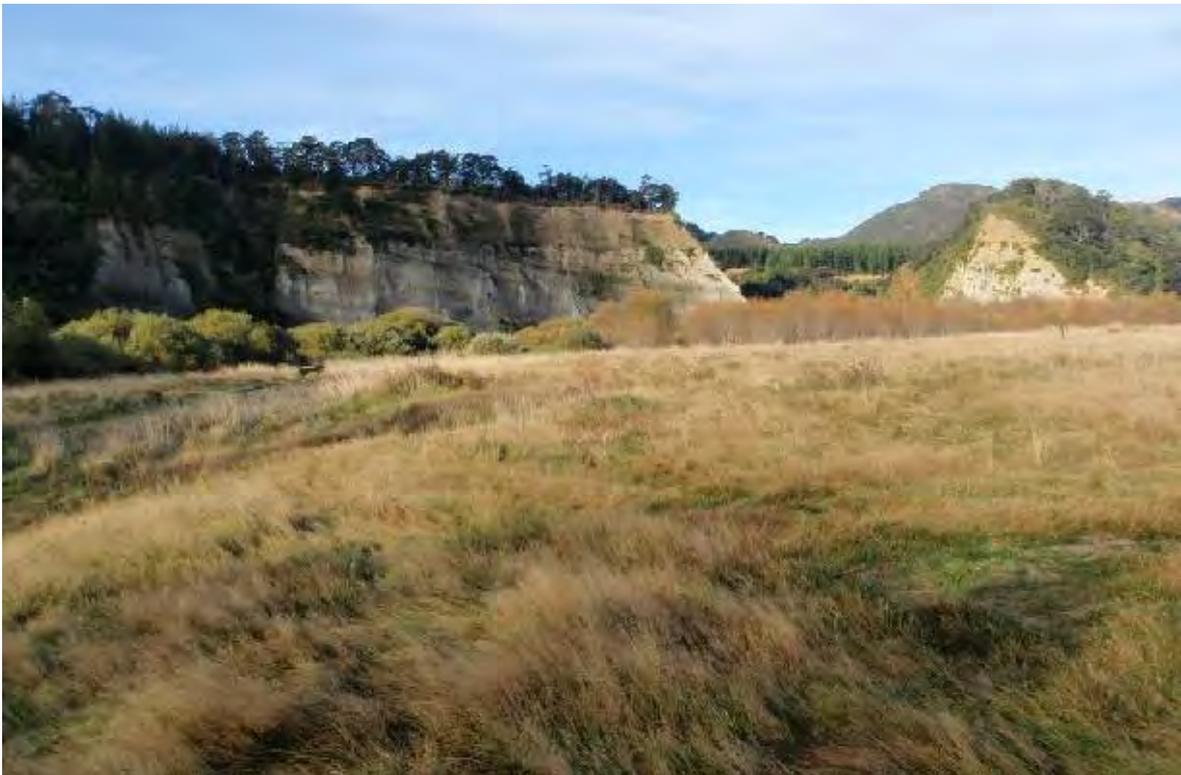
Figure 3-1 Fine sandstone exposed in cliff along northern edge of Makororo River capped by red metals

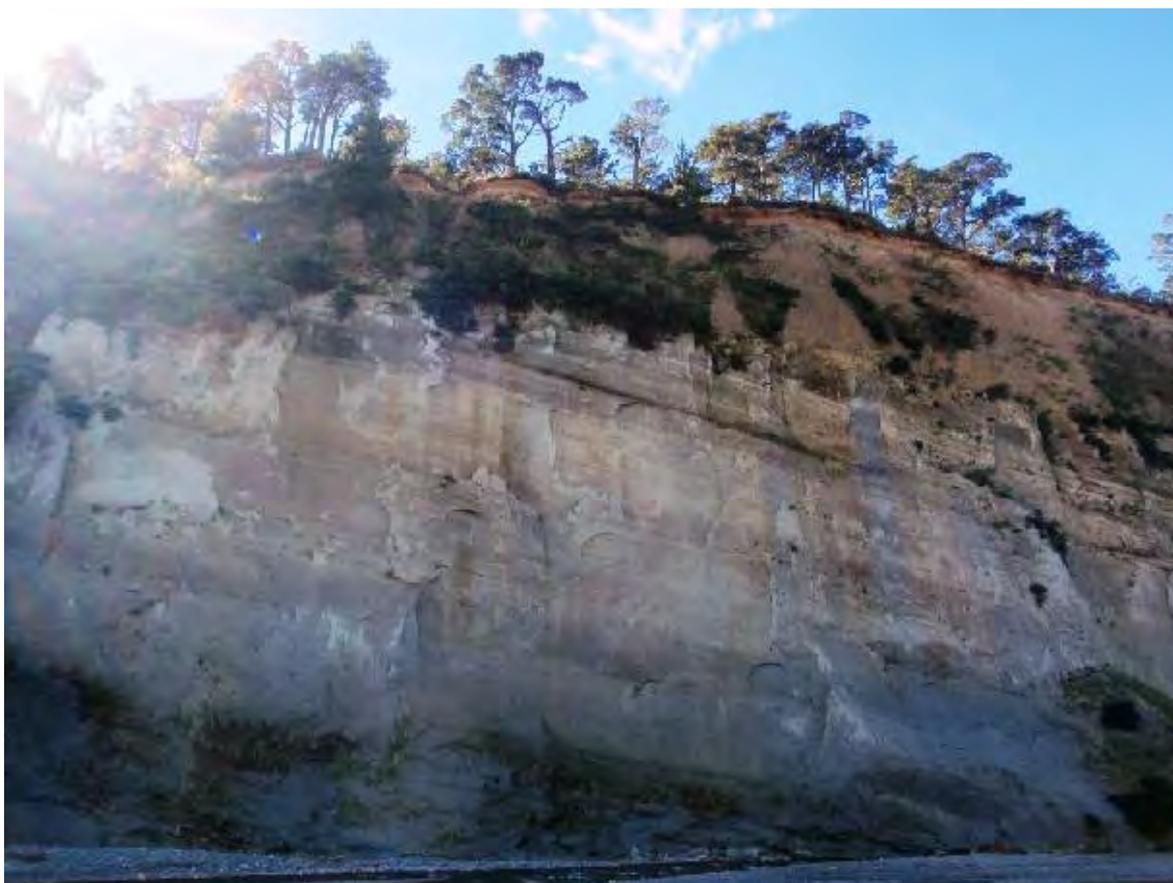
Extremely weak fine sandstone is exposed in the cliff at the northern edge of Makororo River (refer Figure 3-2). A cemented layer was seen in the sandstone separating dry (upper) and wet

Figure 3-2 Fine sandstone exposed in cliff along northern edge of Makororo River (top to bottom: red metals, dry fine sandstone, cemented layer, wet fine sandstone with slabbing)

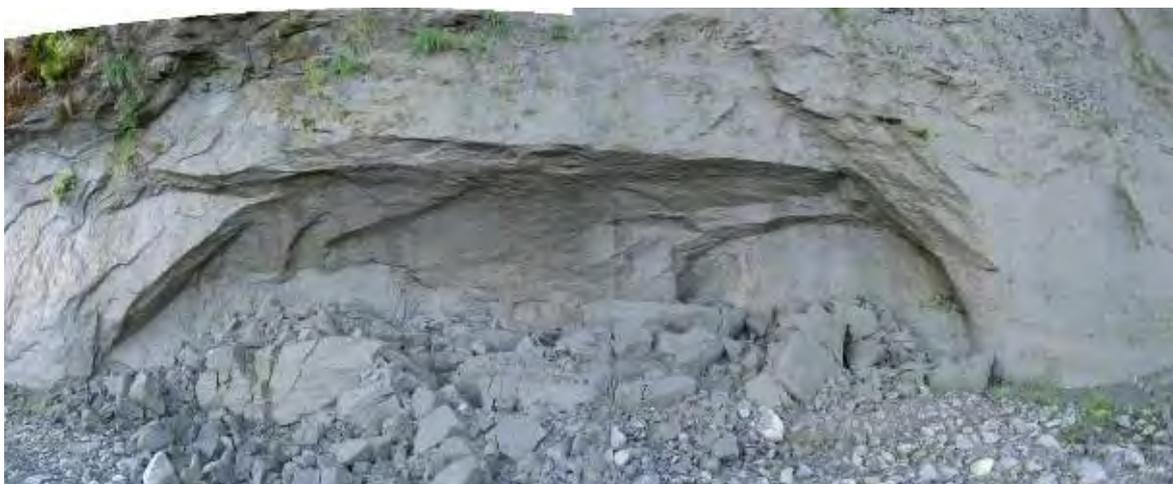
(lower) sandstone, and minor slabbing was visible near the base of the cliff (refer Figure 3-3). Figures follow on pages 8 to 15, and are similarly included for each dam site.

Figure 3-3 Minor slabbing at base of cliff along Makaroro River

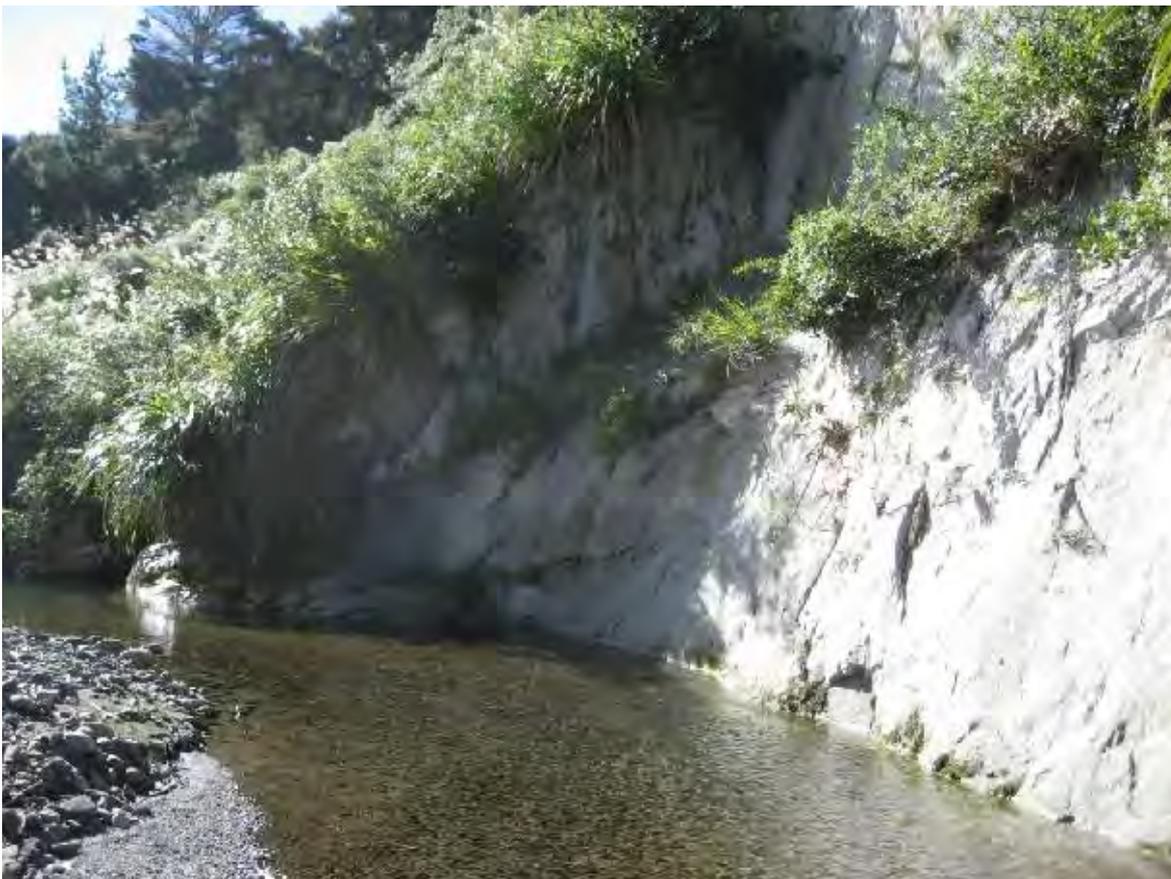
In particular, landsliding on a shear zone dipping at 40° towards 285°-290° was mapped within the footprint of the original dam site (refer Figure 3-6) and 250m downstream (refer Figure 3-4). The two observations of the shear zone plot on a straight line and it is likely that the defect is continuous between the two observations. If so, the shear zone may indicate the presence of faulting subparallel to the nearby major Ruahine and Mohaka faults.

Figure 3-4 Landsliding on joint dipping 40 degrees to 290 degrees 250m downstream of original dam location

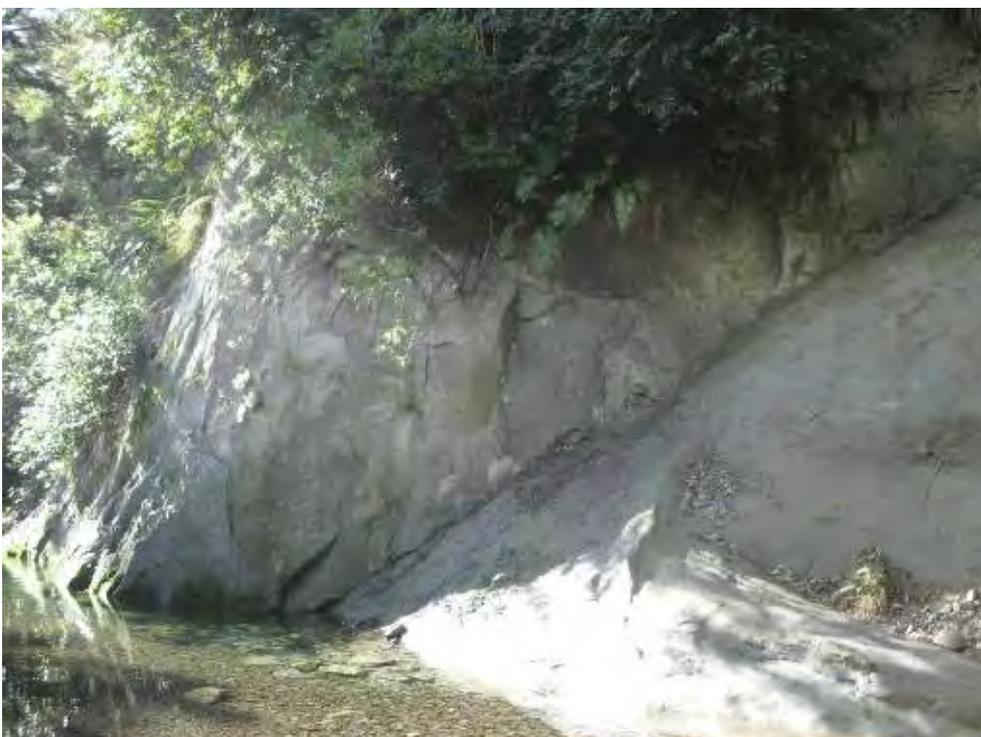
Figure 3-5: Landsliding on a shear zone dipping 40 degrees W

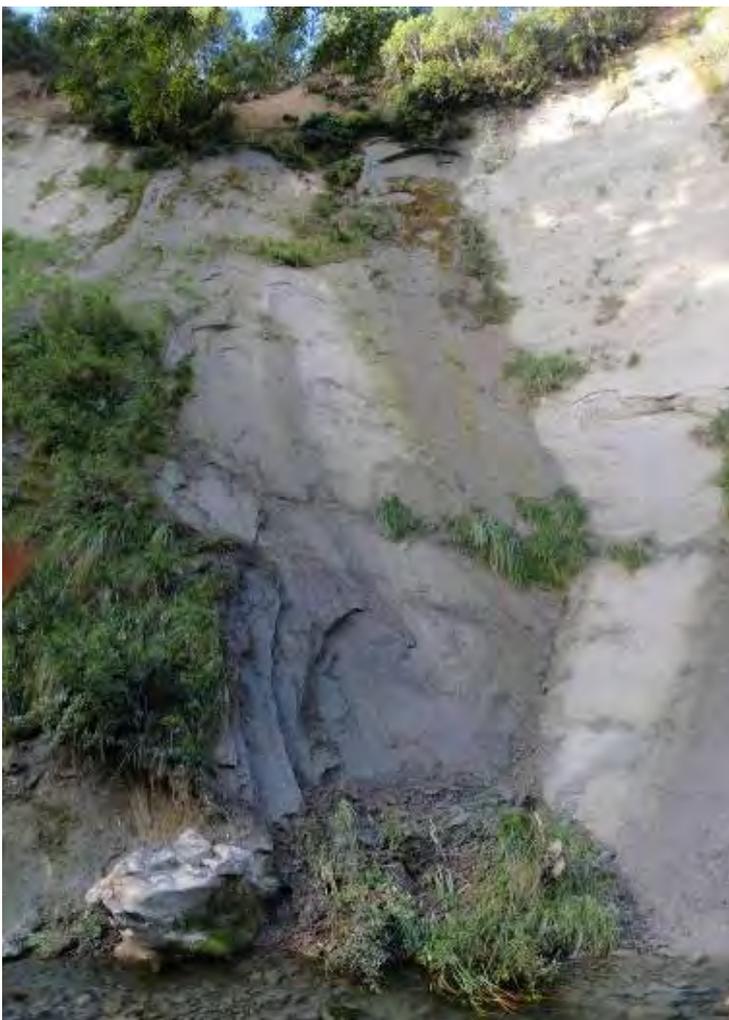
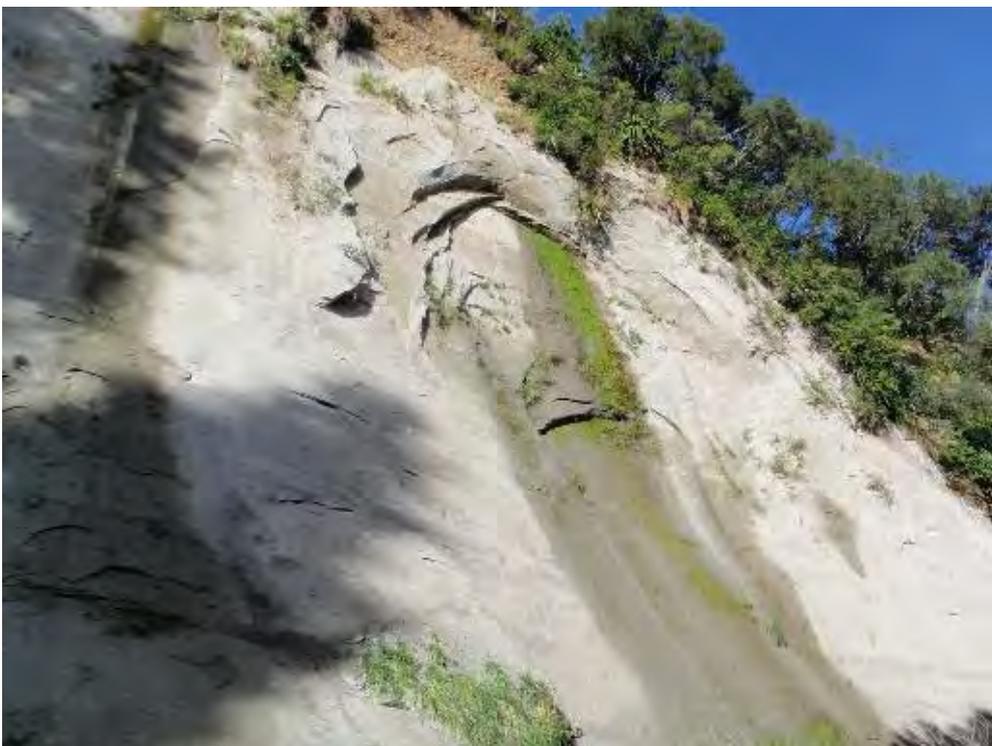
Figure 3-9 Seeps from stress relief jointing near upstream toe of original dam location.

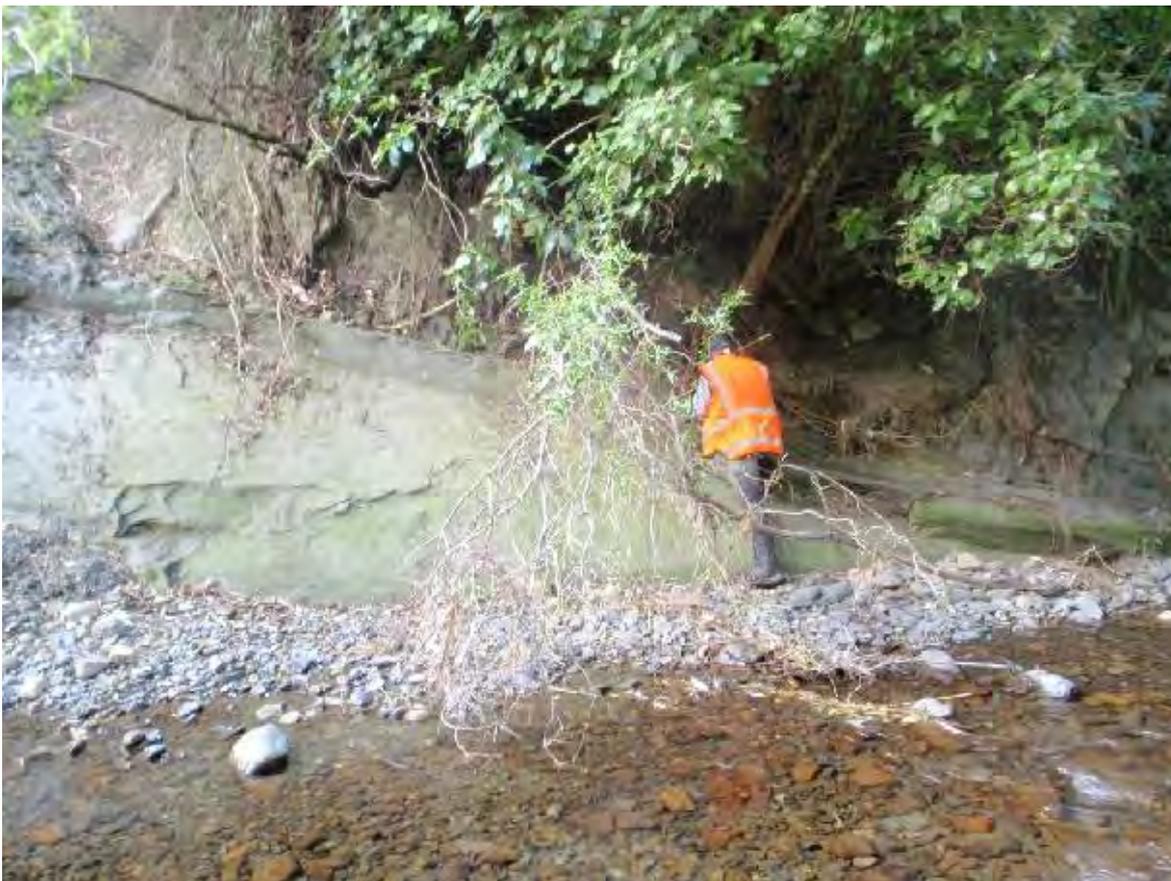
Figure 3-10 Landsliding on bedding plane shear 15 degrees to 158 degrees

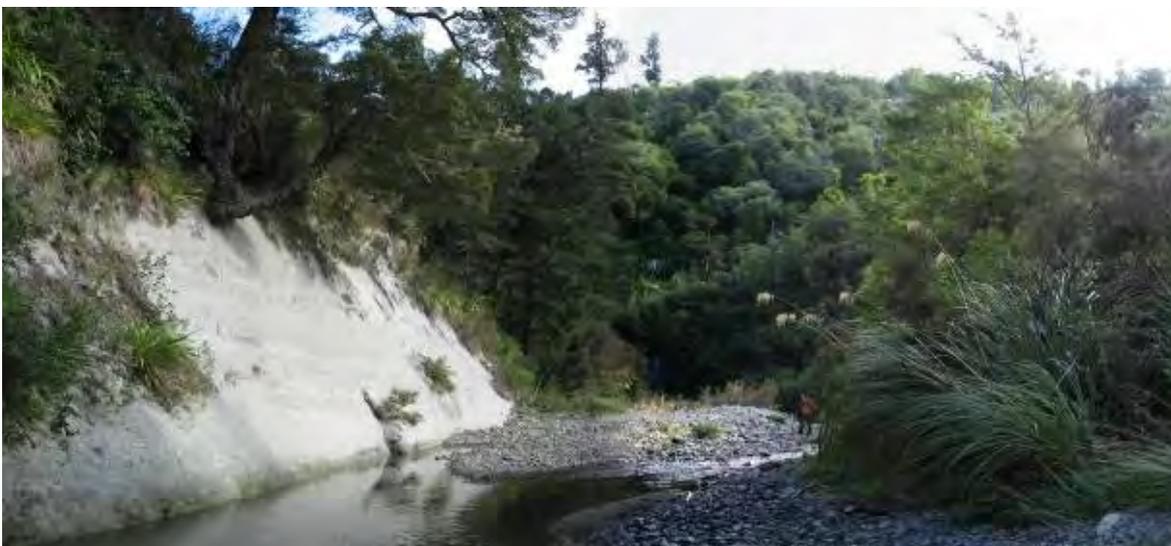
An alternative dam site was identified some 500m upstream of the originally proposed site (refer Figure 3-11). At the alternative site the rock mass appears more massive, and the postulated fault would cross the embankment east of the deeply incised stream valley. Both sites are characterised by bedding plane defects dipping at low angles downstream that may transmit reservoir water pressures beneath the dam (refer Figure 3-8), and a zone of highly disturbed rock mass indicative of significant tectonic disturbance was noted at the location of the upstream toe of the alternative dam (refer Figure 3-12).

Figure 3-11 Alternative dam site

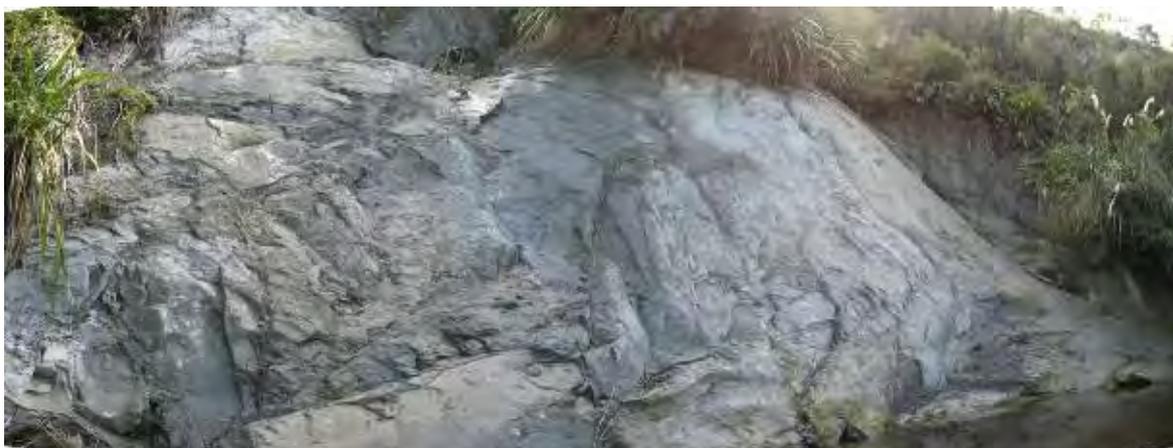
Figure 3-12 Disturbed zone at upstream toe of alternative dam location indicating significant tectonic disturbance

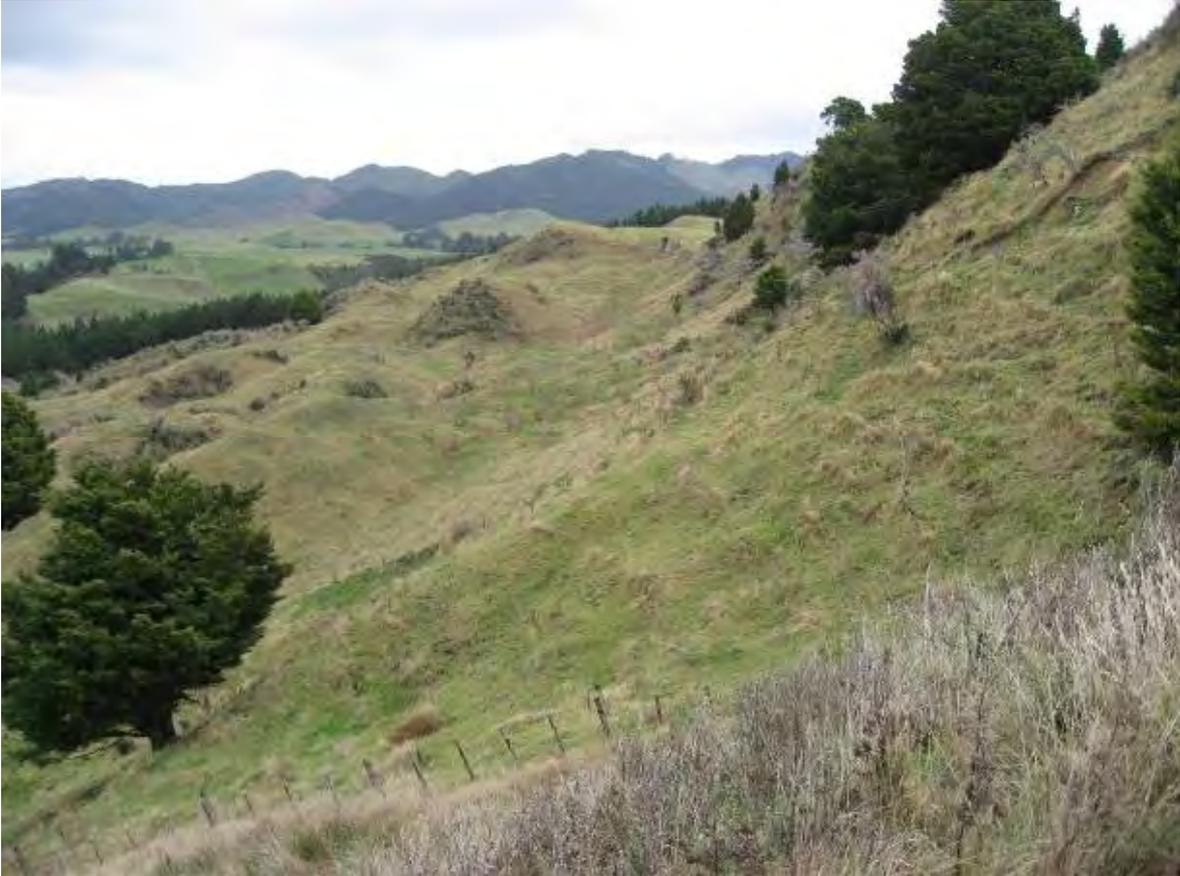
Large scale landsliding, predominantly rotational, was observed in the nearby Mangamauku Stream valley (refer Figure 3-19). Inspection of exposures in the Mangamauku Stream valley

show that the materials involved in the landsliding are similar to those exposed in the valley at the proposed dam site. The landsliding is likely to be occurring on the upper surface of the siltstone or on well developed bedding planes within siltstone as noted in the Middle Upokororo Stream valley, possibly due to strong earthquake shaking. Inspection of contours suggests there might be similar instability upstream of 394mRL (Mean Sea Level = 10mRL) in the Middle Upokororo Stream, which will be within the upper reaches of the proposed reservoir if the storage volume is set above 13 million m³.

Figure 3-19 Landsliding in Mangamauku Stream valley

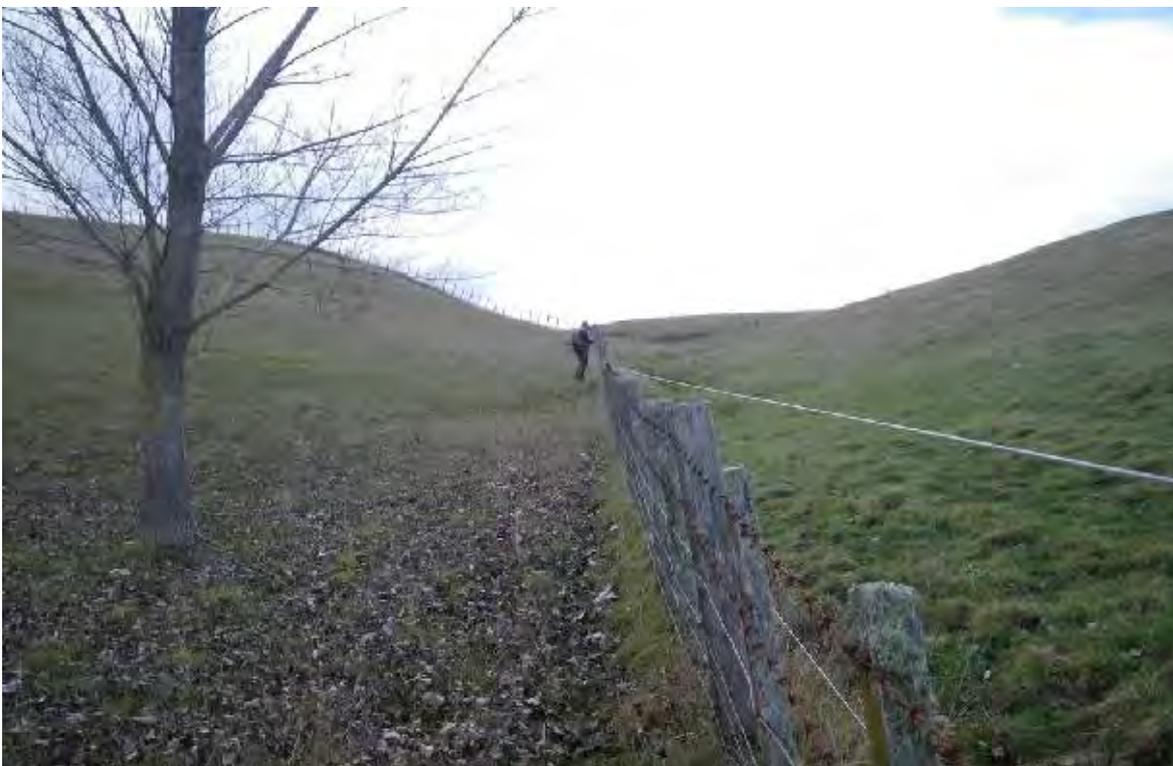
Figure 3-22 Downstream of left abutment: Fence displaced at wet gully bulge

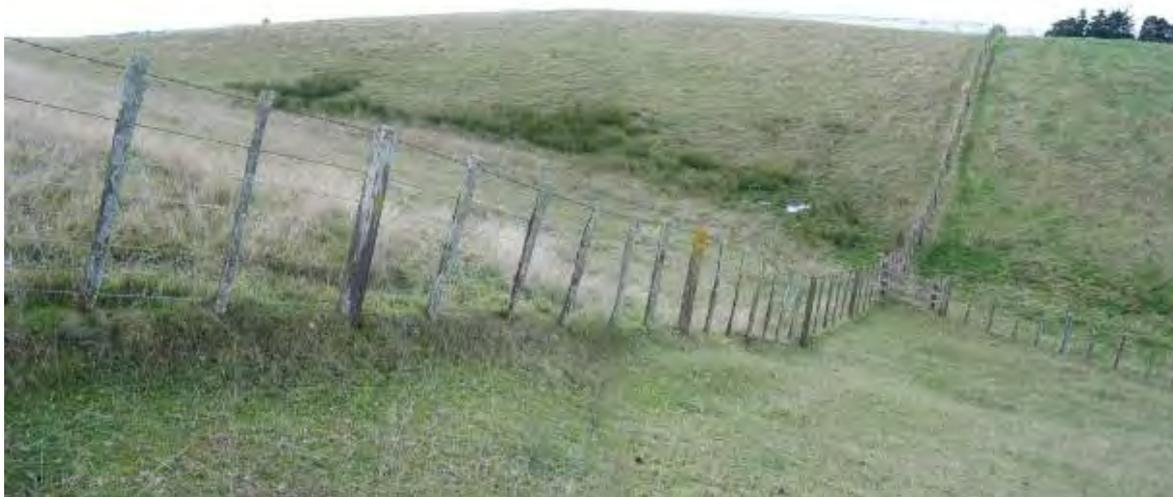
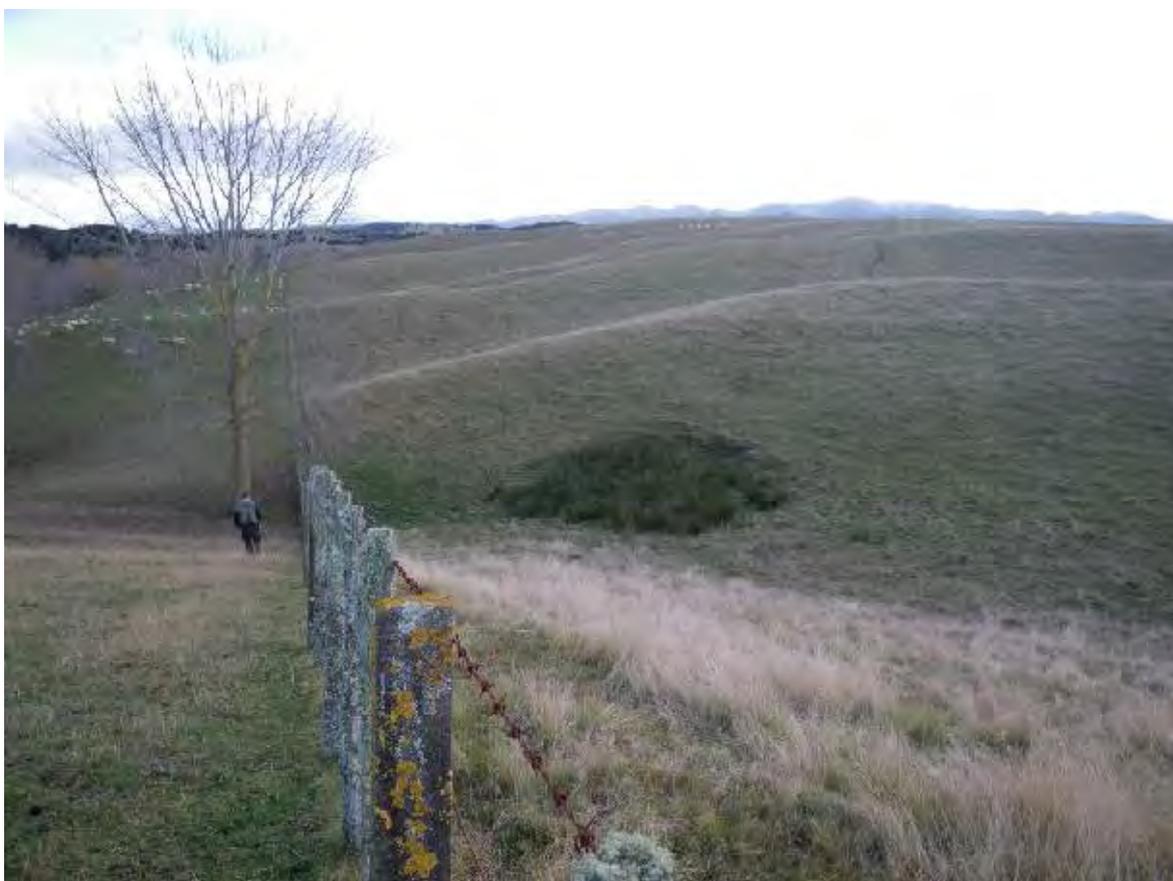
Observations during our site visit confirmed that a complex groundwater system exists. For instance, despite heavy rain during the night prior to our visit, the stream bed was dry in most places with ponding in other places. Seeps were also observed close to the top of the ridge downstream of the left abutment and emerging within the terraces. The drying of the stream bed is likely to be related to a high permeability layer, such as the sand noted in the stream bed downstream of the dam embankment. The high level seeps may be related to the less permeable lenses and beds of silt within the red metals.

Figure 3-23 Downstream of left abutment: Seeps near top of ridge

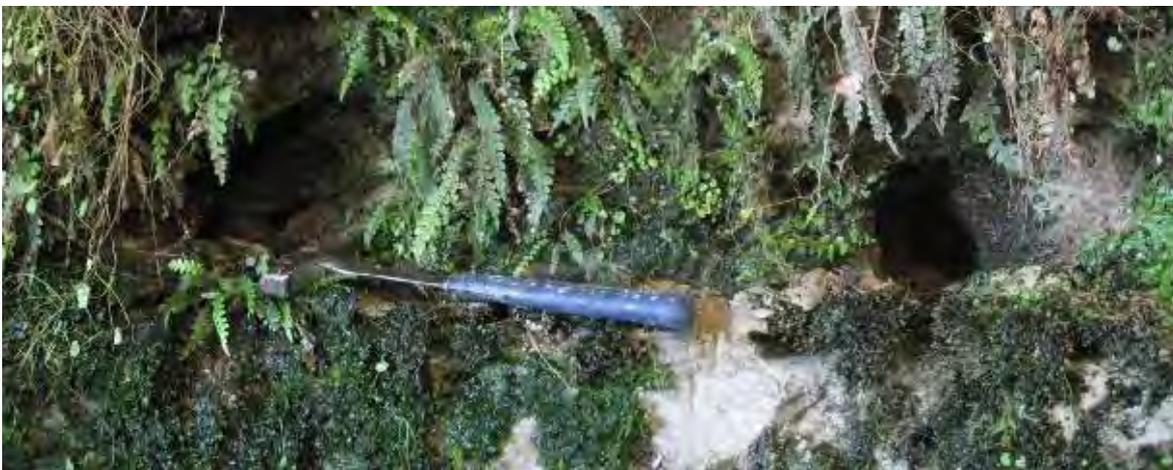
tomos in the pumiceous sediments by internal erosion (suffusion) in the pumiceous silts (refer Figure 3-30).

Figure 3-30 Suffusion through pumiceous silts in forming a tomo

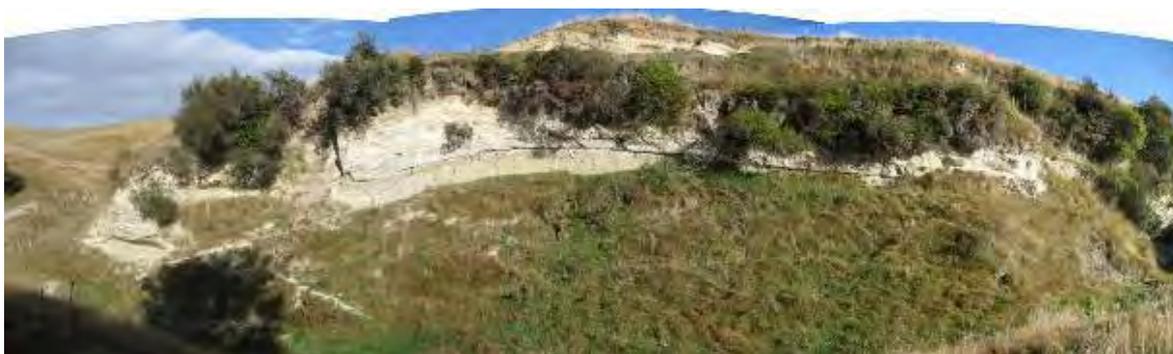
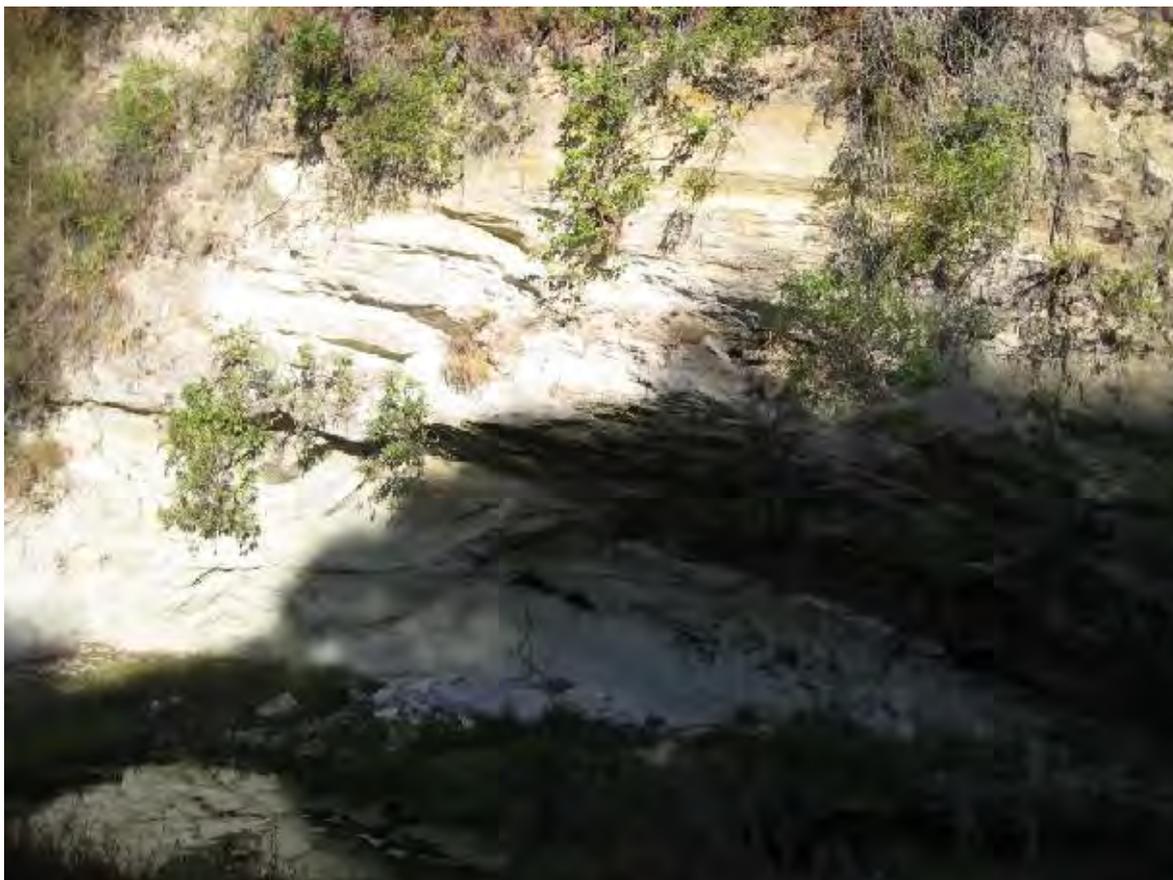
Figure 3-31 White pumice sands and silts dipping 35 degrees to 330 degrees, underlying red metal. Chaotic bedding of pumiceous tephra indicative of major disruption at toe of landslide. Cliff height 10m.

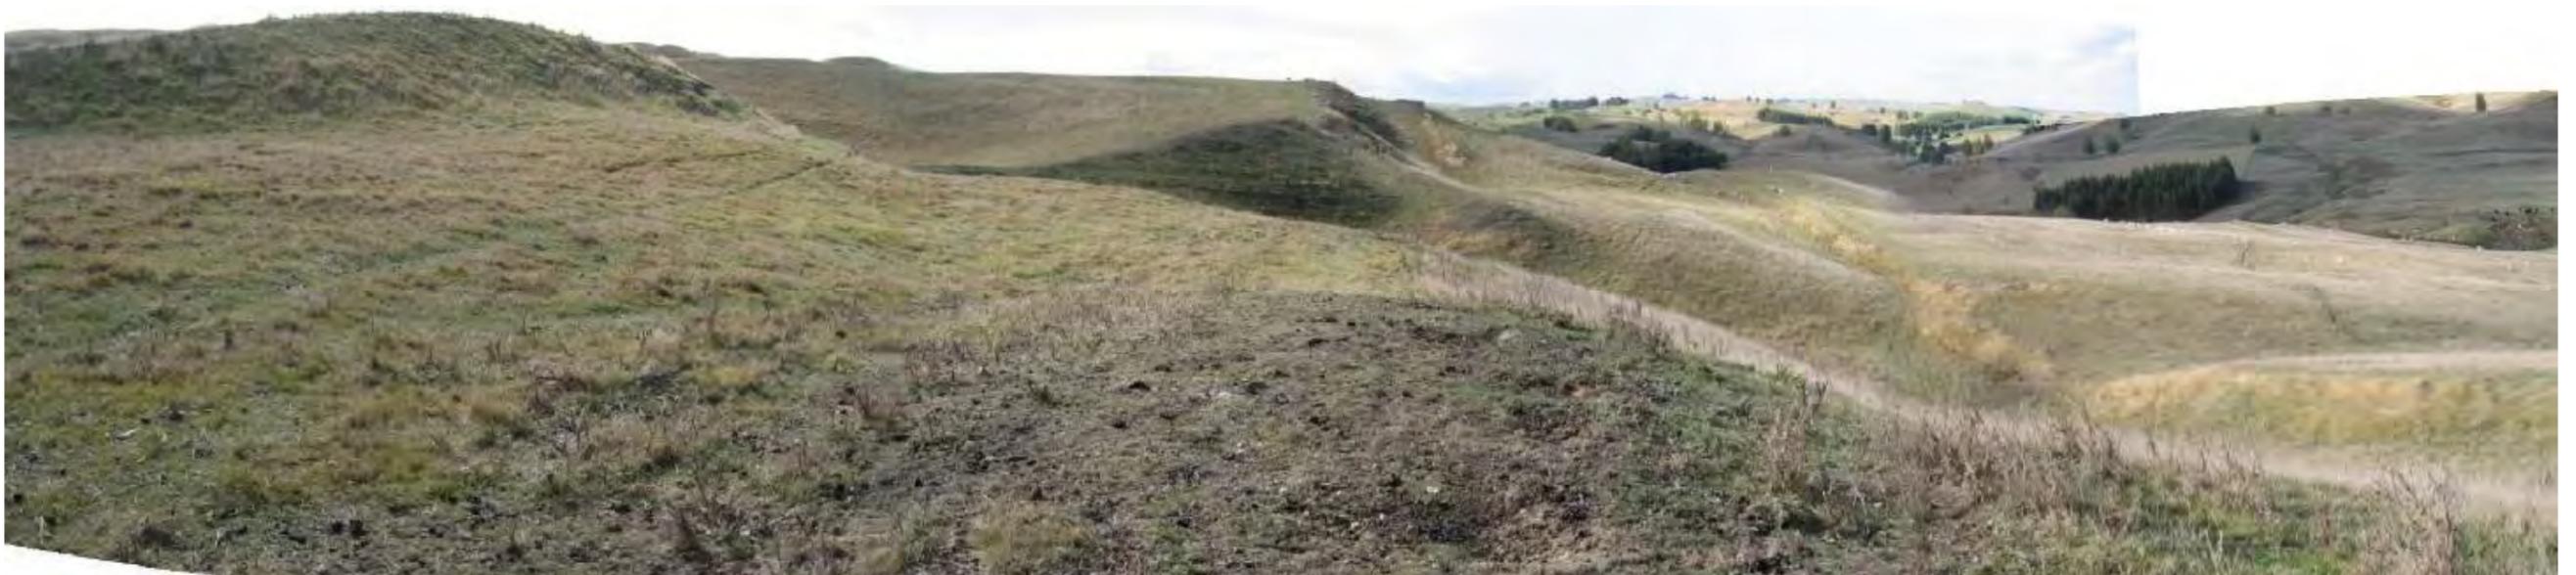
Figure 3-33 60m wide graben of large scale landslide, viewed from west

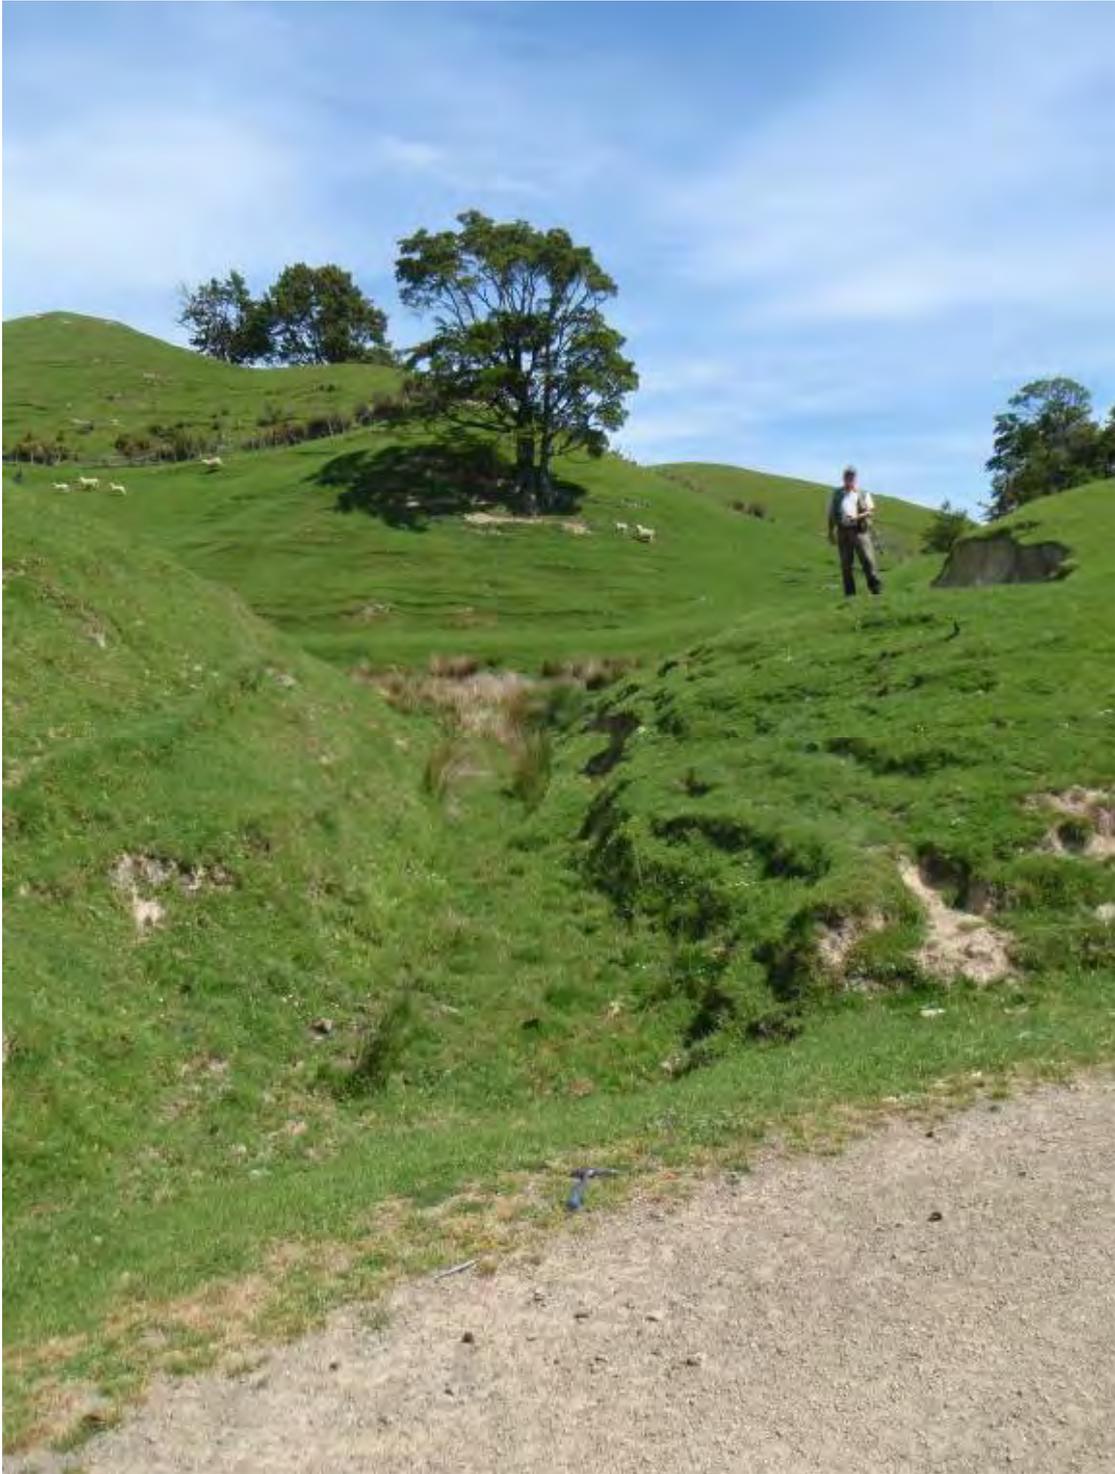
- The Mohaka fault trace separating the greywacke rock mass from the Tertiary rock mass was located in the field some 900m NW from the proposed dam site (Figure 3-36)
- Tertiary aged marine sediments exposed on both the farm track into the proposed dam site and along Wakarara Road consist of extremely weak silty fine sandstone and are non plastic (Figure 3-37)

Figure 3-36 - Mohaka fault trace, looking west

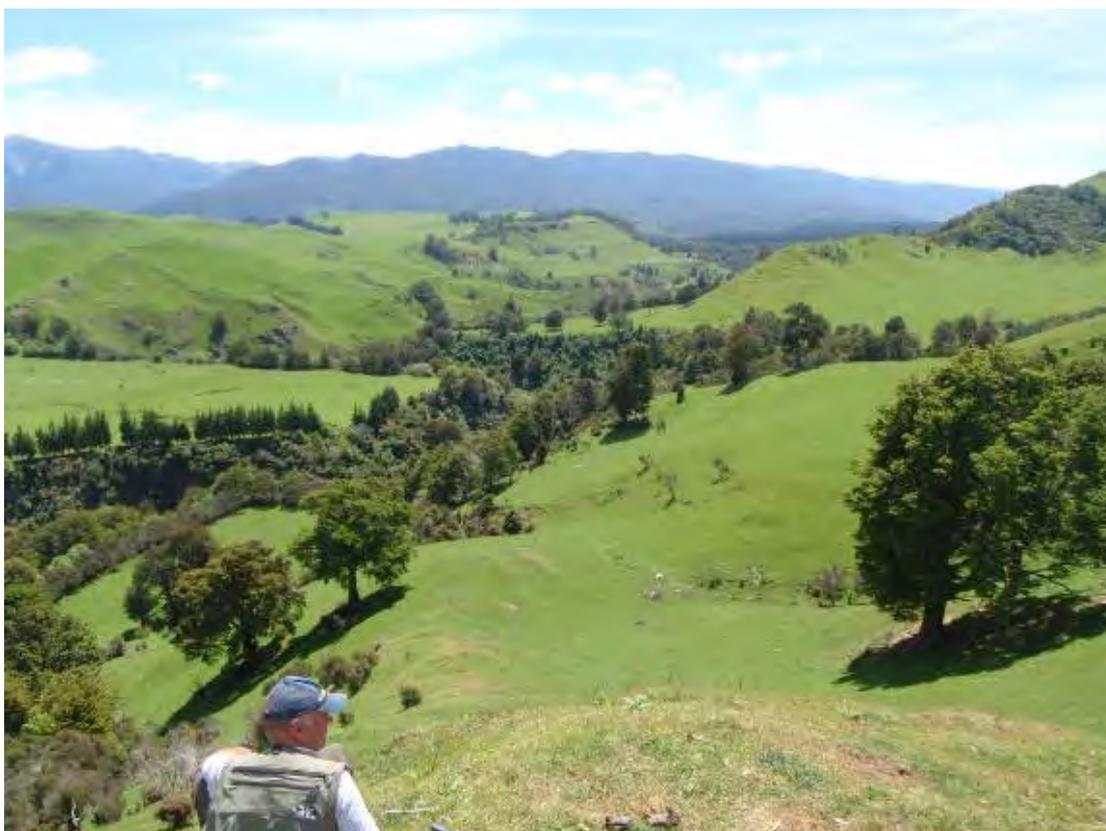
Landslides were noted at reservoir margins, particularly to the west (Figure 3-38). A rapidly eroding gully associated with an observed argillite band was also observed at the reservoir margin

Figure 3-38- Instability at reservoir margins

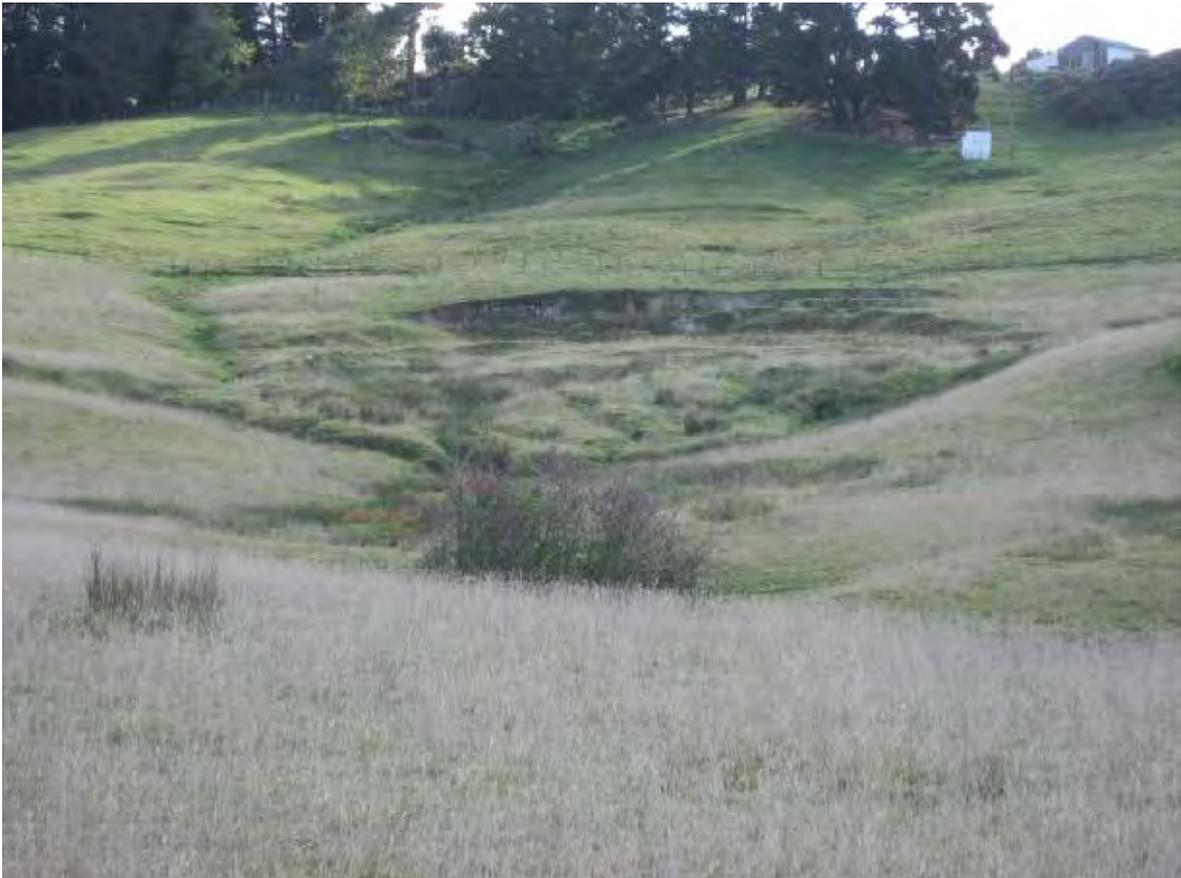
Figure 3-40 Instability in left side of valley towards upstream end of reservoir
