Hawkes Bay Regional Council

Ruataniwha Water Augmentation
Scheme

Advanced Prefeasibility Geotechnical
Investigation Report

T&T Ref: 27195/V04

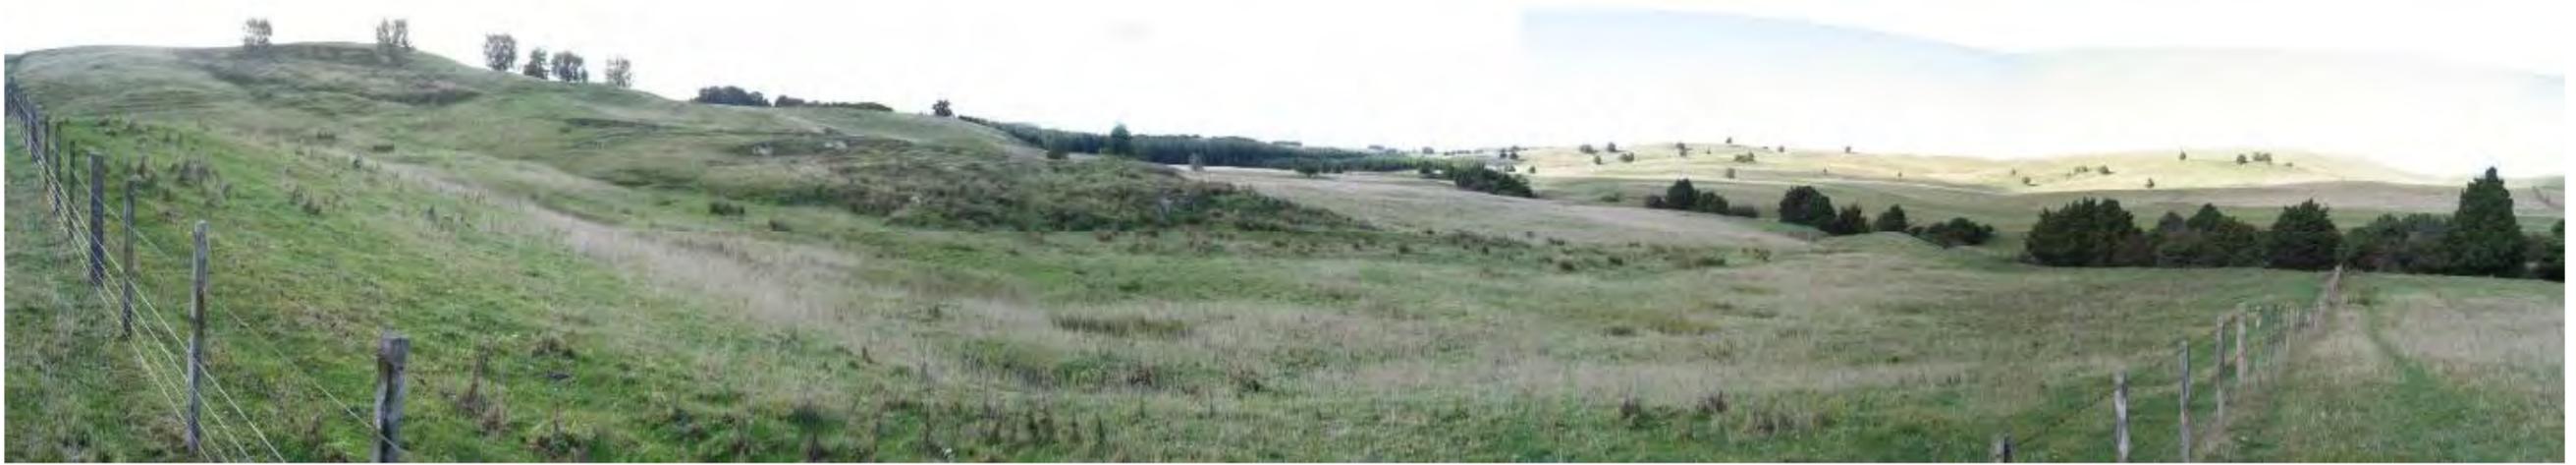
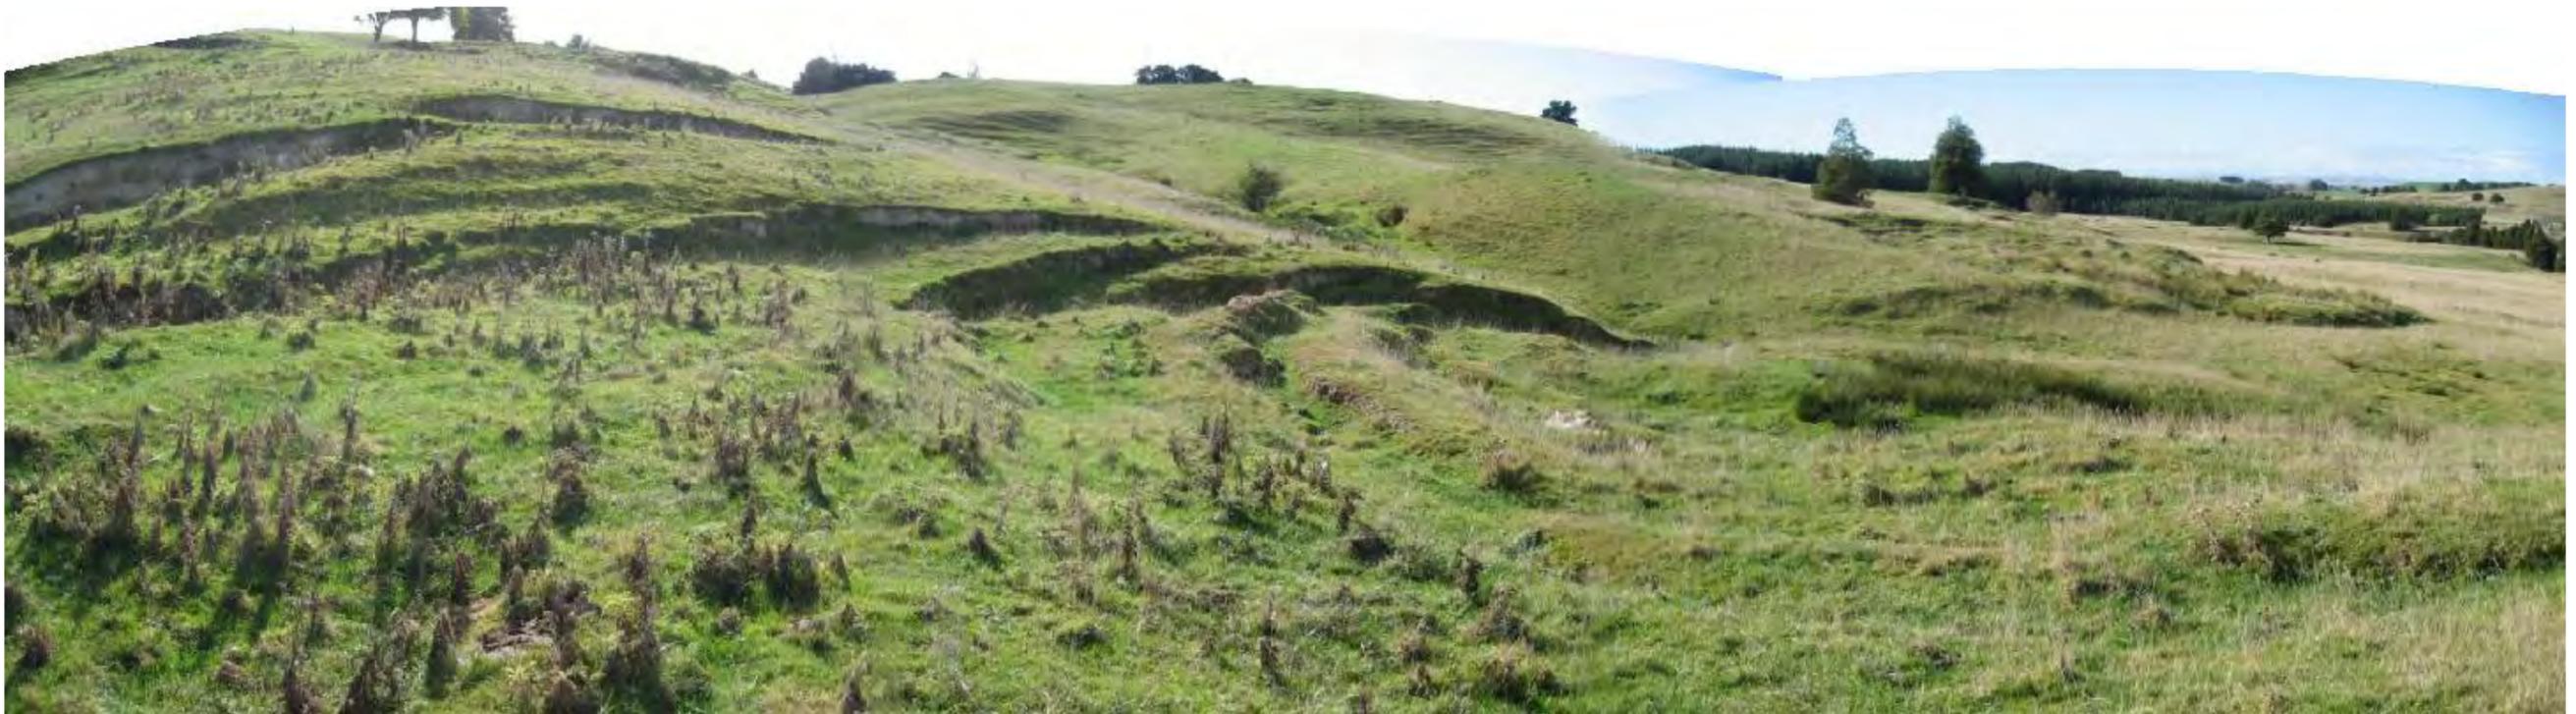
Active landsliding and earthflows of moderate depth were observed on both sides of the valley upstream of the inferred fault, particularly on the left side of the valley at the head of the proposed reservoir (refer Figure 3-41 and Figure 3-42). The local landowner observed that these features tended to move following periods of intense rain extending beyond three days. The landslides on the left side of the valley have active headscarps and toe bulges with the latter occurring above 312mRL approximately e.g. close to but above the potential maximum reservoir level (refer Figure 3-43). Based on the width of the headscarp and graben and the location of the

Figure 3-41 Instability in left side of valley towards upstream end of reservoir

The main risk to reservoir rim stability relates to the active landslides and earthflows observed above reservoir level upstream of the inferred fault. The risk of material sliding into the reservoir from these areas of instability and potential displacement volume will need to be assessed, and if significant, then design will need to allow for a reduction in available storage volume during a landslide event. In addition, if the fault described in Section 3.7.3 is found to be active or subject to reactivation, a reduction in storage volume due to movement of the fault will need to be investigated and assessed.

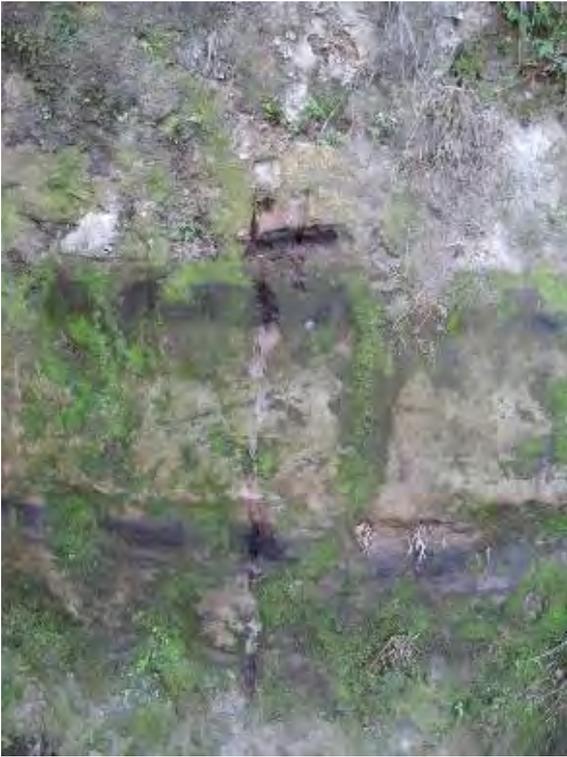
Upstream of the inferred fault, extremely weak white pumiceous siltstone and fine sandstone in thin subhorizontal beds is exposed in the valley floor (refer Figure 3-39). In some of these exposures, dark brown carbonaceous siltstone beds were noted interbedded within the pumiceous siltstone (refer Figure 3-44 and Figure 3-45). Downstream of the inferred fault, exposures comprised interbedded siltstone, sandstone and cemented gravel, in some places overlain by red metals (refer Figure 3-46 and Figure 3-47) dipping 5°S to 15°S were observed.

Figure 3-44 Pumiceous siltstone with two thin dark grey carbonaceous siltstone beds (subhorizontal)

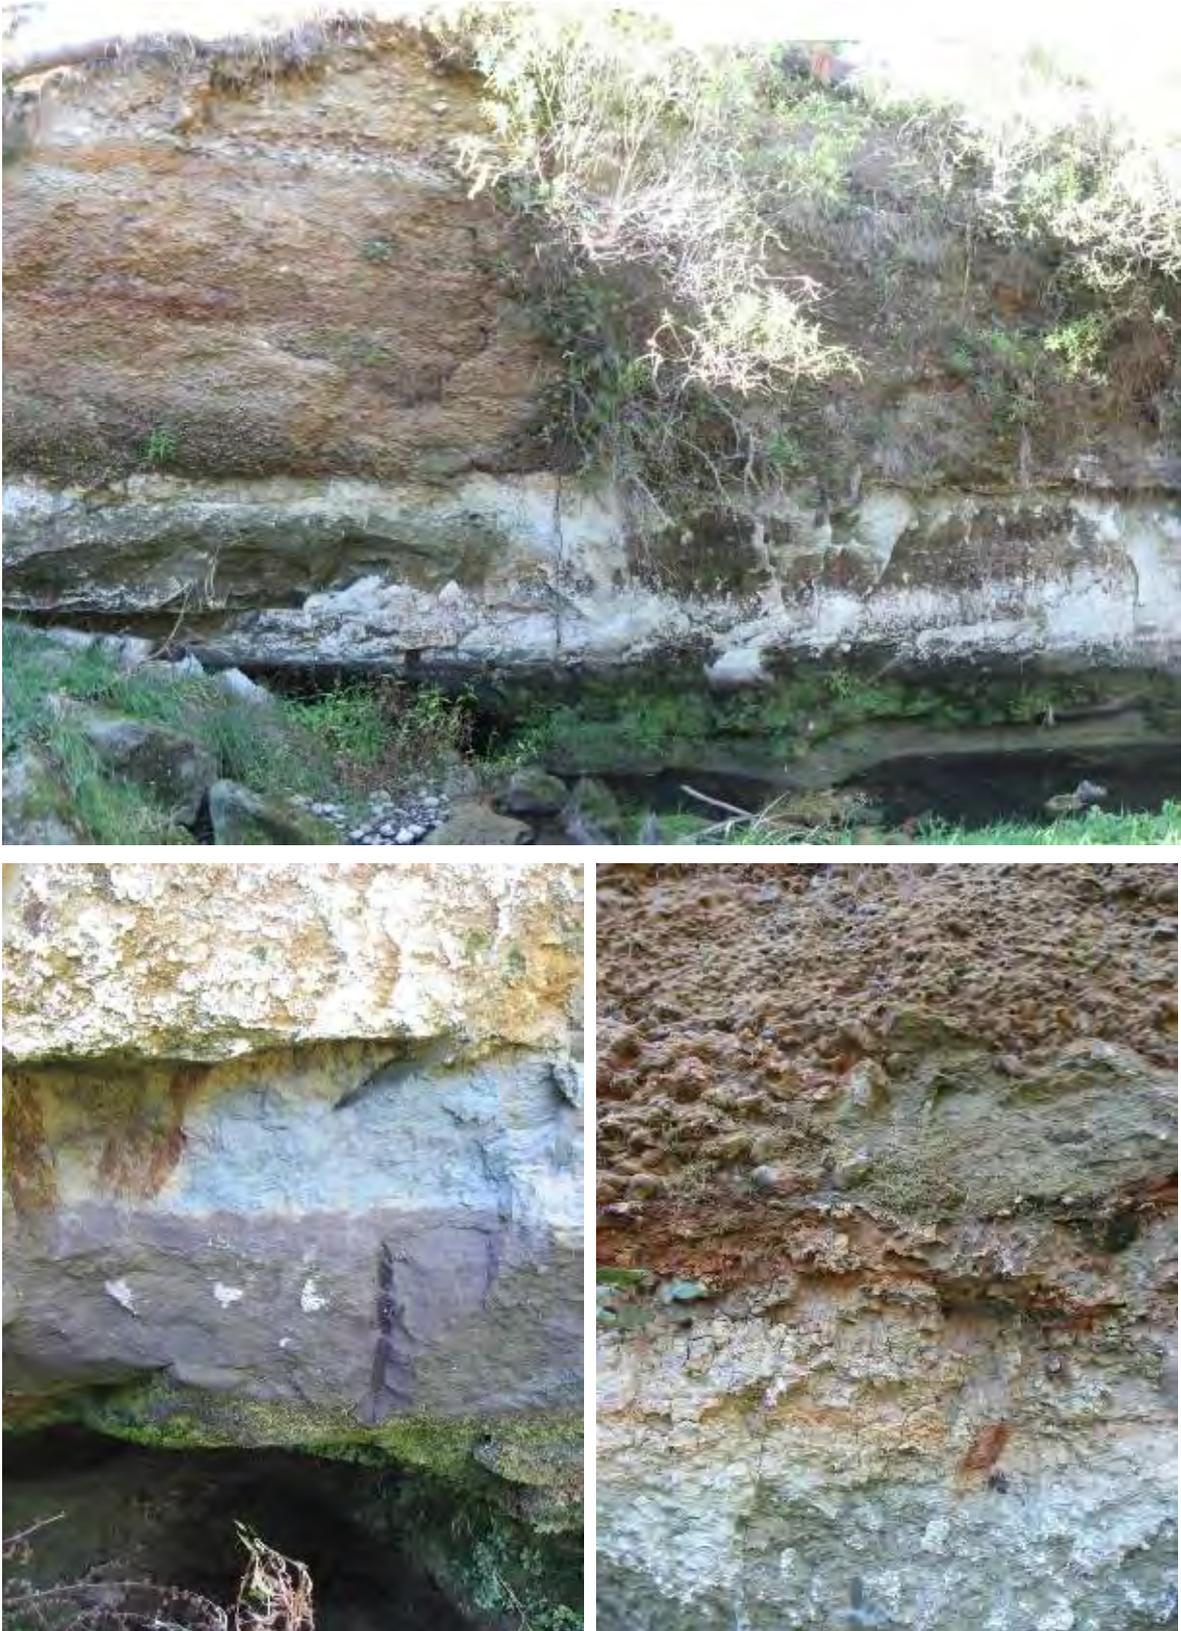
Figure 3-45 (Top to bottom:) 3m red metal, 0.4m soil, 0.8m blue-grey siltstone, 0.1m mudstone, 0.6m carbonaceous siltstone, 0.1m medium sand

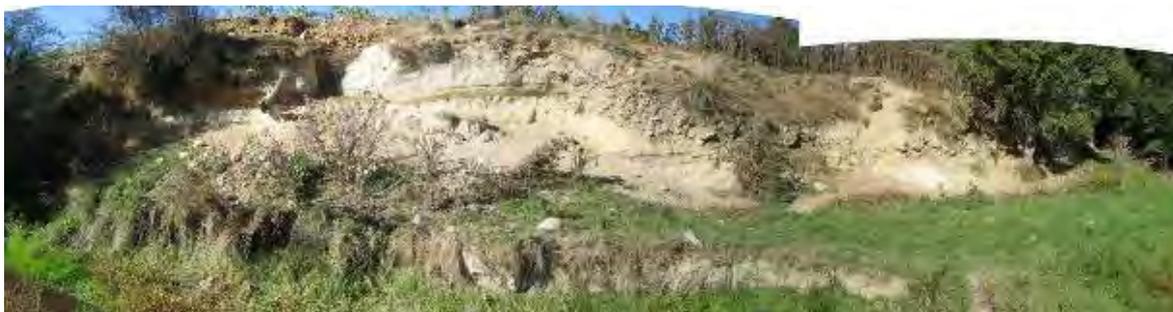
Figure 3-46 Downstream of possible fault: extremely weak fine to medium sandstone interbedded with minor siltstone, dipping 5 deg downstream, overlain by gravel

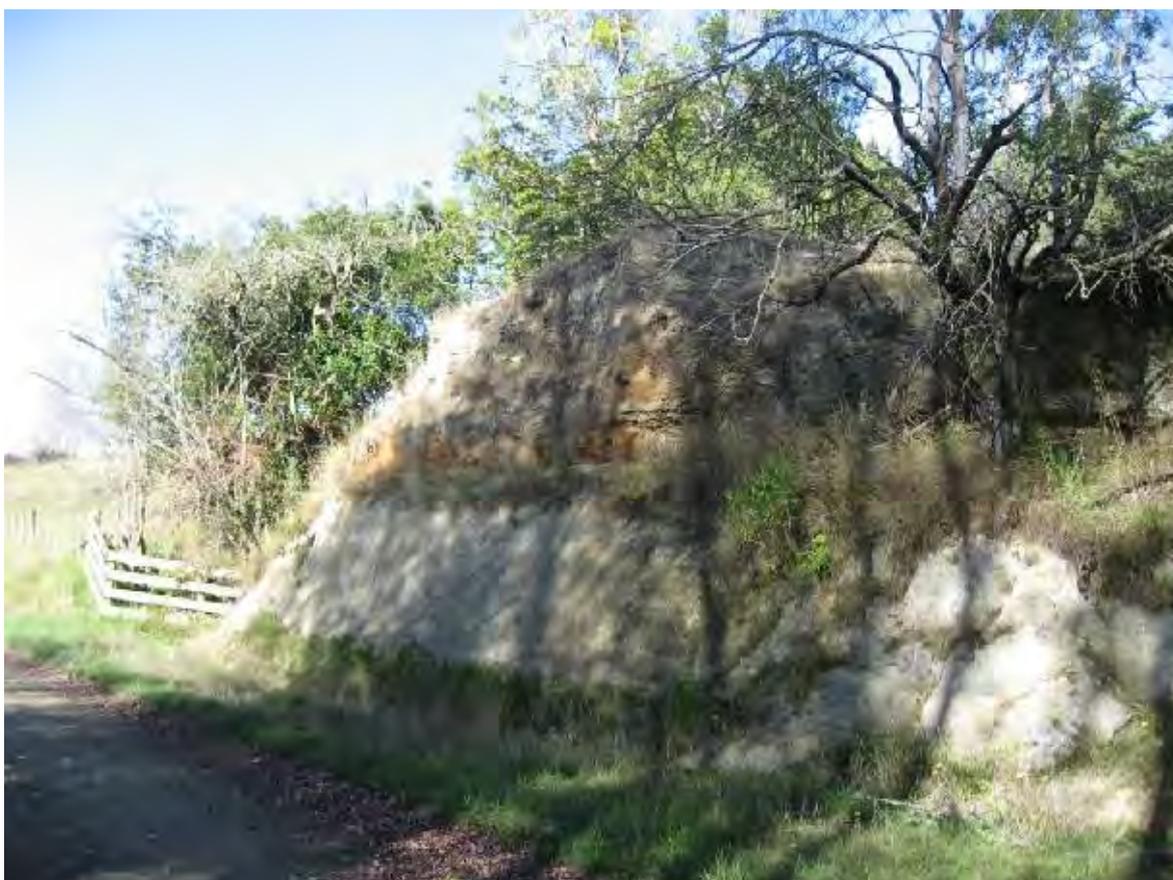
Figure 3-47 Downstream of original dam location: Red metal above white massive siltstone at side of road

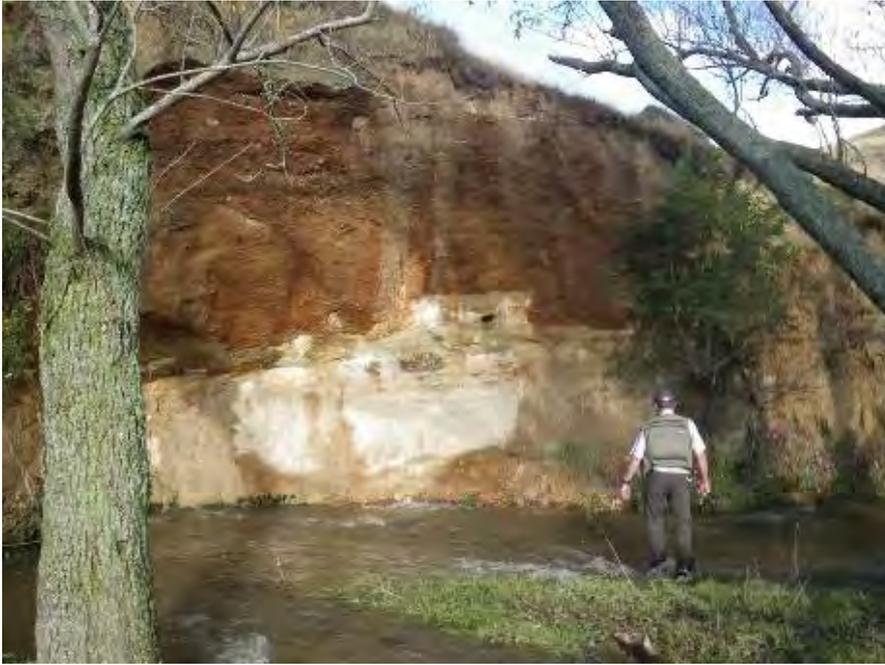
The exposures in the true right stream bank on the valley floor comprise weathered greywacke gravel (red metal) interbedded with siltstone and pumiceous layers (refer Figure 3-48 and Figure 3-49). These sediments are overlain by gravelly sandy SILT seen exposed in the gully above the stream at the right abutment and at the top of the red metal quarry on the true left side of the valley. All are part of the Castlecliffian high terrace sediments mapped by Kingma in the ridges. Also there is a noticeable change in alignment of the side gullies where they encounter the gravelly silts above the main valley floor.

Figure 3-48 Moderately weathered red metals overlying 200mm pumice overlying siltstone

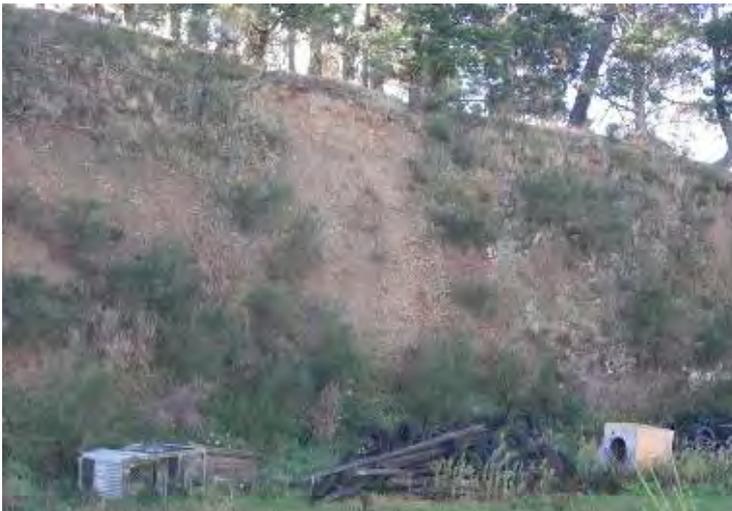
Figure 3-49 Quarry at left abutment: Moderately weathered red metals capped by siltstone

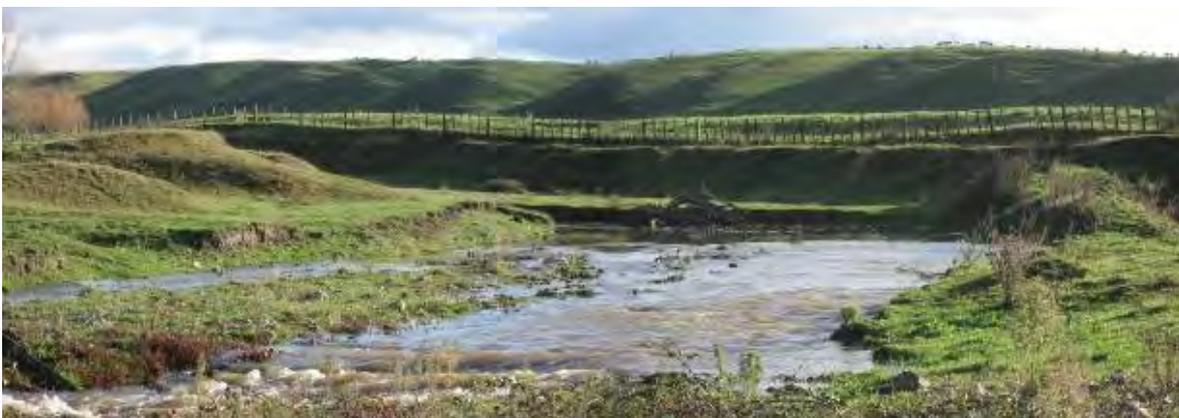
The valley slopes on the true left of Ongaonga Stream have a “puckered” appearance (refer Figure 3-50), which might reflect surficial creep or differences in material properties of the interbedded silts and red metals. A seep was observed well up the valley sides on the left side of the valley upstream of the reservoir, which may be associated with a continuous layer of lower permeability material. A linear feature, which may also be associated with a low permeability layer, was also noted near the foot of the true left valley slope within the reservoir, (refer Figure 3-55).

Figure 3-50 Left side of valley visible in background with "puckered" appearance

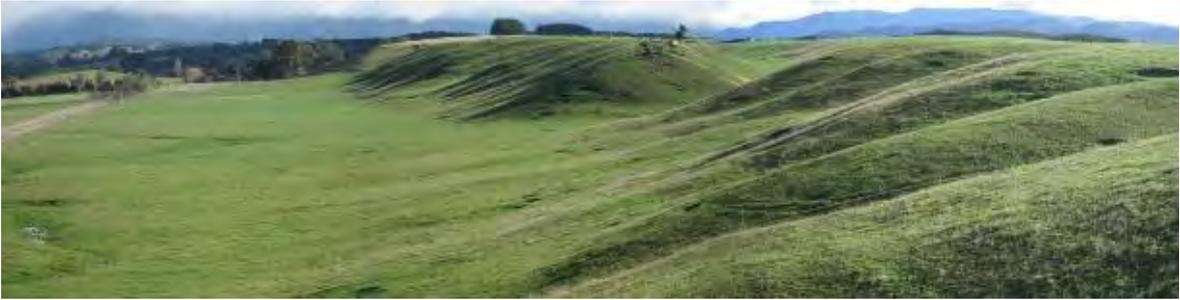
Some landsliding was observed within the reservoir (refer Figure 3-52 and Figure 3-53). In particular, landslide debris is exposed in the right abutment, but an alternative abutment location immediately upstream appears suitable (refer Figure 3-54). A major gully shaped feature previously identified on Google imagery is not a landslide feature (refer Figure 3-51).

Figure 3-51 Looking up right side of valley, gully feature visible at right

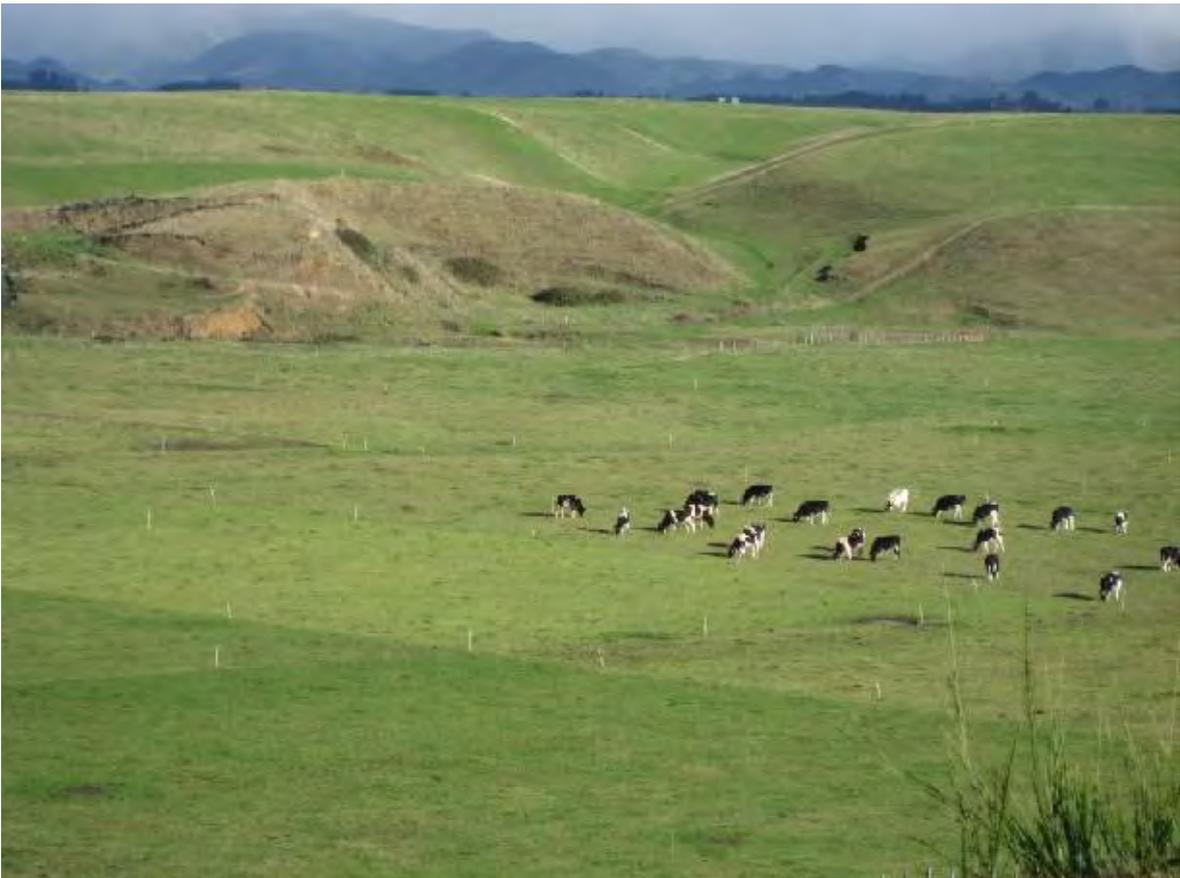
Figure 3-52 Landslide feature in right side of valley at foot of gully

Some instability has been noted in the reservoir rim as described in Section 3.8.3 above. This should be addressed via appropriate investigation and design.

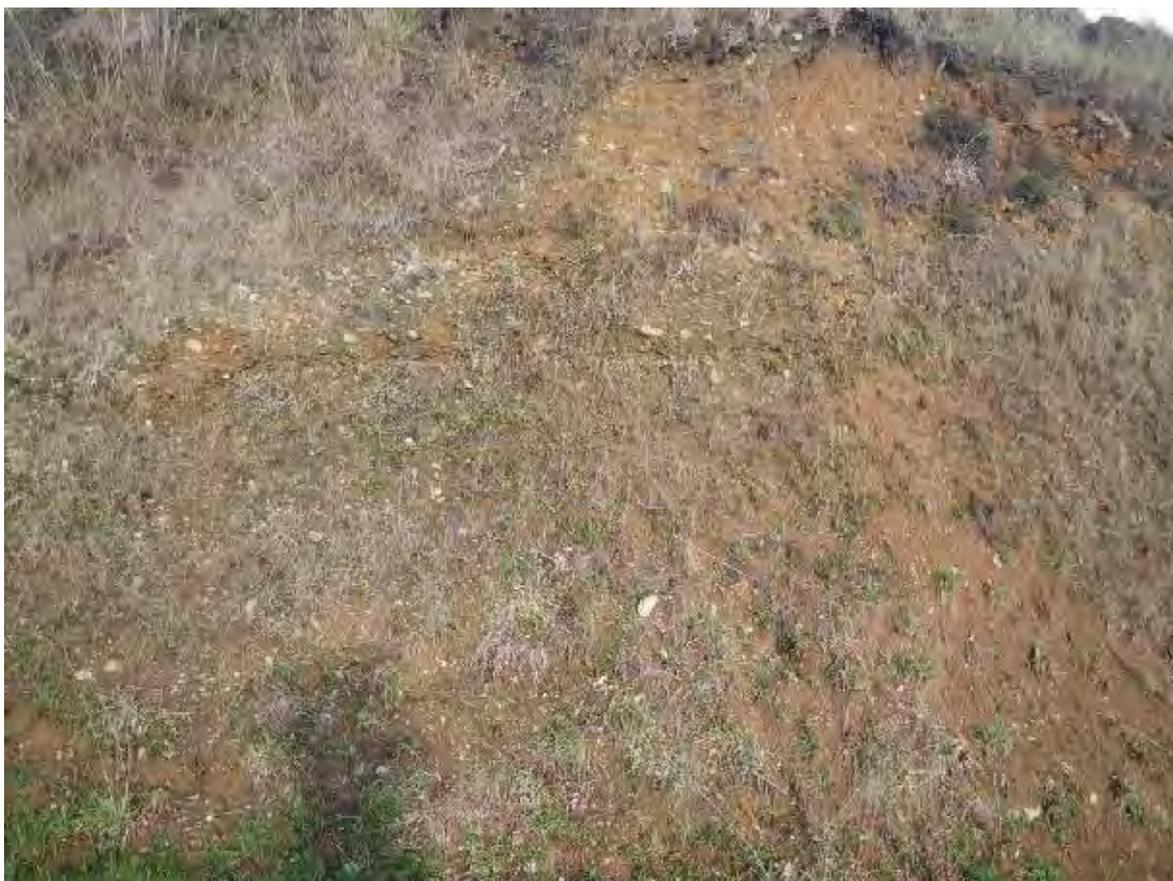
Figure 3-53 Landslide debris from feature in right side of valley at foot of gully

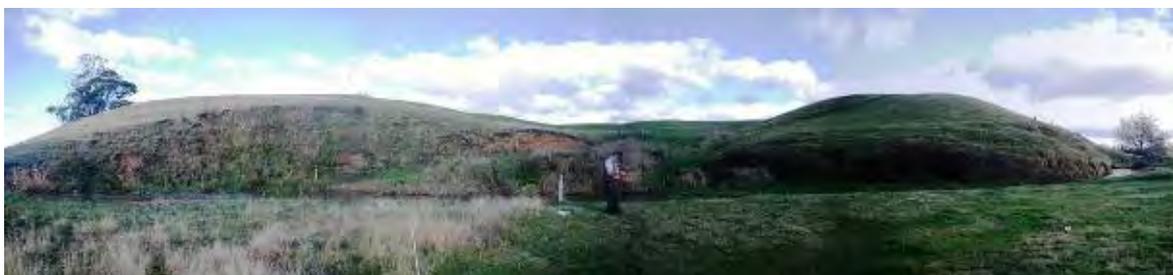
Figure 3-54 Right abutment: disrupted debris at current location at left of photo, alternative proposed location at right of photo

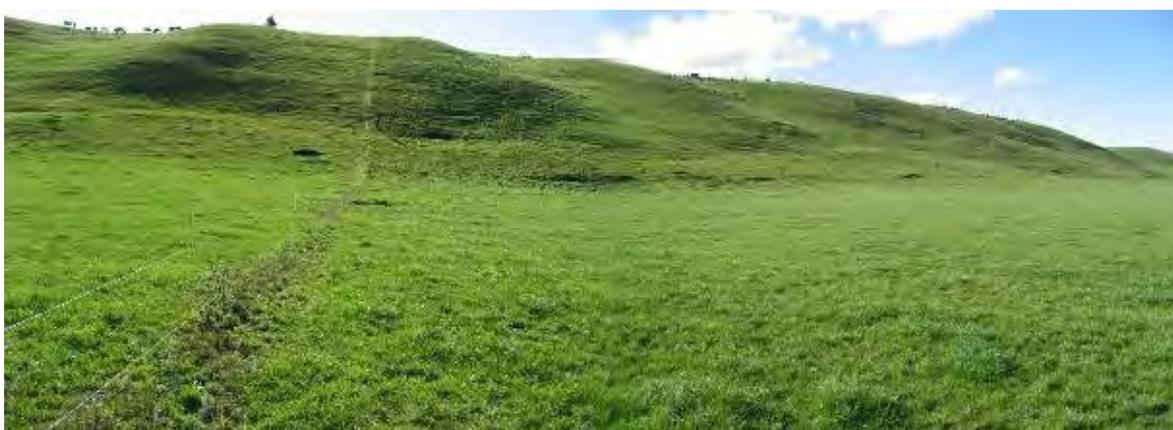
Figure 3-55 Left side of valley: linear feature visible near foot of slope

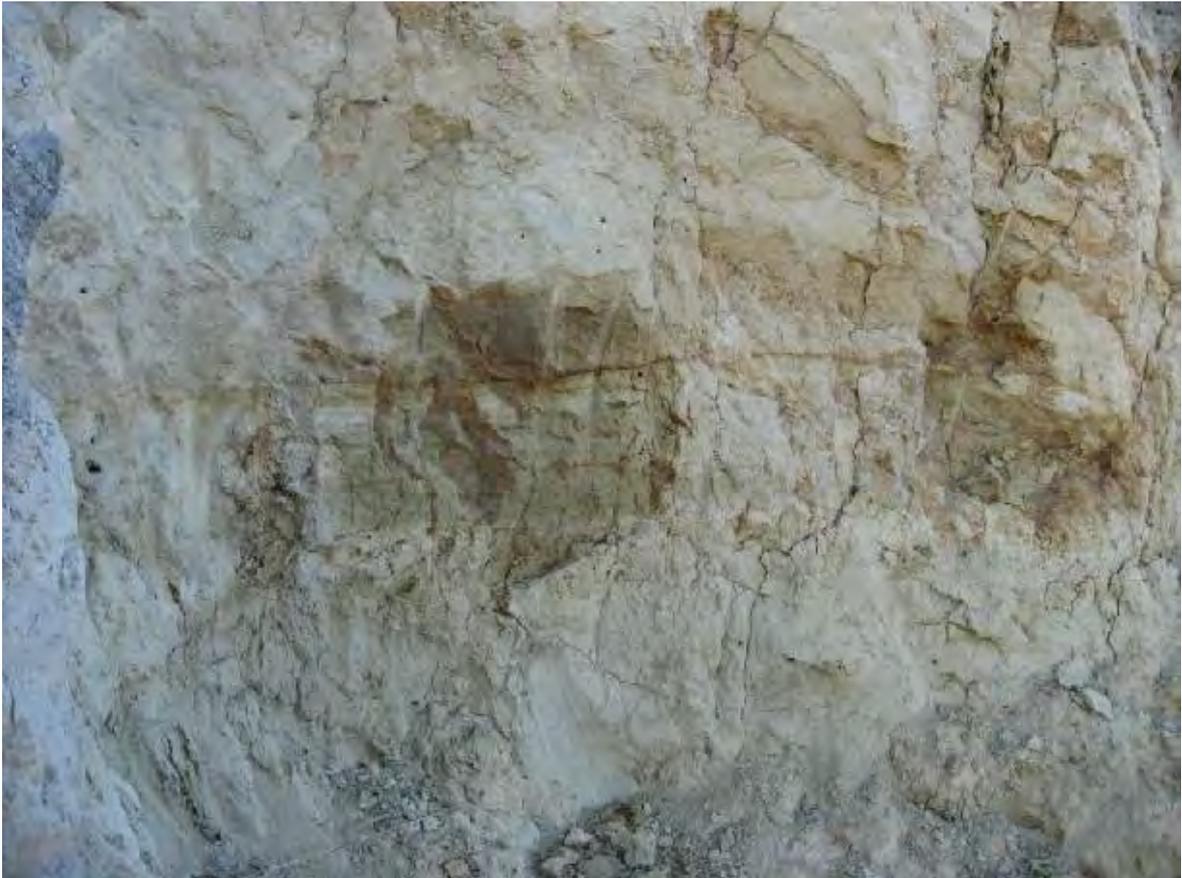
Exposures along the valley side at the right abutment comprised extremely weak sandstone capped by red metal (refer Figure 3-58) and overlying extremely weak coarse siltstone of Castlecliffian age. The sandstone is bedding dips 5° to 360° (north) (refer Figure 3-57), and contains interbedded pumiceous layers. Sandstone was also observed in the floor of the creek at the toe of the right abutment slope.

Figure 3-57 Sub horizontally bedded sandstone in ridge at right abutment

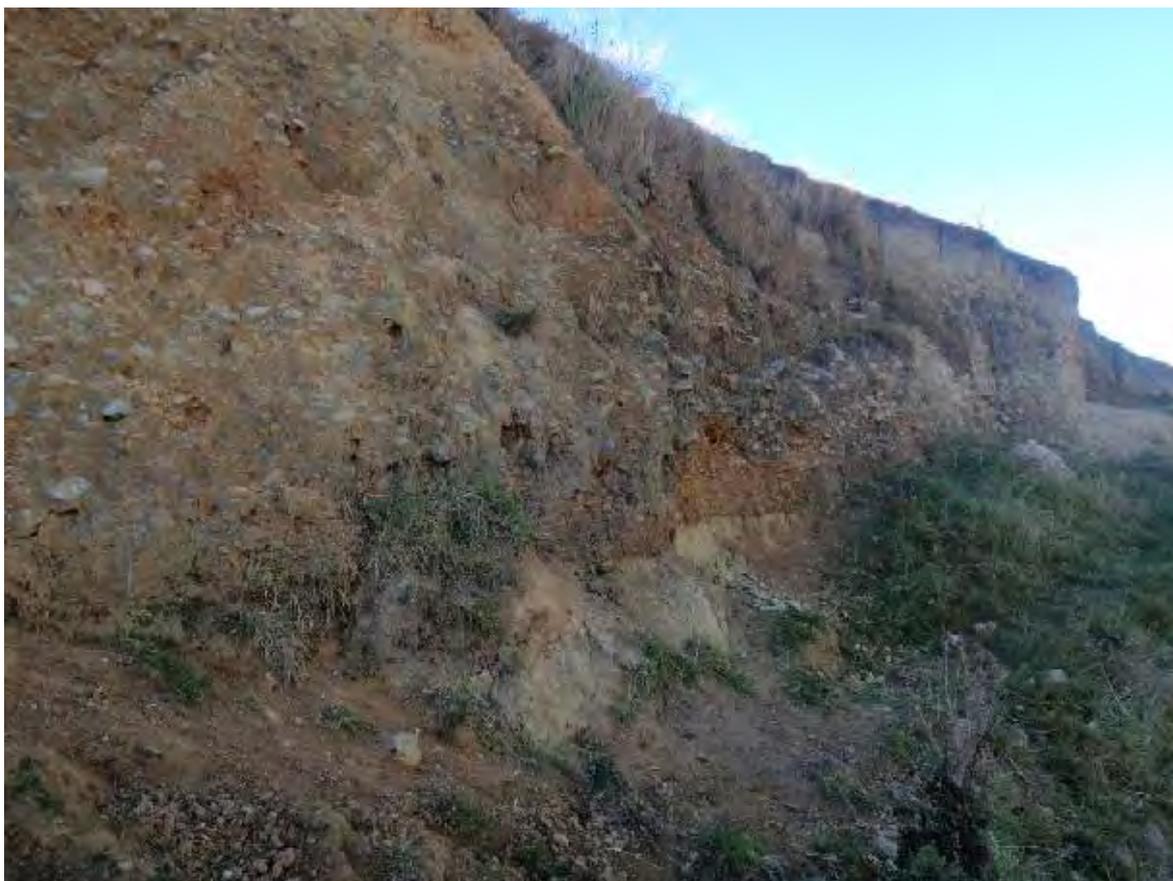
Figure 3-58 Red metal capping sandstone in ridge at right abutment

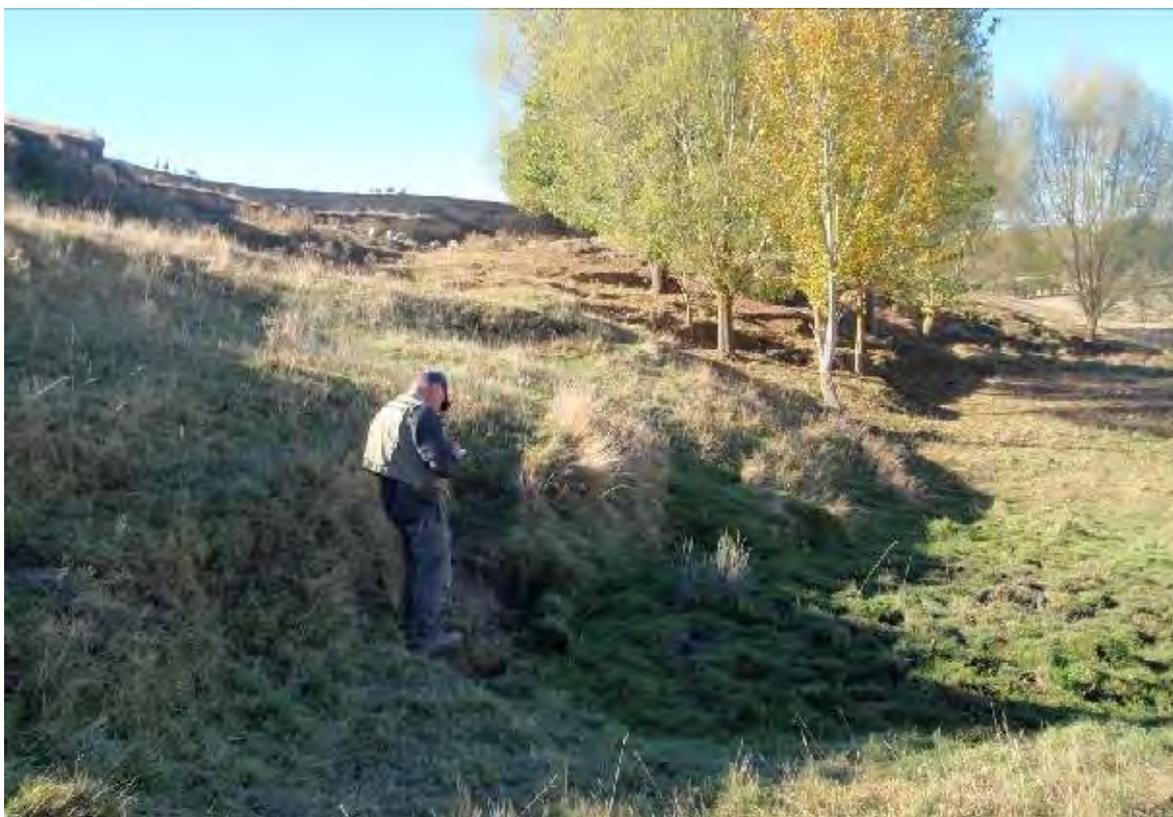
Figure 3-59 Siltstone exposure and seep at toe of landslide in southeast face of ridge at right abutment

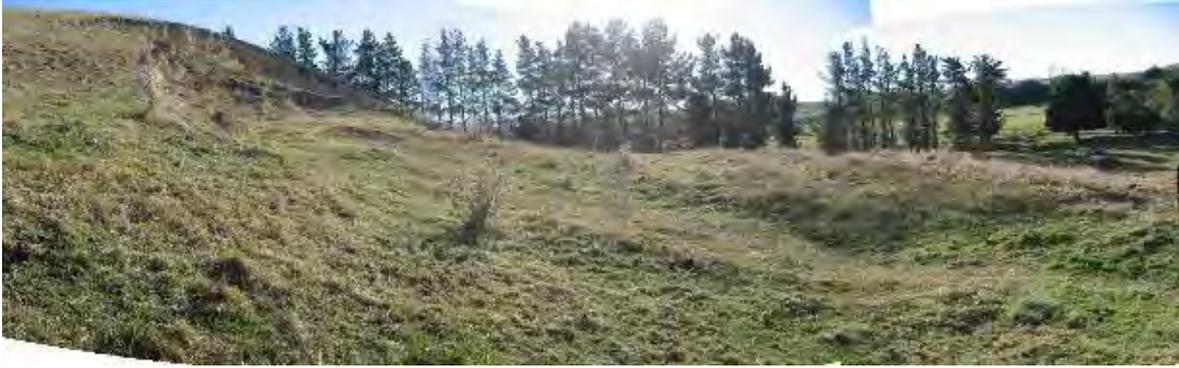
A ridge running parallel with the dam embankment, located at the right abutment, has landslides both on its south east (refer Figure 3-56) and north east (Figure 3-60) faces. The toe of the landslide on the south-east side of the ridge, located close to the interface between the sandstone and underlying siltstone, is marked by a strong groundwater seep (refer Figure 3-59) reflecting lower permeability in the siltstone relative to the sandstone. Multiple uphill facing scarps were seen in the south east landslide, indicating the landslide is likely to be translational. The landsliding may be occurring on the softened interface between the siltstone and sandstone, and is likely to have occurred during severe earthquake shaking.

Figure 3-60 Landslide in northeast face of ridge at right abutment

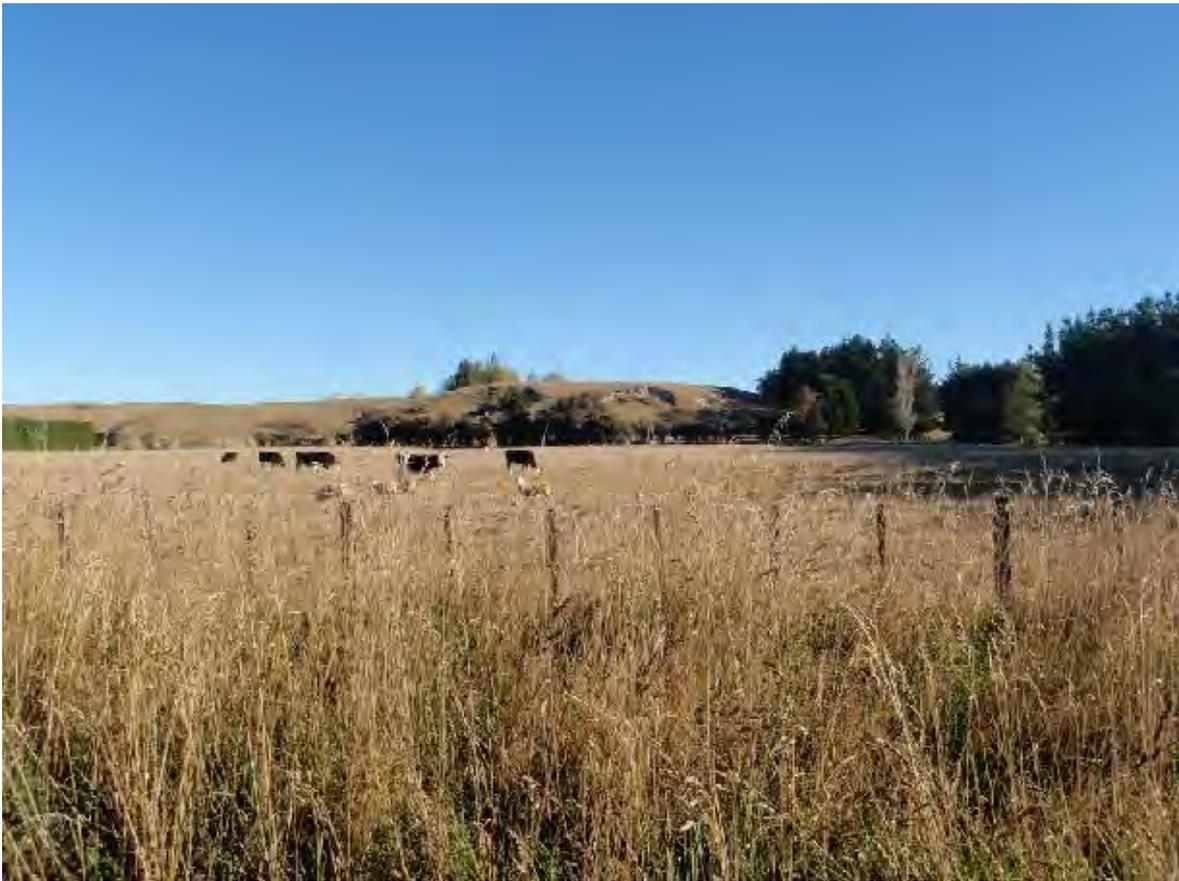
Figure 3-61 Landsliding in left side of valley

Instability has been noted throughout the reservoir as discussed above, and will need to be assessed and accommodated as necessary by design works.

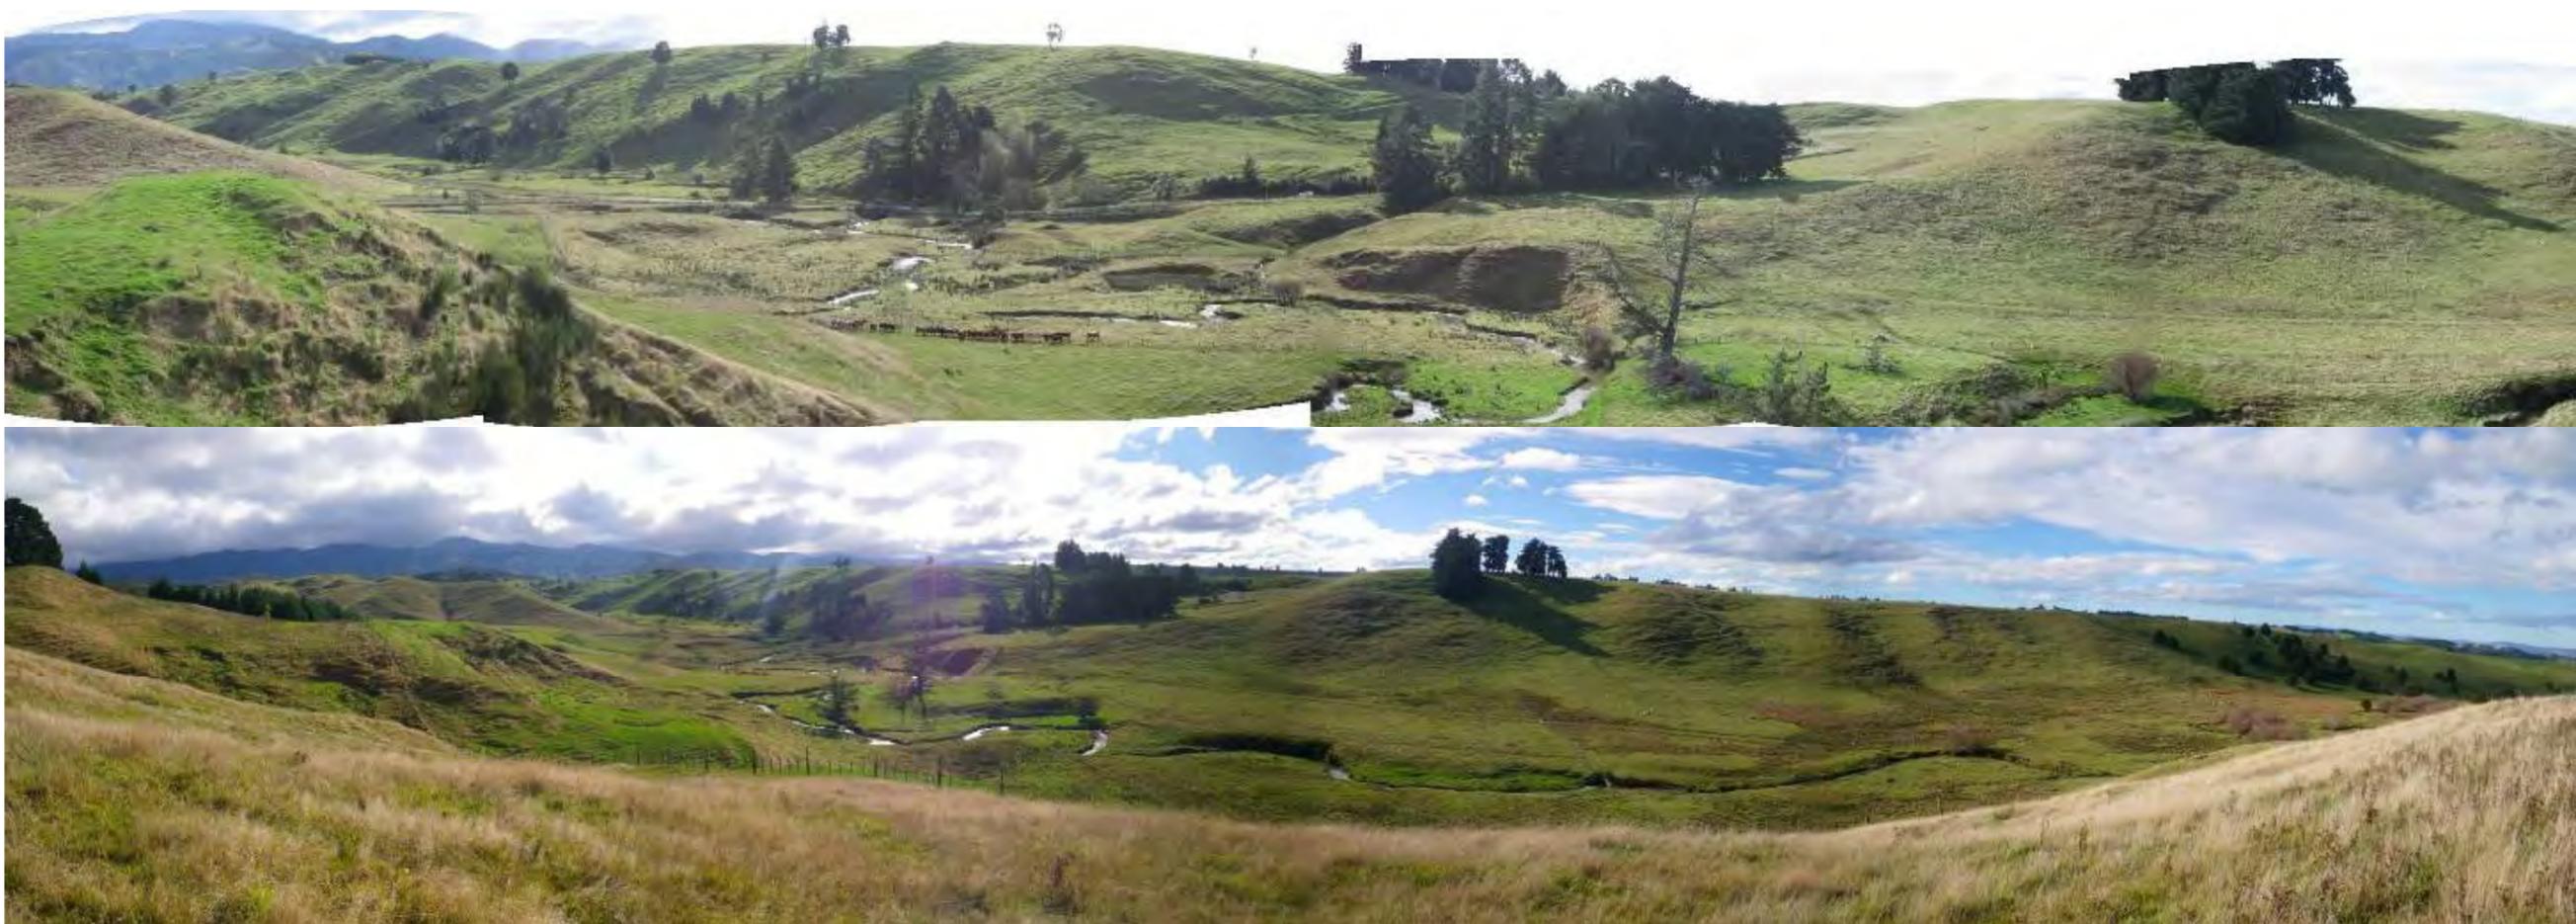
Figure 3-63 Upstream of right abutment: Panning from upstream to downstream

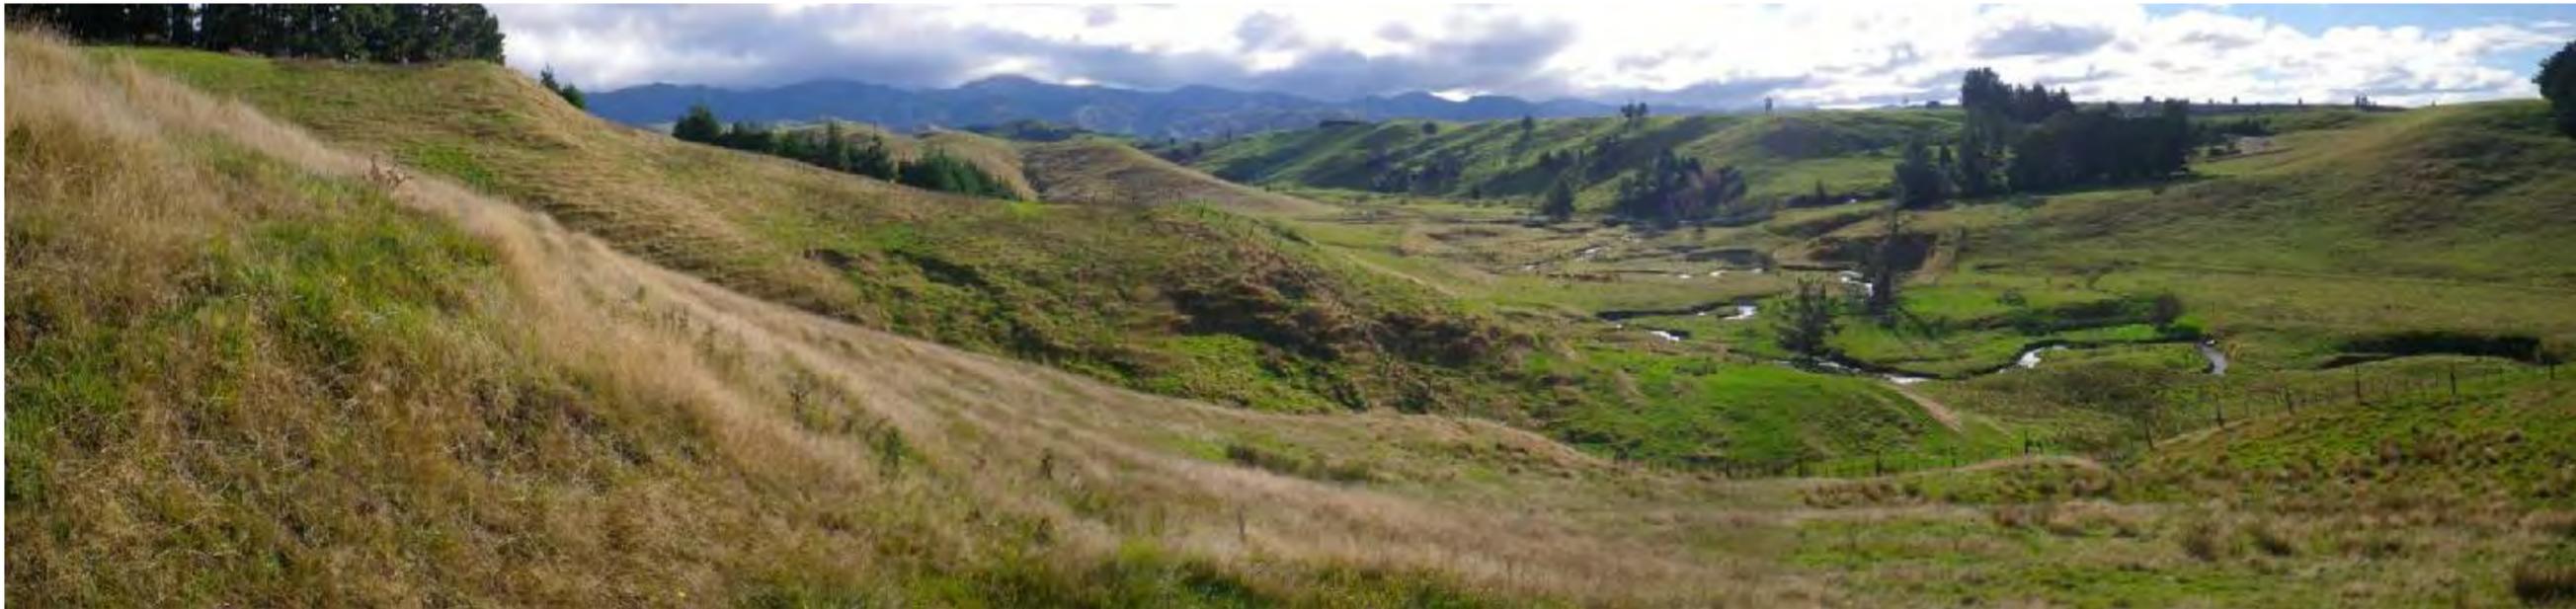
Figure 3-64 Upstream of right abutment, looking upstream: Graben visible at left side of photo

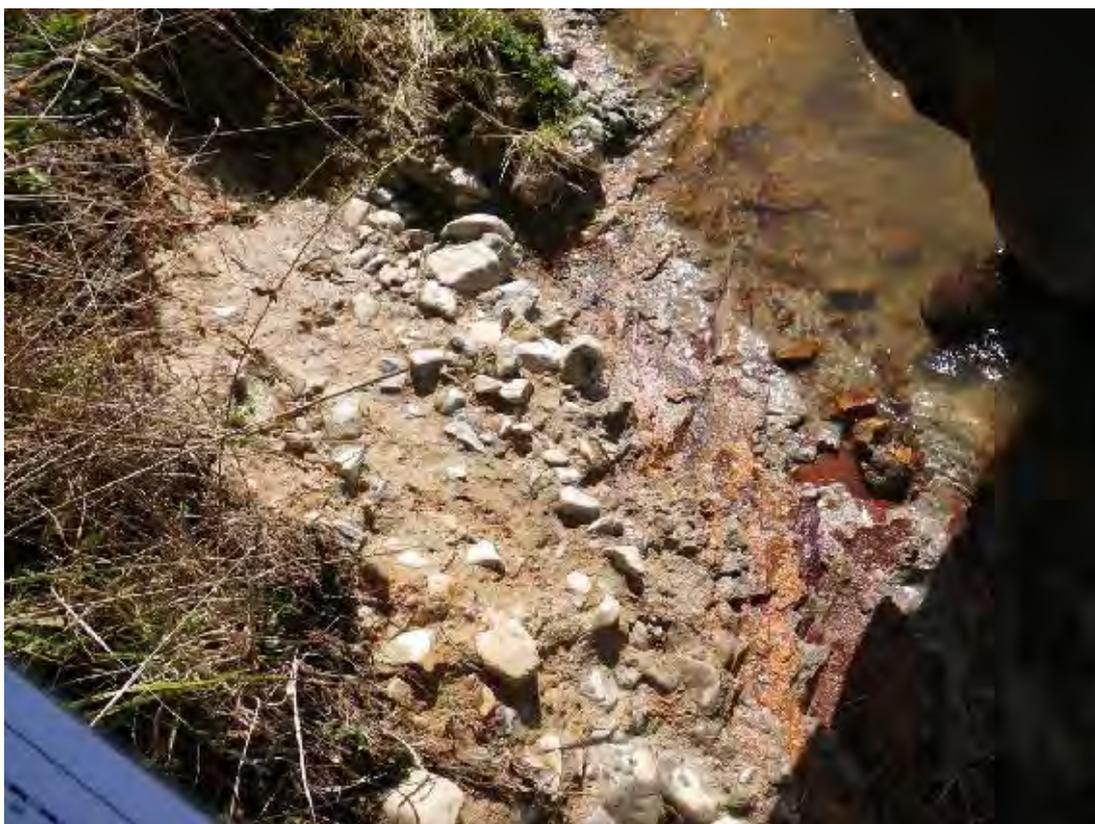
Exposures seen during our site visit generally comprised coarse extremely weak to very weak jointed siltstone underlying weathered, in places cemented, greywacke gravel (red metal) (refer Figure 3-65, Figure 3-66, Figure 3-67 and Figure 3-68). The siltstone exposures continued well up the valley sides, 6m above the stream invert in one place. Seeps emerging part way up the valley slope and truncated ridges also are taken to indicate that siltstone, which is likely to be less permeable than the red metals, is present at high elevations in the valley sides (refer Figure 3-70). Note that in some places the stream was flooded in red metals indicating that there is some variation in the level of the top of the siltstone, and there may be paleochannels

Figure 3-65 Red metals overlying siltstone in stream bed upstream of embankment
