Hawkes Bay Regional Council

Ruataniwha Water Augmentation
Scheme

Advanced Prefeasibility Geotechnical
Investigation Report

T&T Ref: 27195/V04

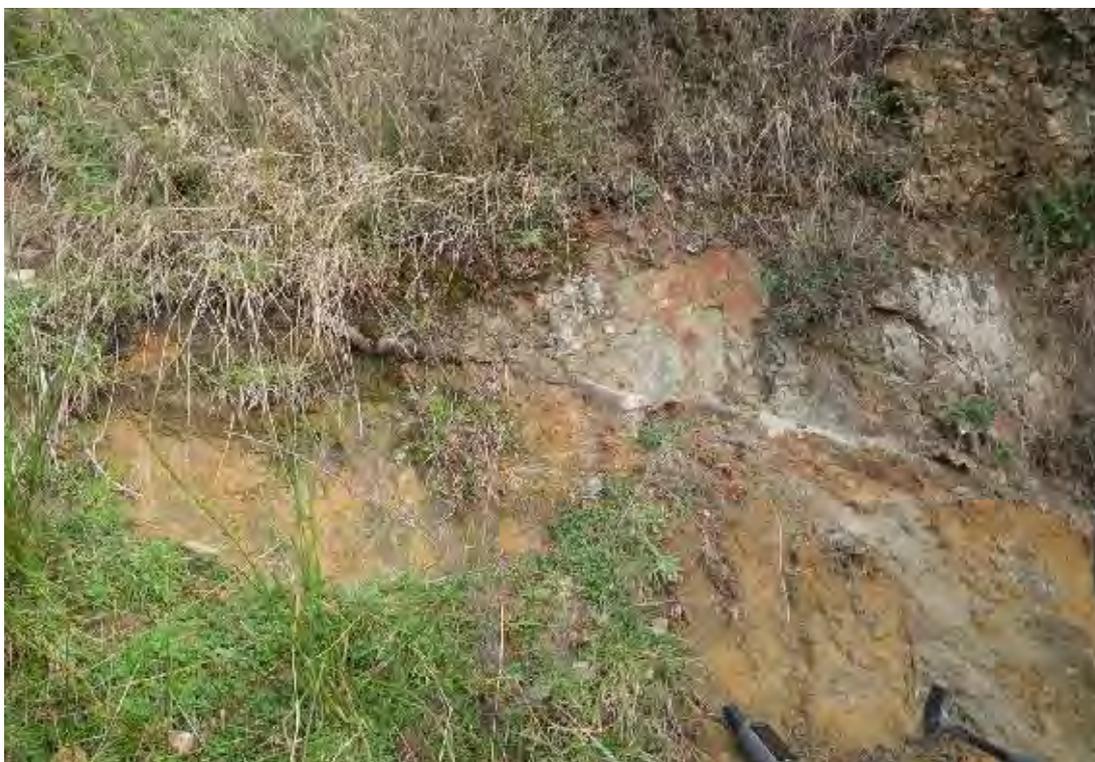
Exposures seen during our site visit generally comprised coarse extremely weak to very weak jointed siltstone underlying weathered, in places cemented, greywacke gravel (red metal) (refer Figure 3-65, Figure 3-66, Figure 3-67 and Figure 3-68). The siltstone exposures continued well up the valley sides, 6m above the stream invert in one place. Seeps emerging part way up the valley slope and truncated ridges also are taken to indicate that siltstone, which is likely to be less permeable than the red metals, is present at high elevations in the valley sides (refer Figure 3-70). Note that in some places the stream was flooded in red metals indicating that there is some variation in the level of the top of the siltstone, and there may be paleochannels

Figure 3-66 Moderately to highly weathered slightly cemented red metal overlying slightly weathered iron stained extremely weak fine sandy coarse SILTSTONE with a 15mm thick cemented bed dipping 50 deg to 265 deg

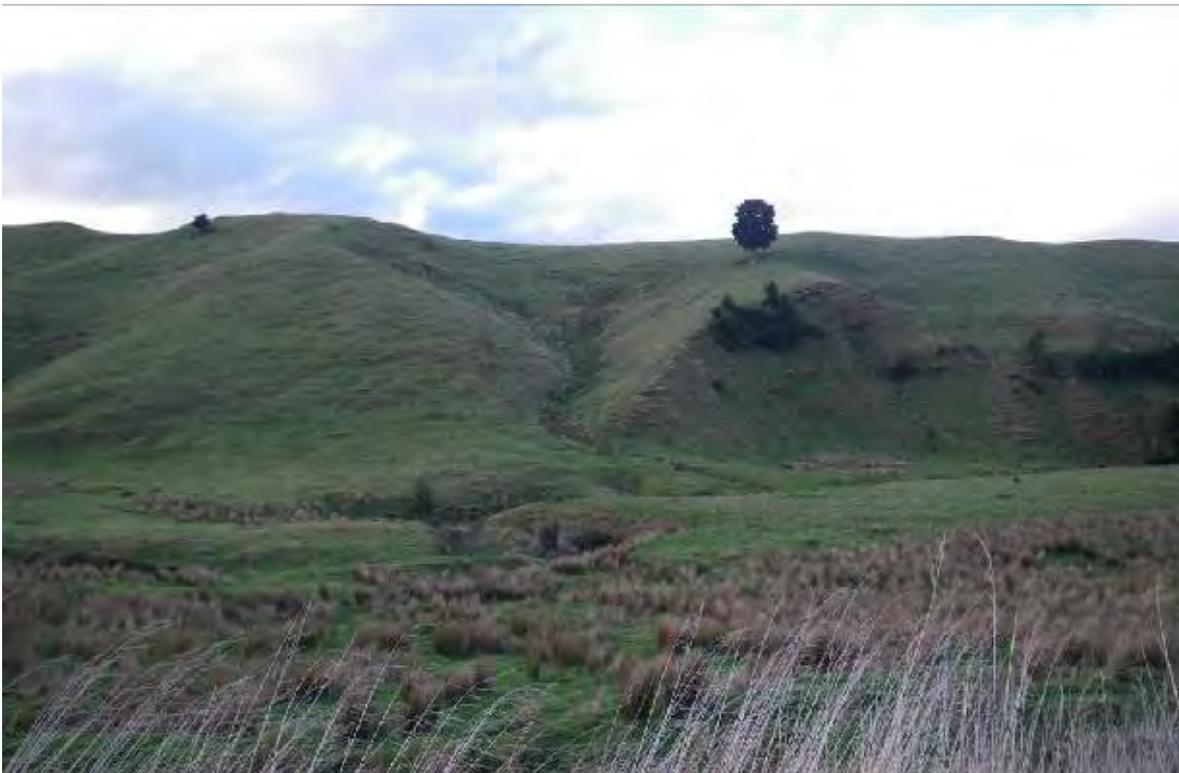
Figure 3-70 Truncated ridges along left side of valley within reservoir, seeps at level of top of siltstone

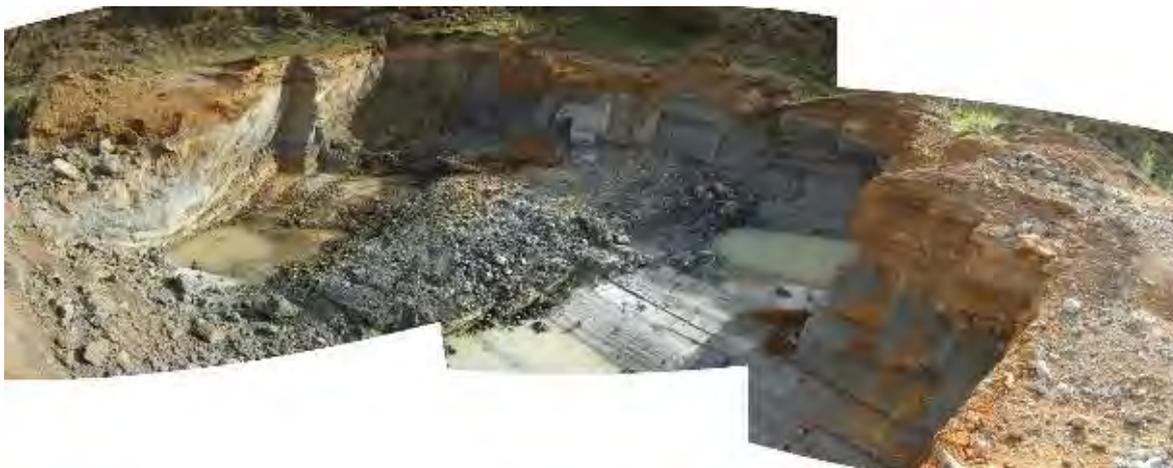
Some minor instability was noted (refer Figure 3-73) in the slopes upstream of Mill Road. Seeps were observed in the vicinity. It is possible that the instability relates to sliding on the interface between the red metals and less permeable siltstone, which can become softened by groundwater. Softening of the siltstone at the interface with the red metals was noted in the quarry (refer Figure 3-71).

Figure 3-71 Quarry upstream of Mill Road: Red metal on top of softened white siltstone

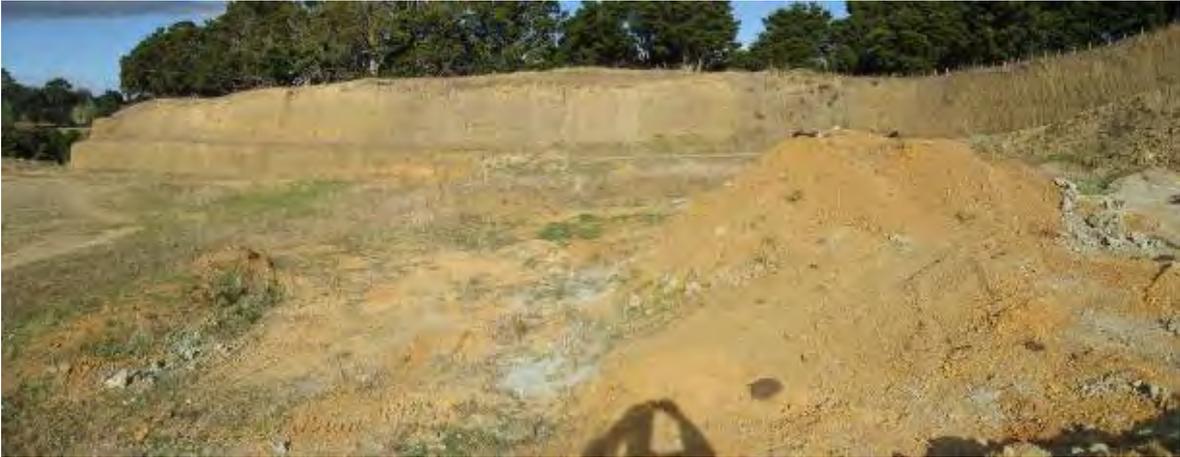
Figure 3-72 Red metal walls of quarry upstream of Mill Road

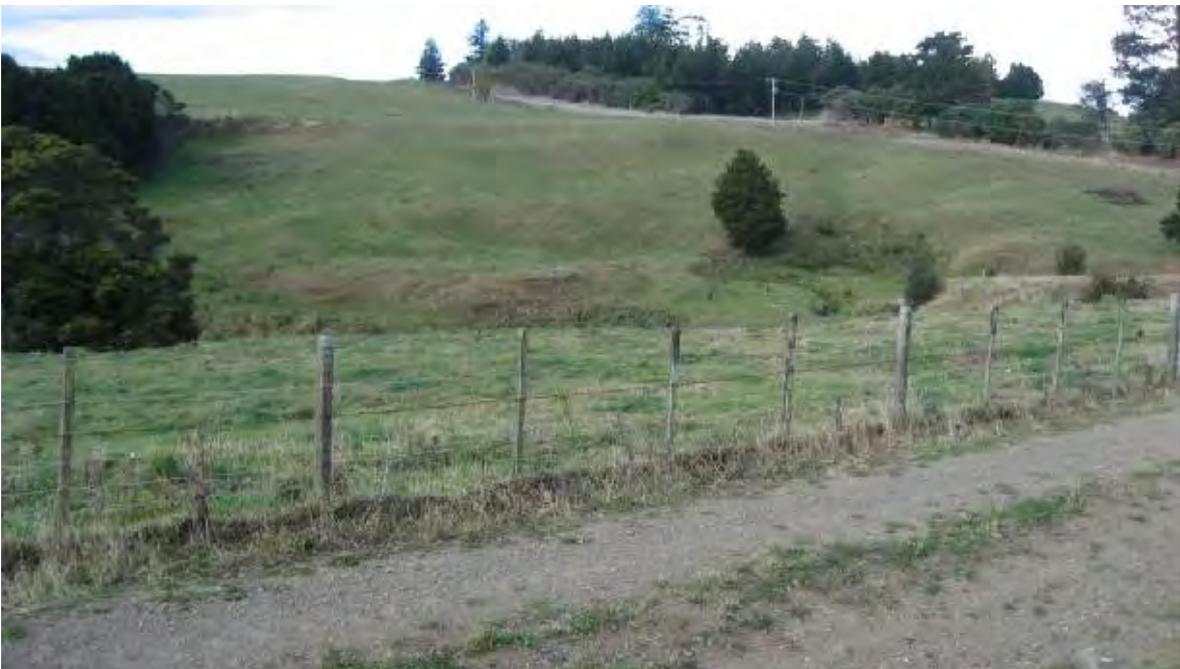
Figure 3-73 Minor instability north-east of quarry road upstream of Mill Road

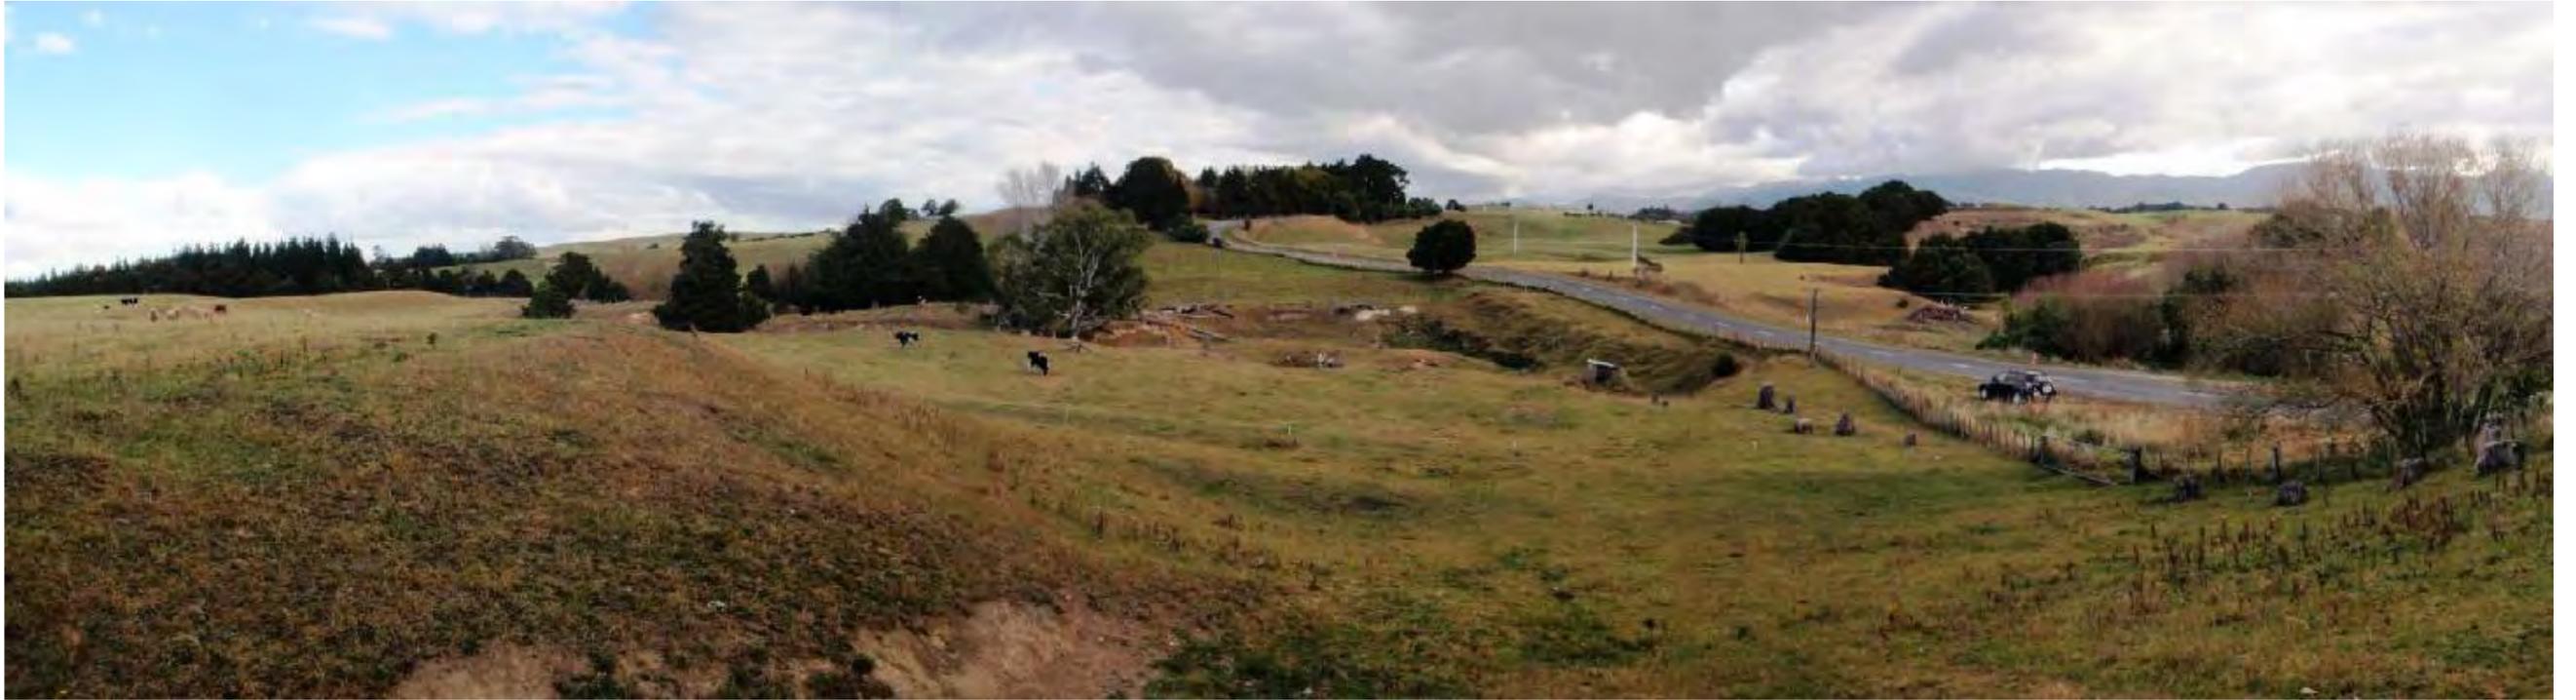
Figure 3-74 Looking south-east from left side of valley downstream of Mill Road

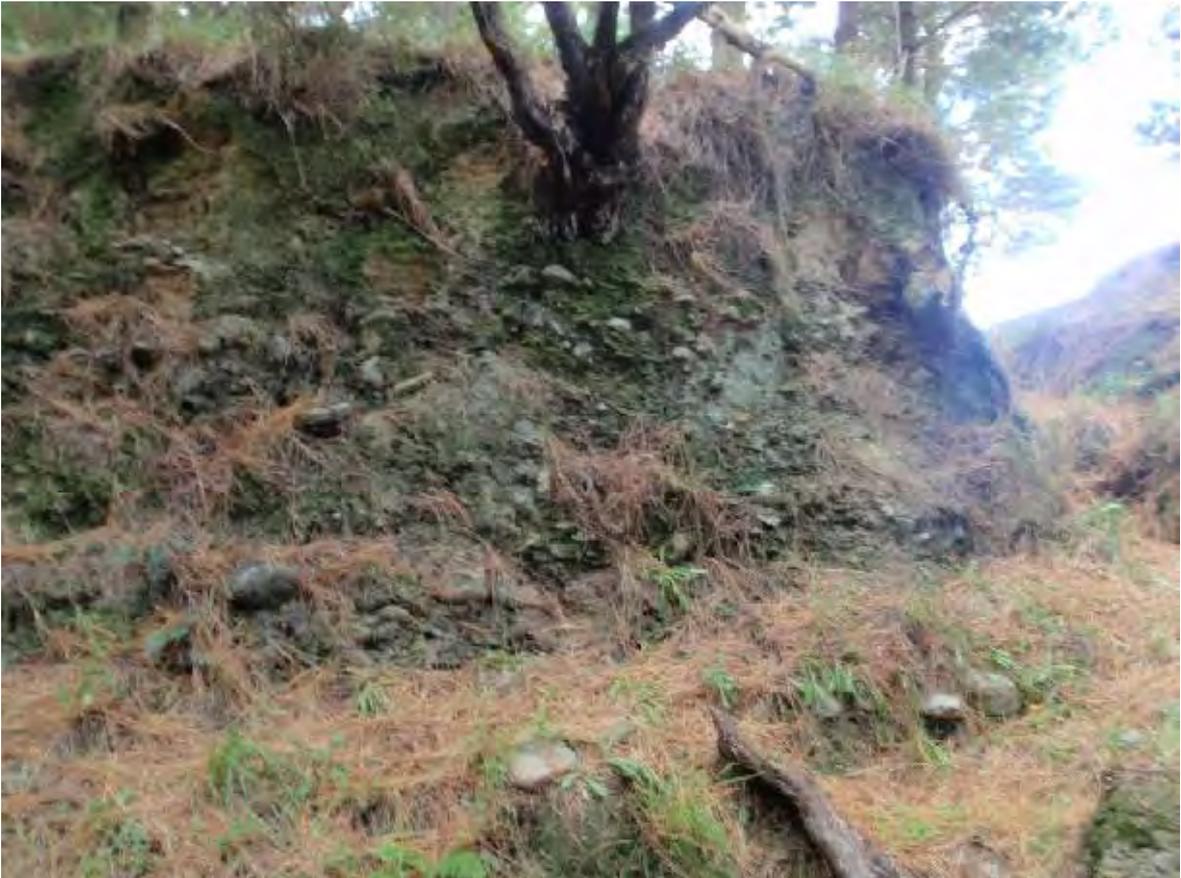
Figure 3-75 Red metal capping incised river banks / cliffs approximately 350m upstream of dam location

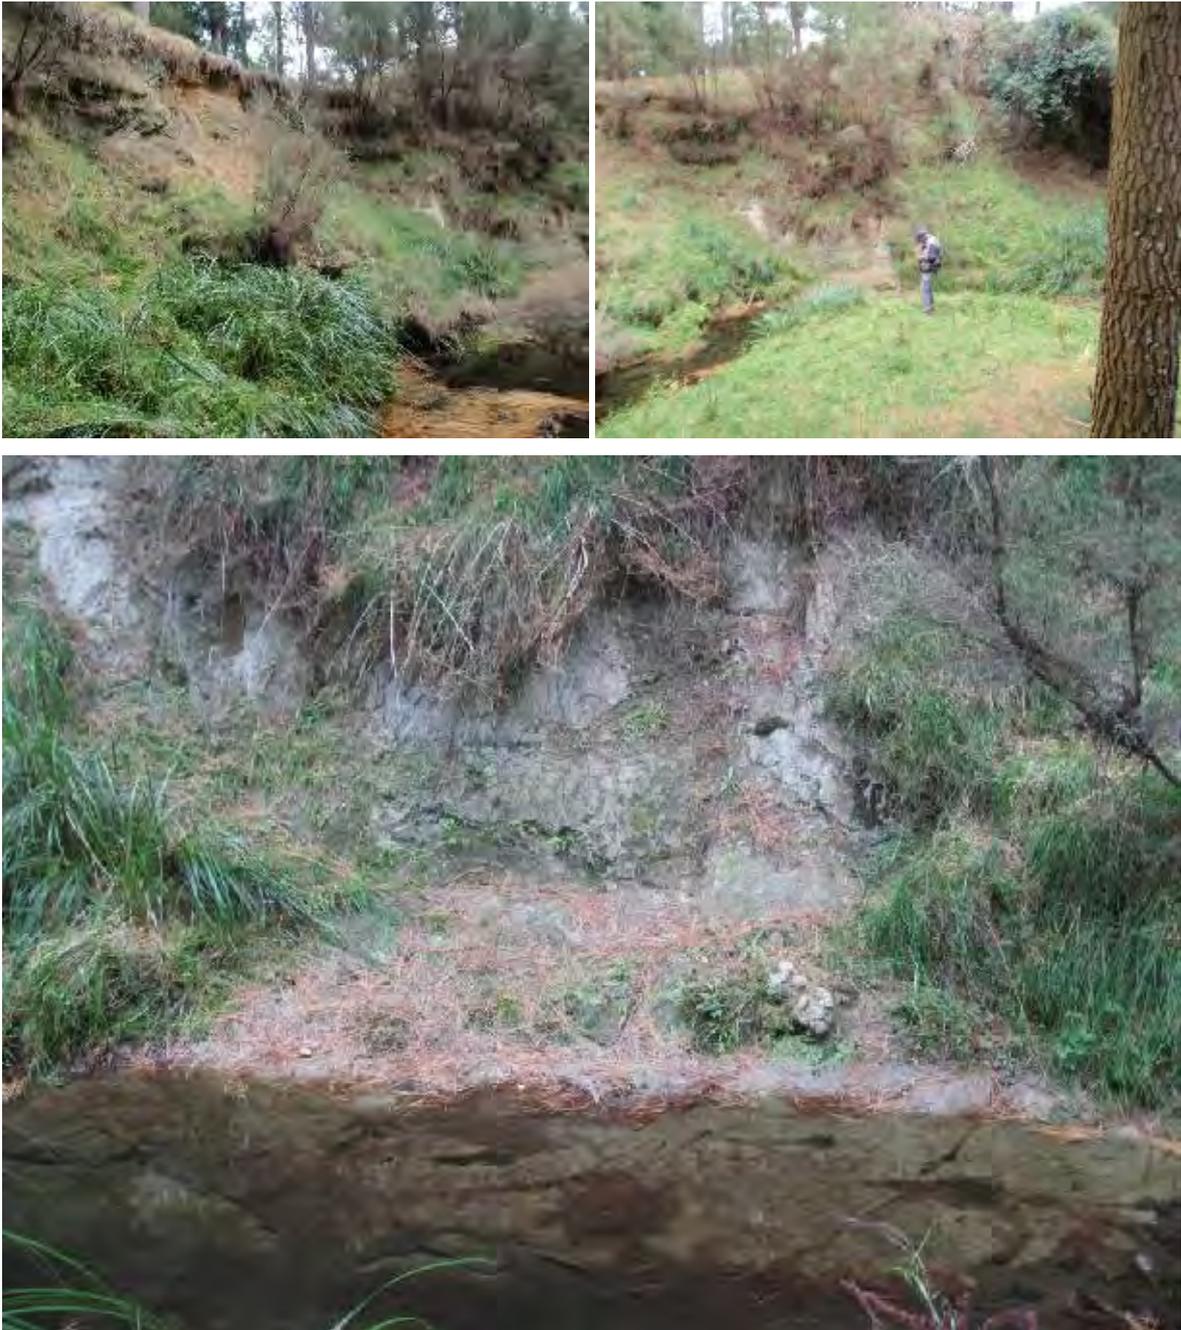
Exposures were inspected at the quarry upstream of Mill Road at the head of the potential reservoir and in the steeply incised channel upstream of the proposed dam. Extremely weak white siltstone is exposed in the stream floor and up to 5m above the invert in one place (refer Figure 3-76). Weakly cemented weathered greywacke gravel (red metal) with interbedded sand was observed overlying the siltstone (refer Figure 3-71 and Figure 3-75). In the quarry the greywacke gravel (red metal) had been removed exposing the softened upper surface of the siltstone.

Figure 3-76 White extremely weak siltstone in creek to 5m above, capped by red metal

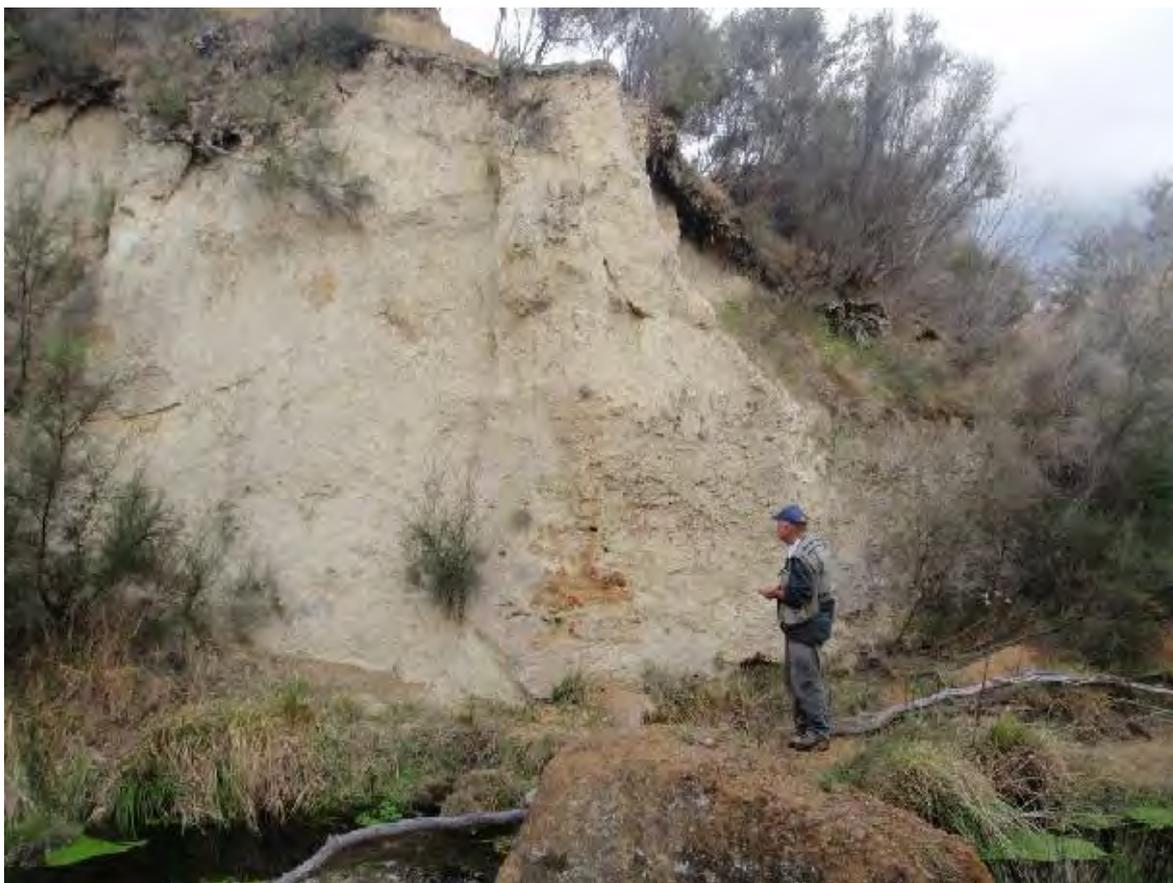
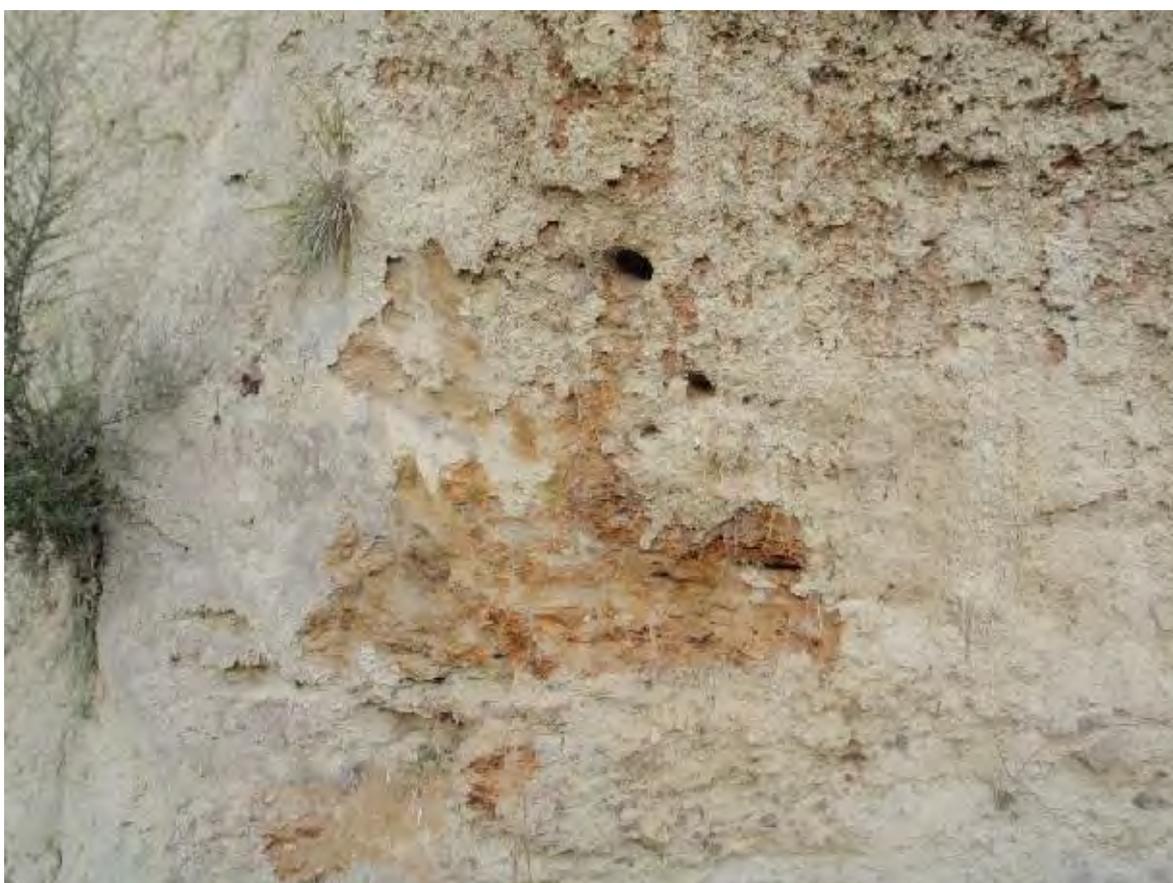
Figure 3-77 Upstream toe of embankment: red metal in creek comprising greywacke gravel interbedded with sand. No siltstone seen. Dipping 5-10 deg to 180 deg.

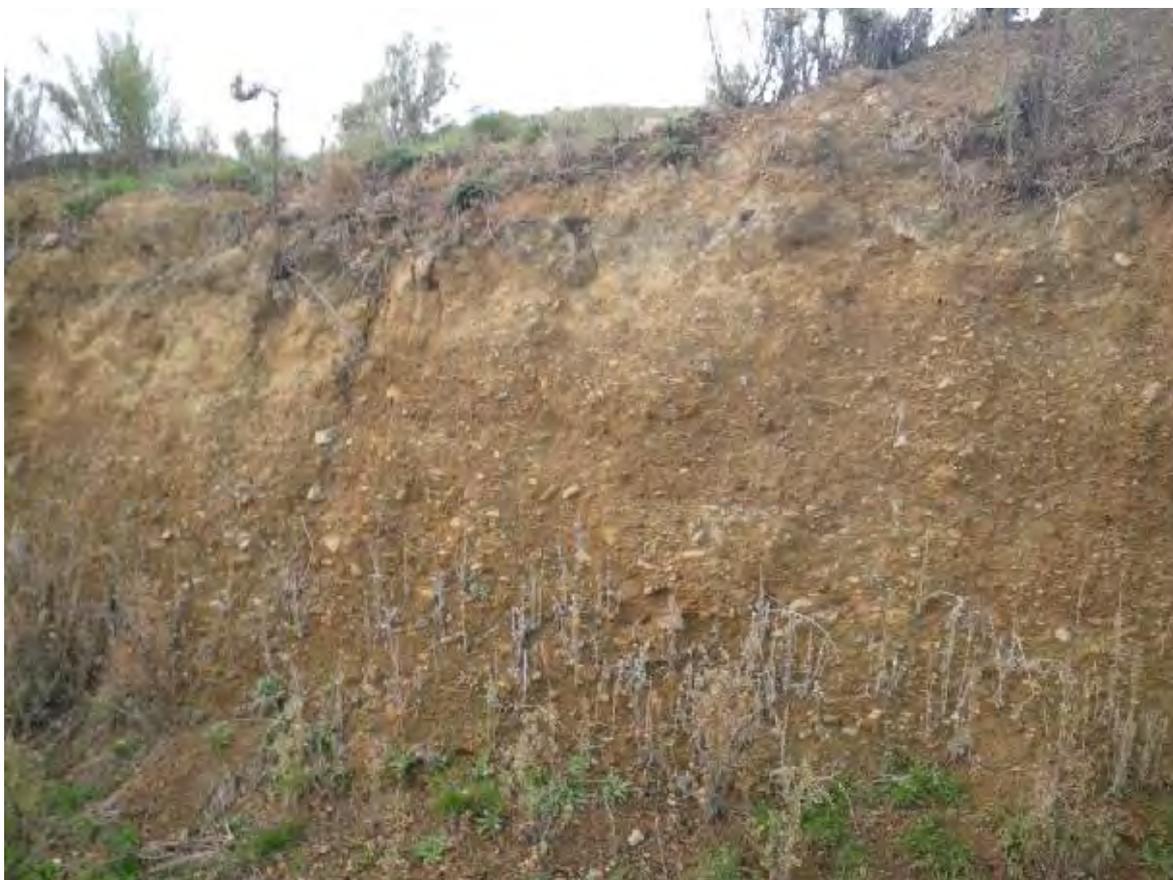
Exposures in the stream bed comprised weathered greywacke gravel (red metal) interbedded with thick beds of siltstone with pumiceous layers (refer Figure 3-78, Figure 3-79 and Figure 3-81). The stream channel passes between shallow sloping banks formed by the red metal and narrow gorges through the thick siltstone beds (refer Figure 3-80). The variation in the levels of the siltstone beds indicates that paleochannels may be present.

Figure 3-78 Red metal quarry above right abutment: Moderately to highly weathered silty sandy fine GRAVEL with low fines content

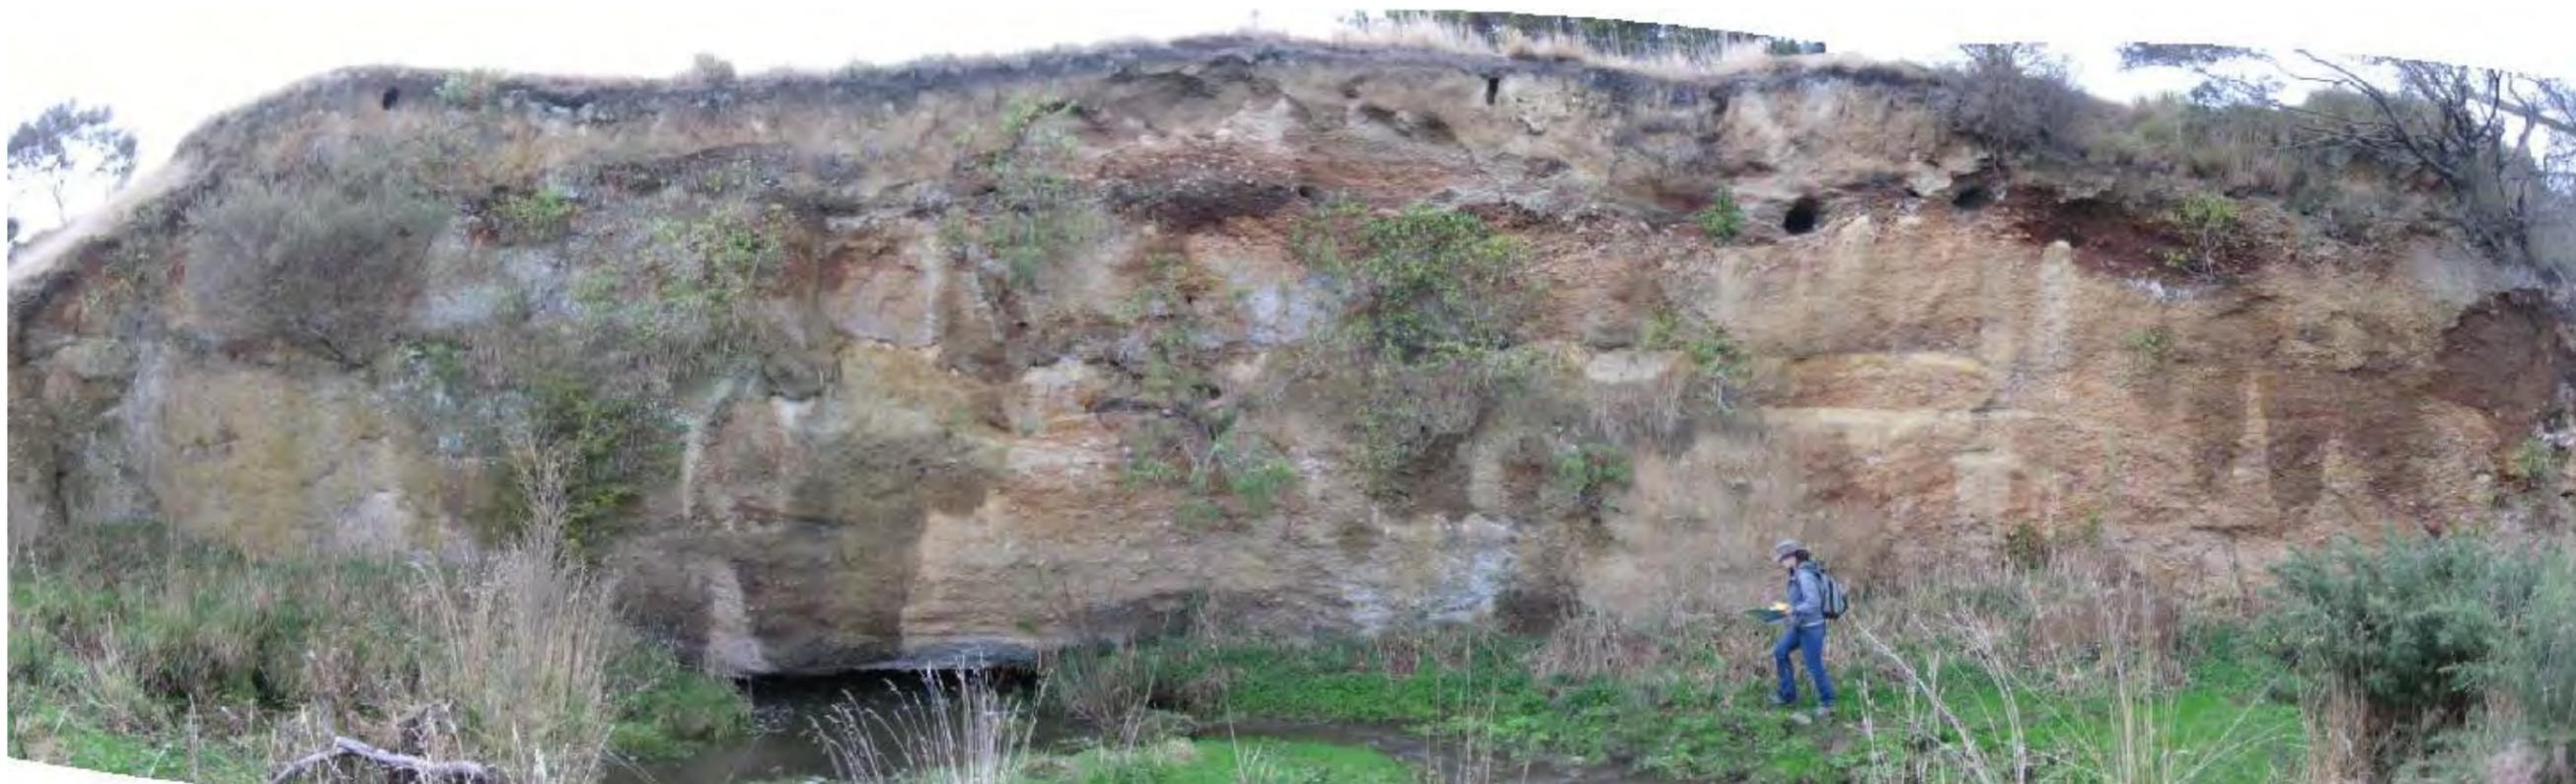
Figure 3-79 Loess overlying two ages of red metals with siltstone inclusions

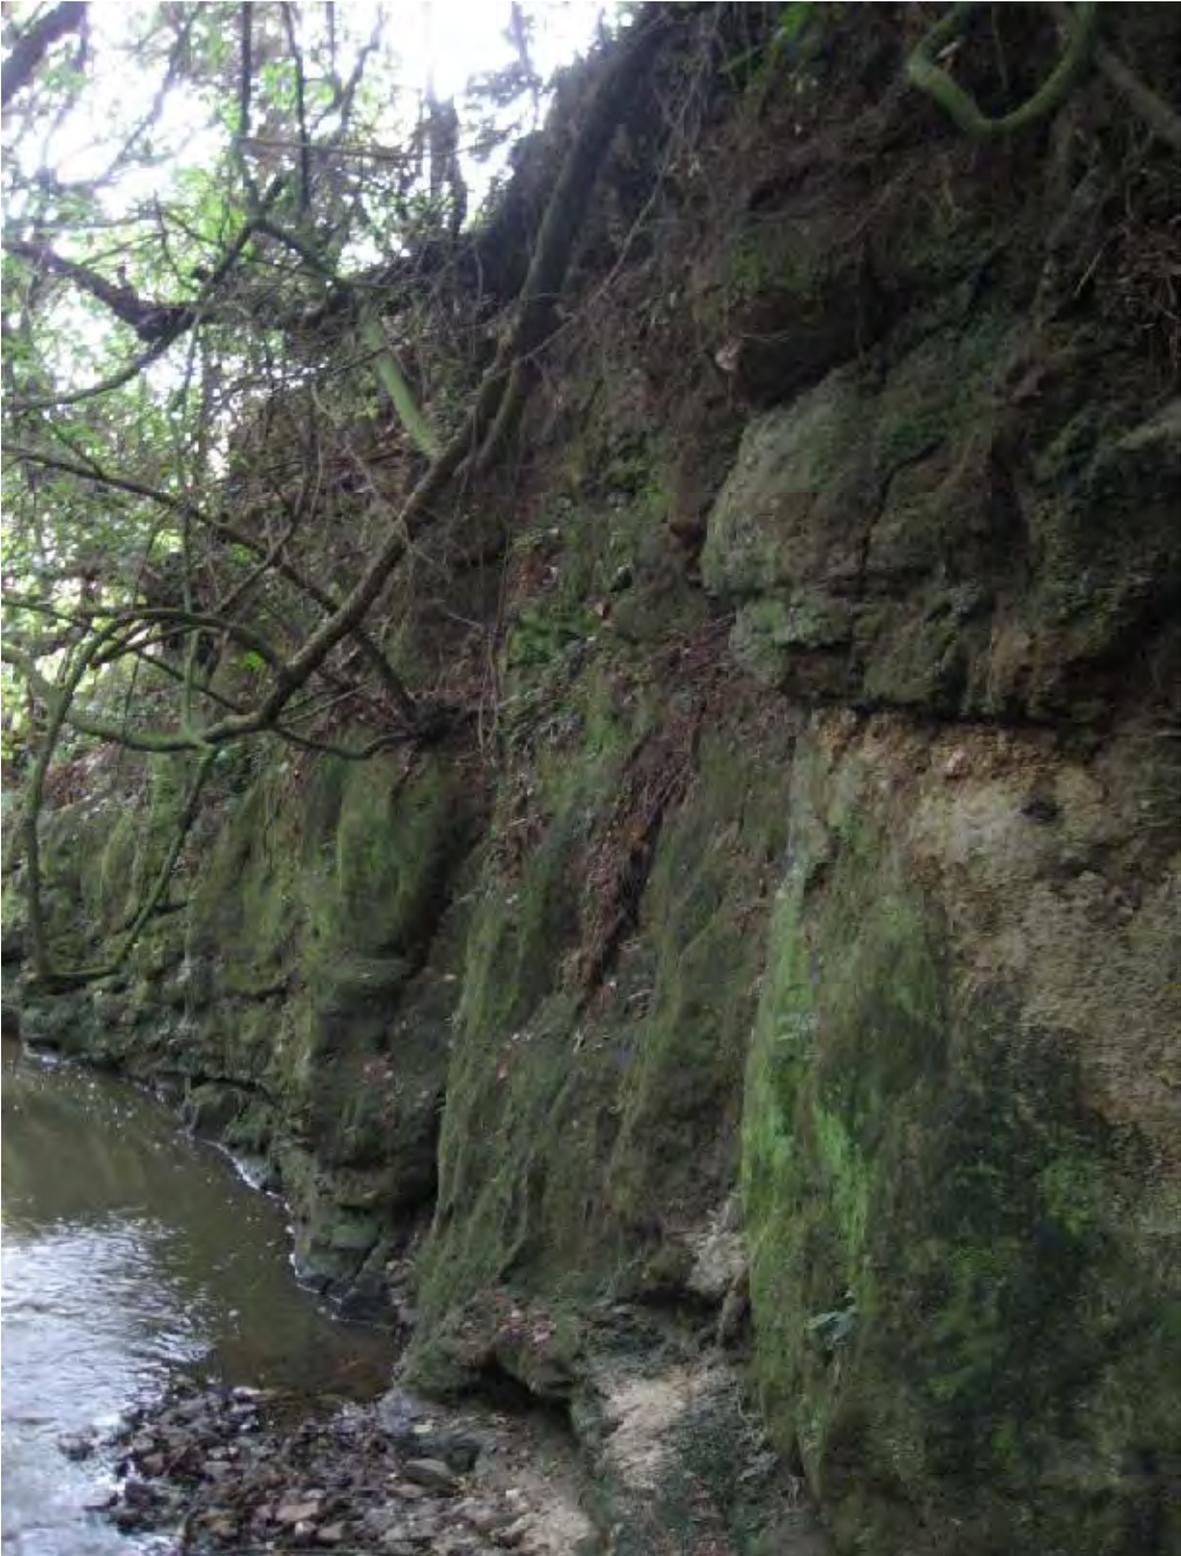
Figure 3-80 Gorge feature: Siltstone, possibly pumiceous, with sandstone beds

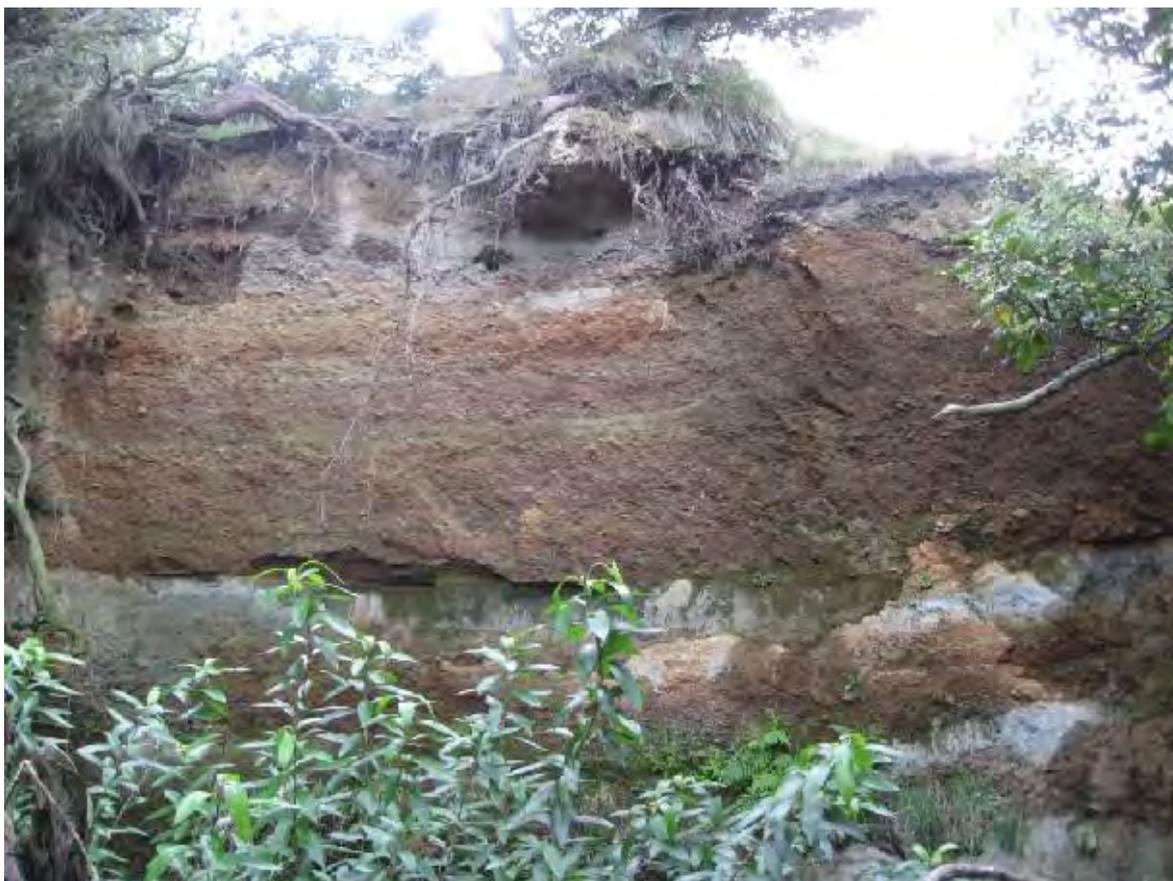
Figure 3-81 Red metals interbedded with white-grey siltstone, sub horizontal bedding

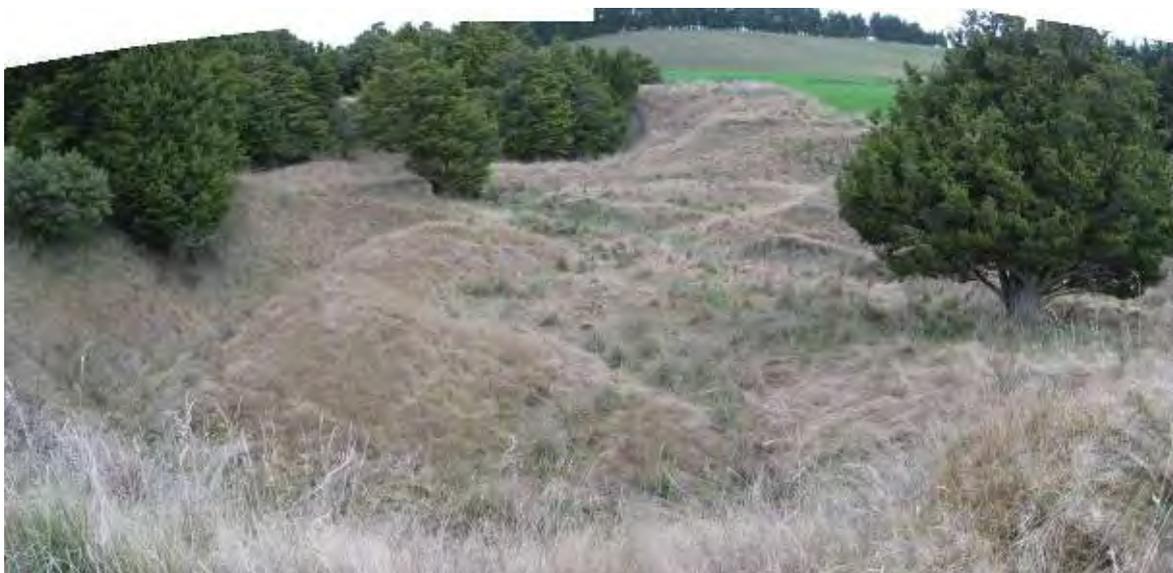
Abandoned marshy meanders were observed (refer Figure 3-82).

Figure 3-82 Unusual meanders developed within the red metal terrace surface

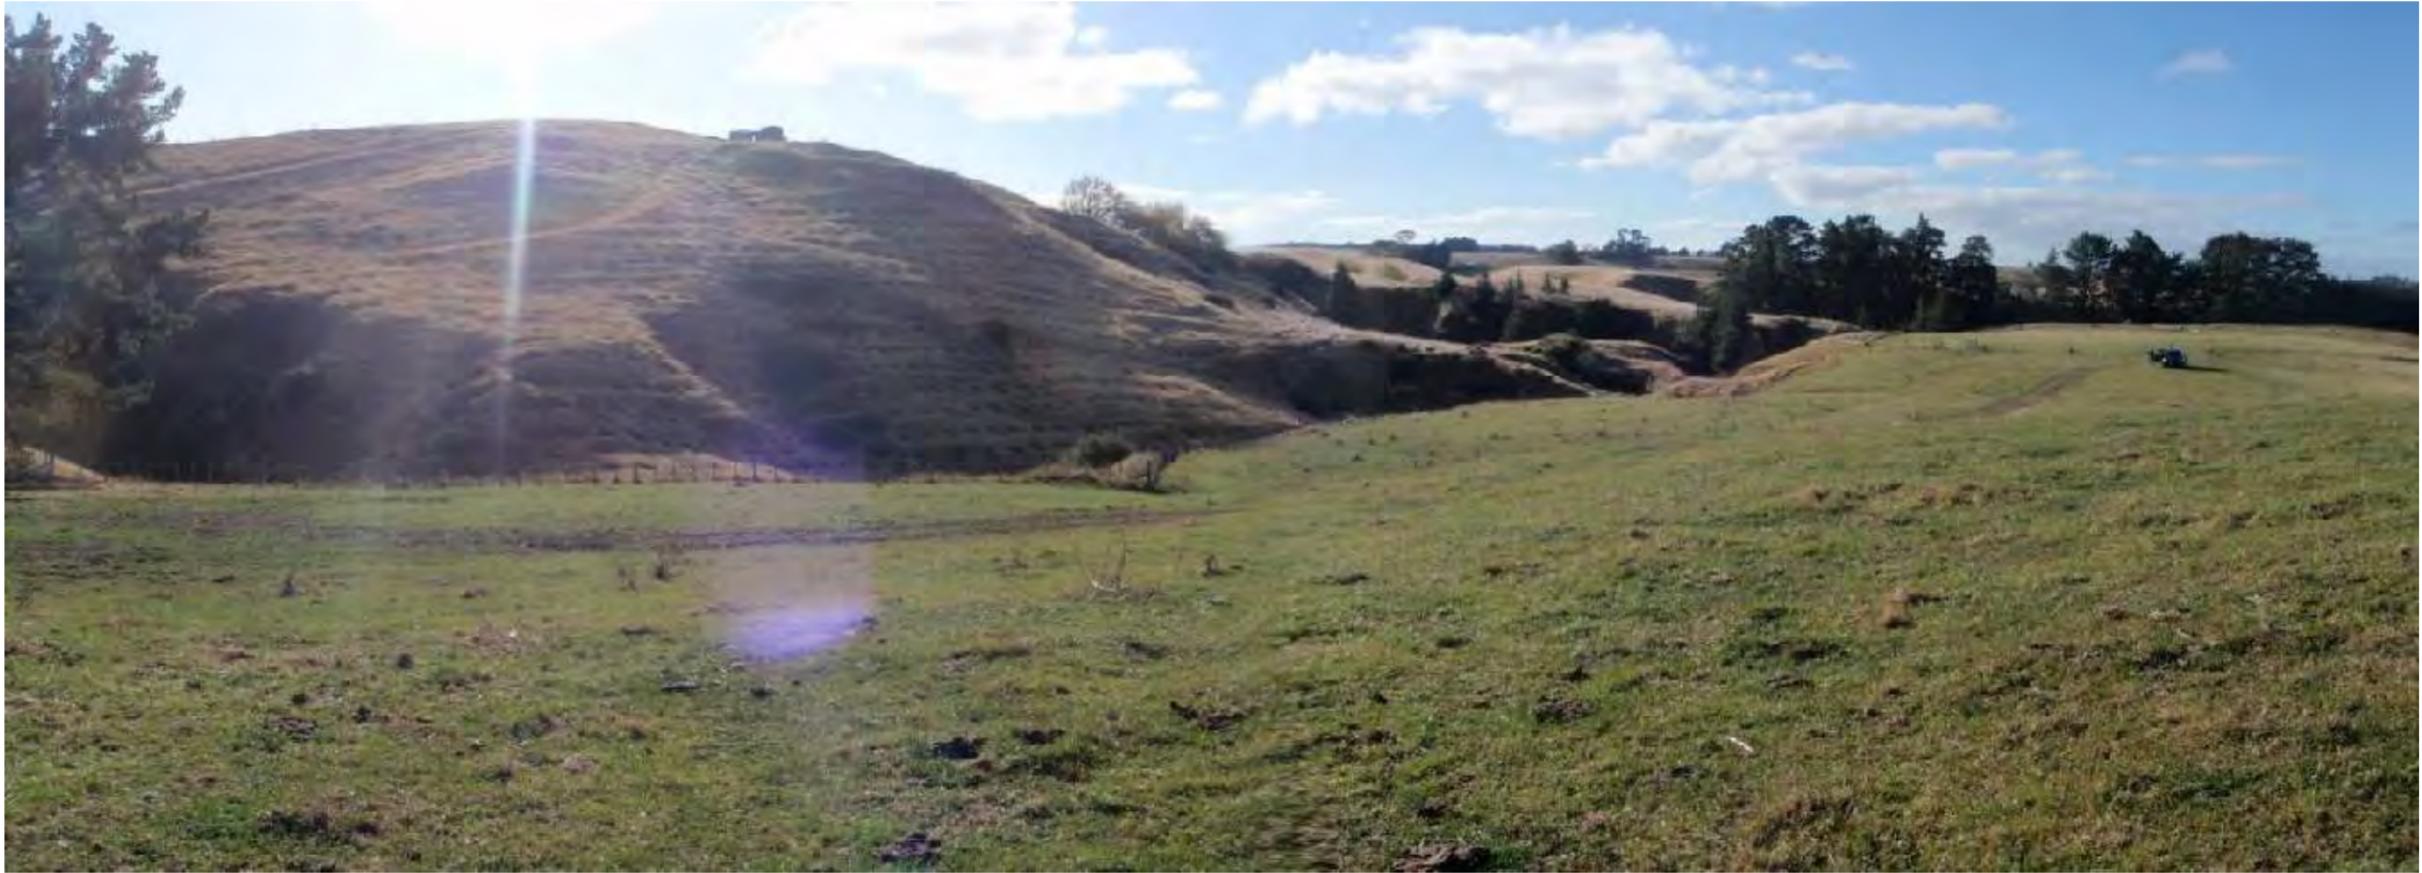
Figure 3-83 Looking downstream at proposed dam site from right side of stream

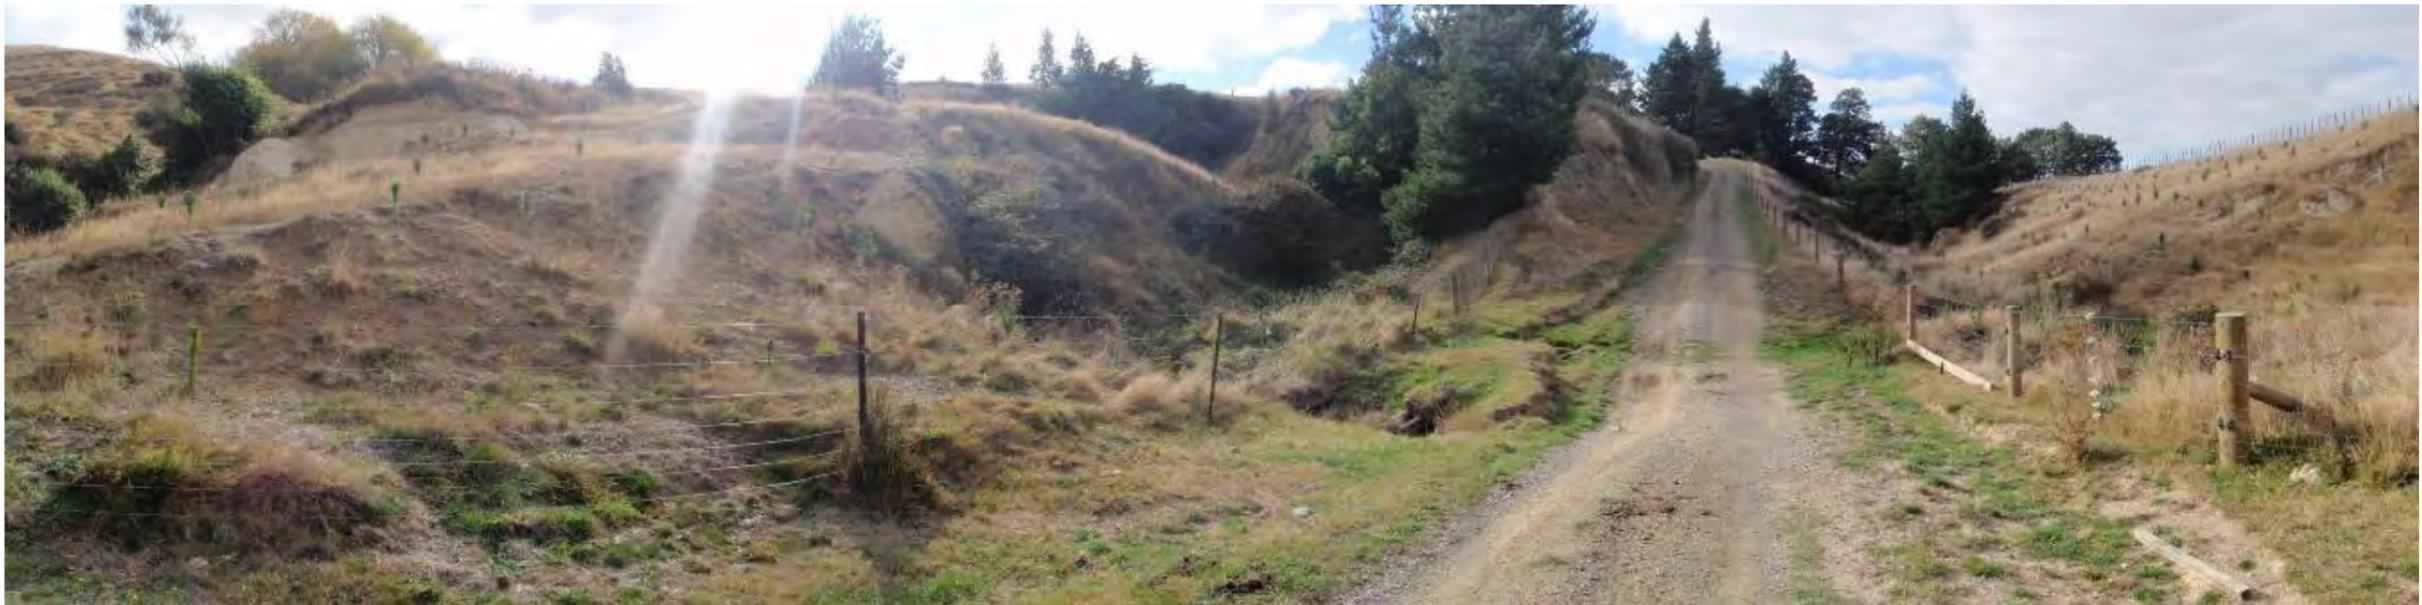
The study team considers the active fault to construe a fatal flaw and likely to require impractical (unaffordable) measures for achieving an adequately safe storage. After team discussion, Site D1 was abandoned and so further discussion of issues and risks and recommendations for future investigations have not been set out.

Figure 3-84 Looking down fault trace in stream

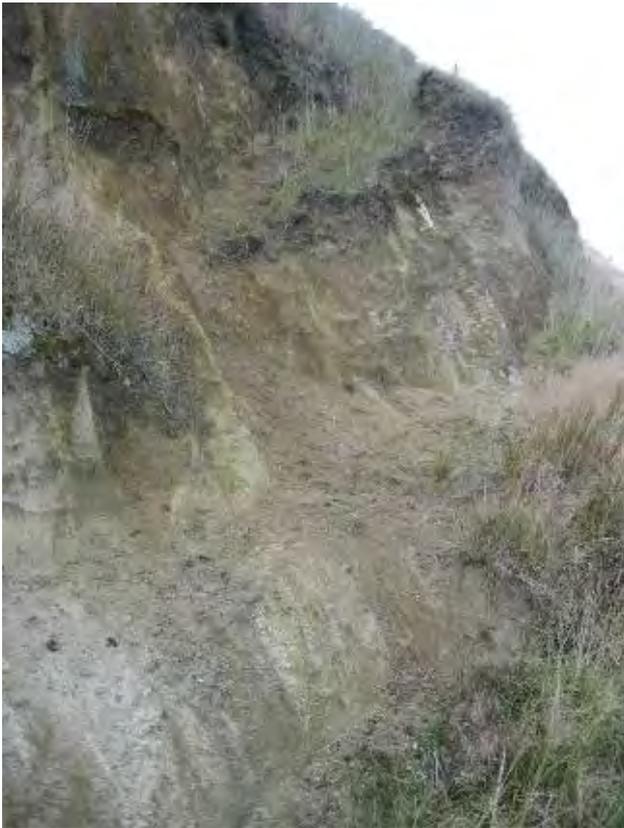
Only a limited inspection was made since the presence of a geologically active fault trace in the GNS data base was confirmed during the site visit. Vertical bedding within the older Castlecliffian weathered greywacke gravel was seen in the creek within the dam footprint (refer Figure 3-85), and extensive jointing in an overlying limestone exposure indicating significant disruption was observed (refer Figure 3-86). In addition to the fault trace following the stream bed, a more recent fault trace was observed parallel and 100m south-east of the fault in the stream (refer Figure 3-87).

Figure 3-85 Vertical bedding in stream fault trace
