Hawkes Bay Regional Council

Ruataniwha Water Augmentation
Scheme

Advanced Prefeasibility Geotechnical
Investigation Report

T&T Ref: 27195/V04

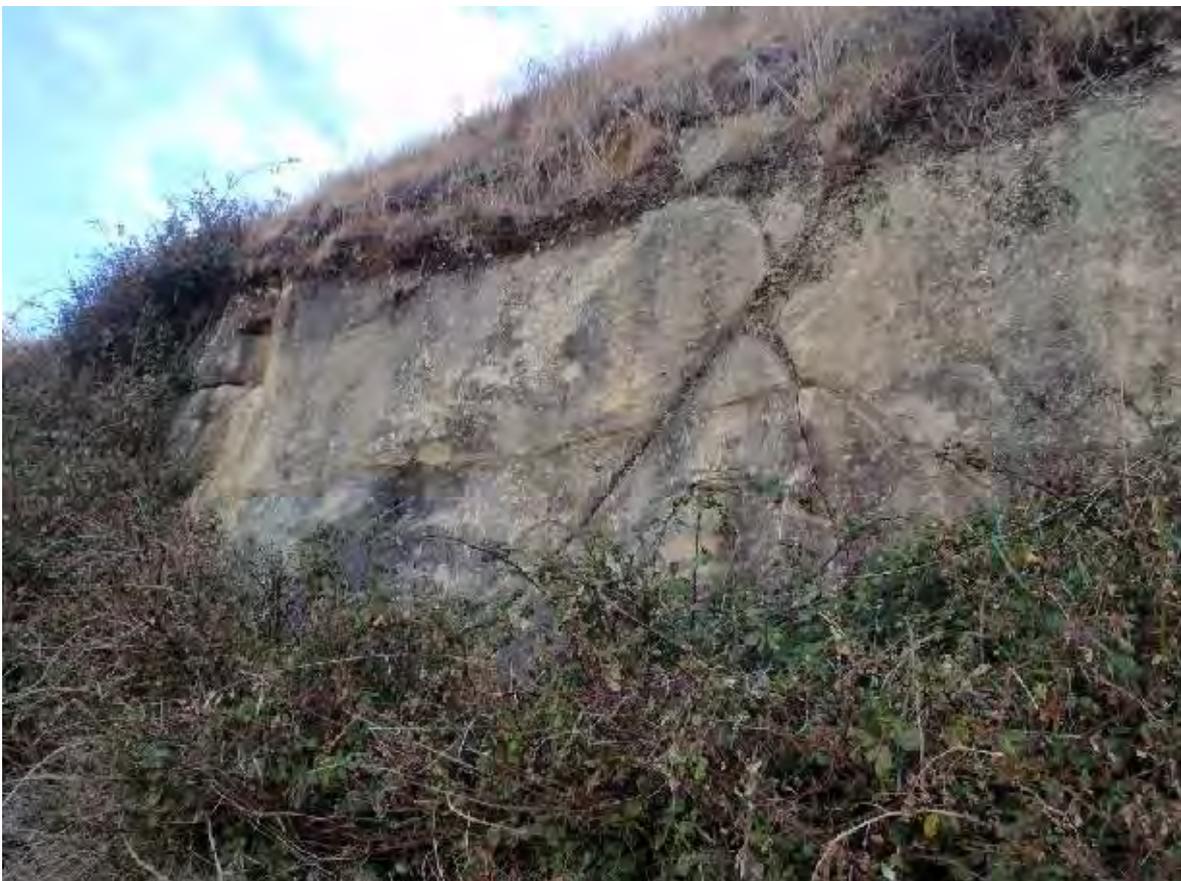
Only a limited inspection was made since the presence of a geologically active fault trace in the GNS data base was confirmed during the site visit. Vertical bedding within the older Castlecliffian weathered greywacke gravel was seen in the creek within the dam footprint (refer Figure 3-85), and extensive jointing in an overlying limestone exposure indicating significant disruption was observed (refer Figure 3-86). In addition to the fault trace following the stream bed, a more recent fault trace was observed parallel and 100m south-east of the fault in the stream (refer Figure 3-87).

Figure 3-86 Jointed limestone exposure in main fault trace indicating significant disruption

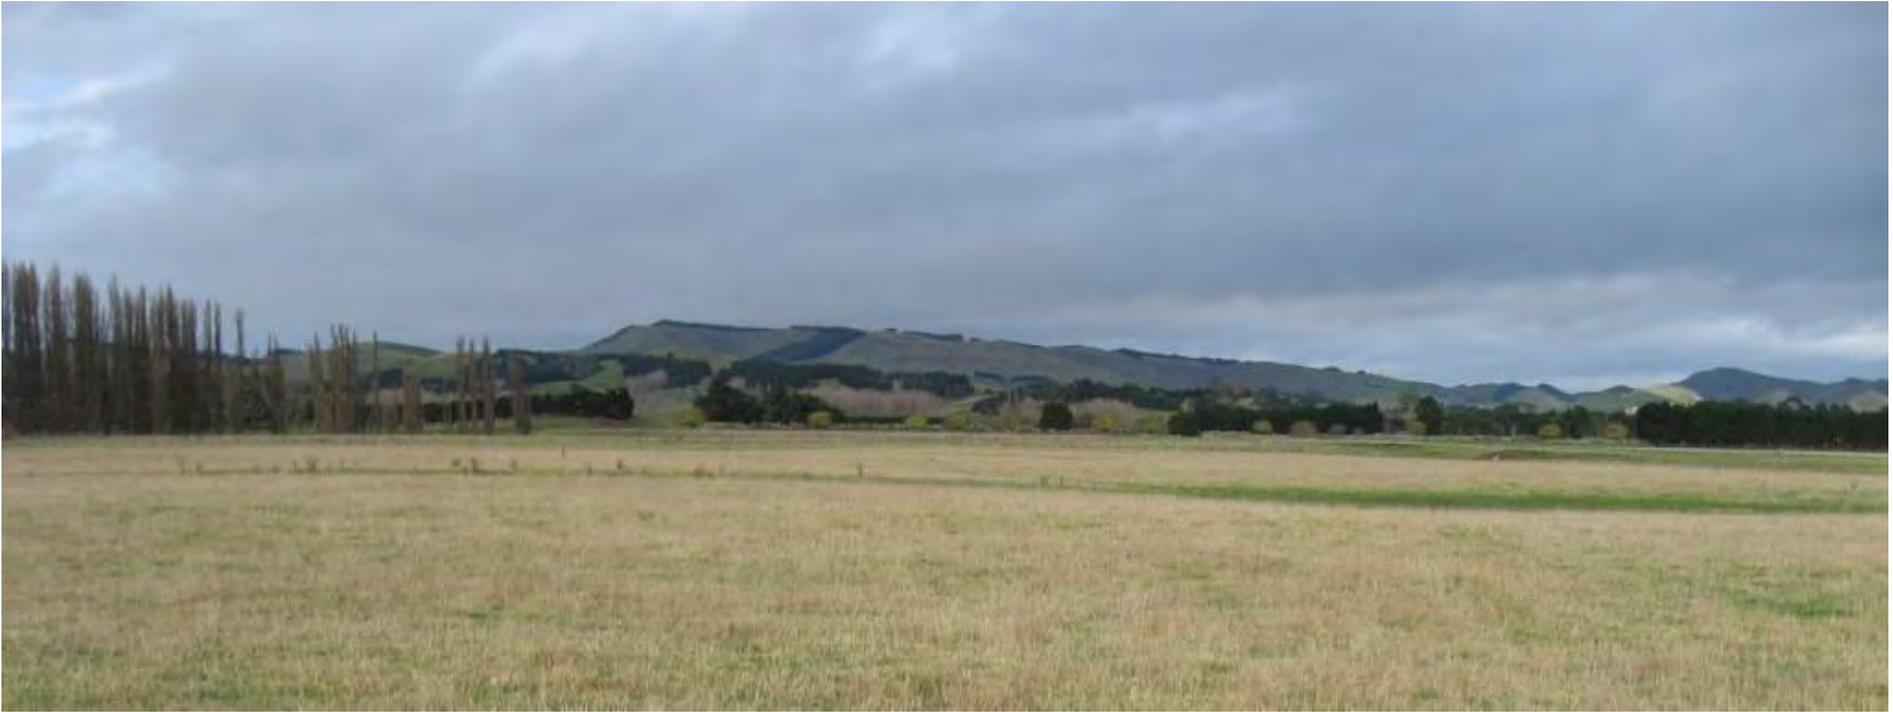
Limestone slopes were observed rising to the east above the right abutment (refer Figure 3-90). Nukumaruan marine siltstones and sandstones are exposed in the banks of the eastern-most stream within the reservoir. The extremely weak siltstones and sandstones are shelly in places with a thin horizon of limestone seen in the right bank and coarse sand and gravel (greywacke and limestone) layers observed in the left bank (refer Figure 3-91). Limestone debris was also exposed in the stream banks. The contact between the limestone and siltstone / sandstones is expected to be close to the right side of the reservoir. HBRC has supplied the driller's log for a water bore located in the valley floor near the right abutment. The log indicates that the main limestone bed was encountered at a depth of 70m below ground level with the borehole having passed down through siltstone and fine sandstone with thin limestone beds.

Figure 3-90 Looking upstream and to true right side of reservoir: Dip angle of LIMESTONE visible in background.

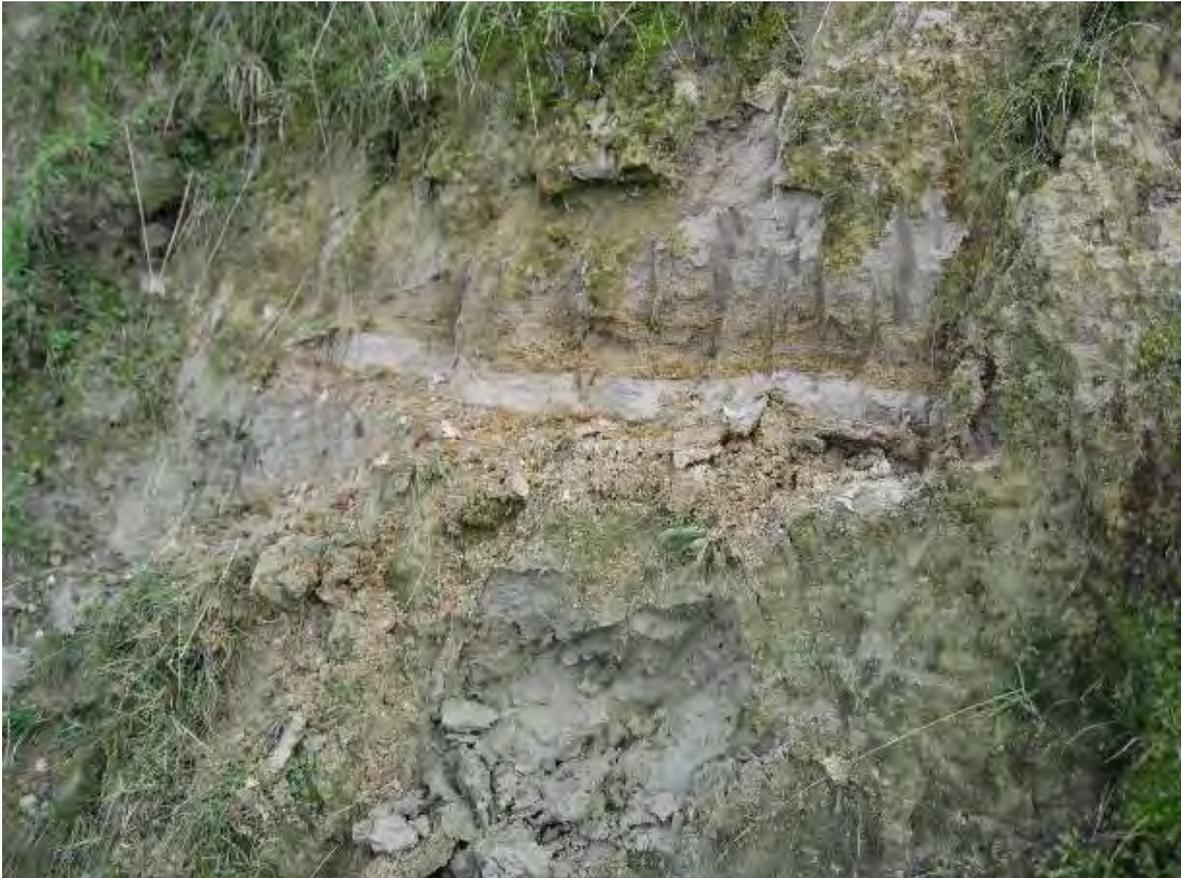
Figure 3-91 Stream at right abutment: Grey shelly SILTSTONE overlain by 50mm white SILTSTONE then 100mm coarse SAND

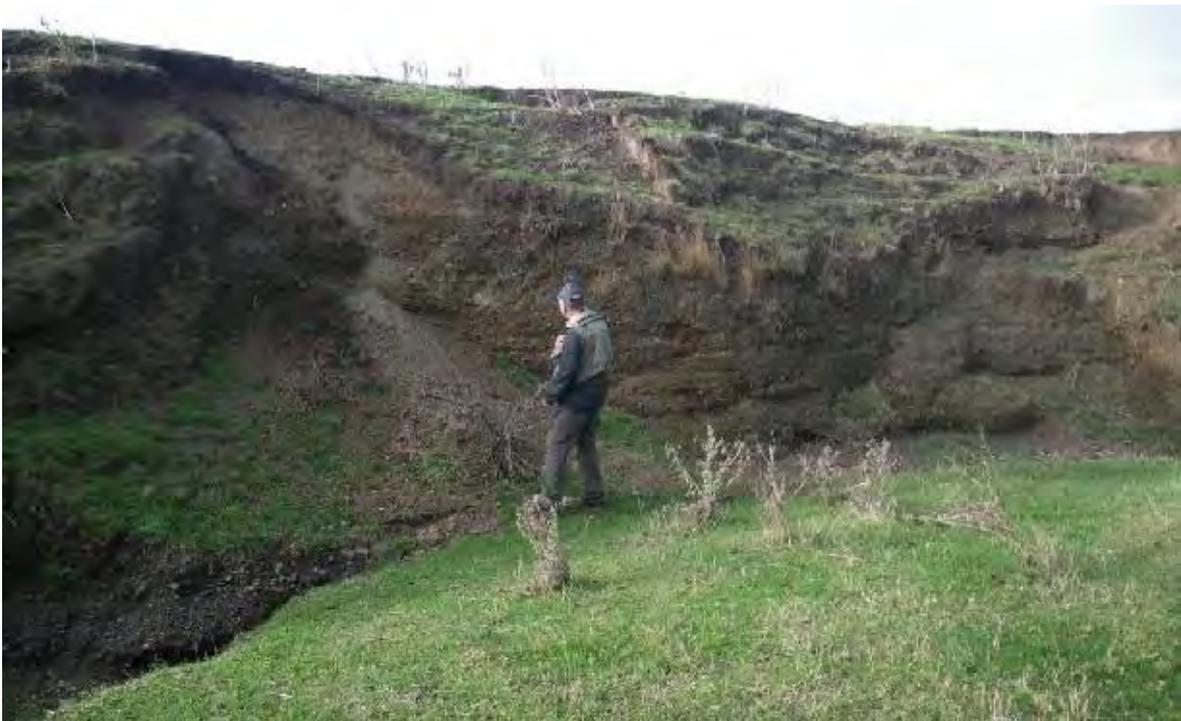
In the next stream to the west crossing the proposed dam centreline, approximately 350m in from the right abutment, younger red metal gravels were exposed upstream of the dam (refer Figure 3-92), and Nukumaruan sandstones/siltstones are exposed in the floor of the stream at the dam centreline. In the Maharakeke Stream towards the left abutment, the bank exposures comprised red metals interbedded with younger sands and silts (refer Figure 3-93 and Figure 3-94). A red metal quarry was observed at the upstream extent of the reservoir beside the Maharakeke Stream (refer Figure 3-95).

Figure 3-92 In central creek upstream of dam embankment: red metals with sandstone floaters

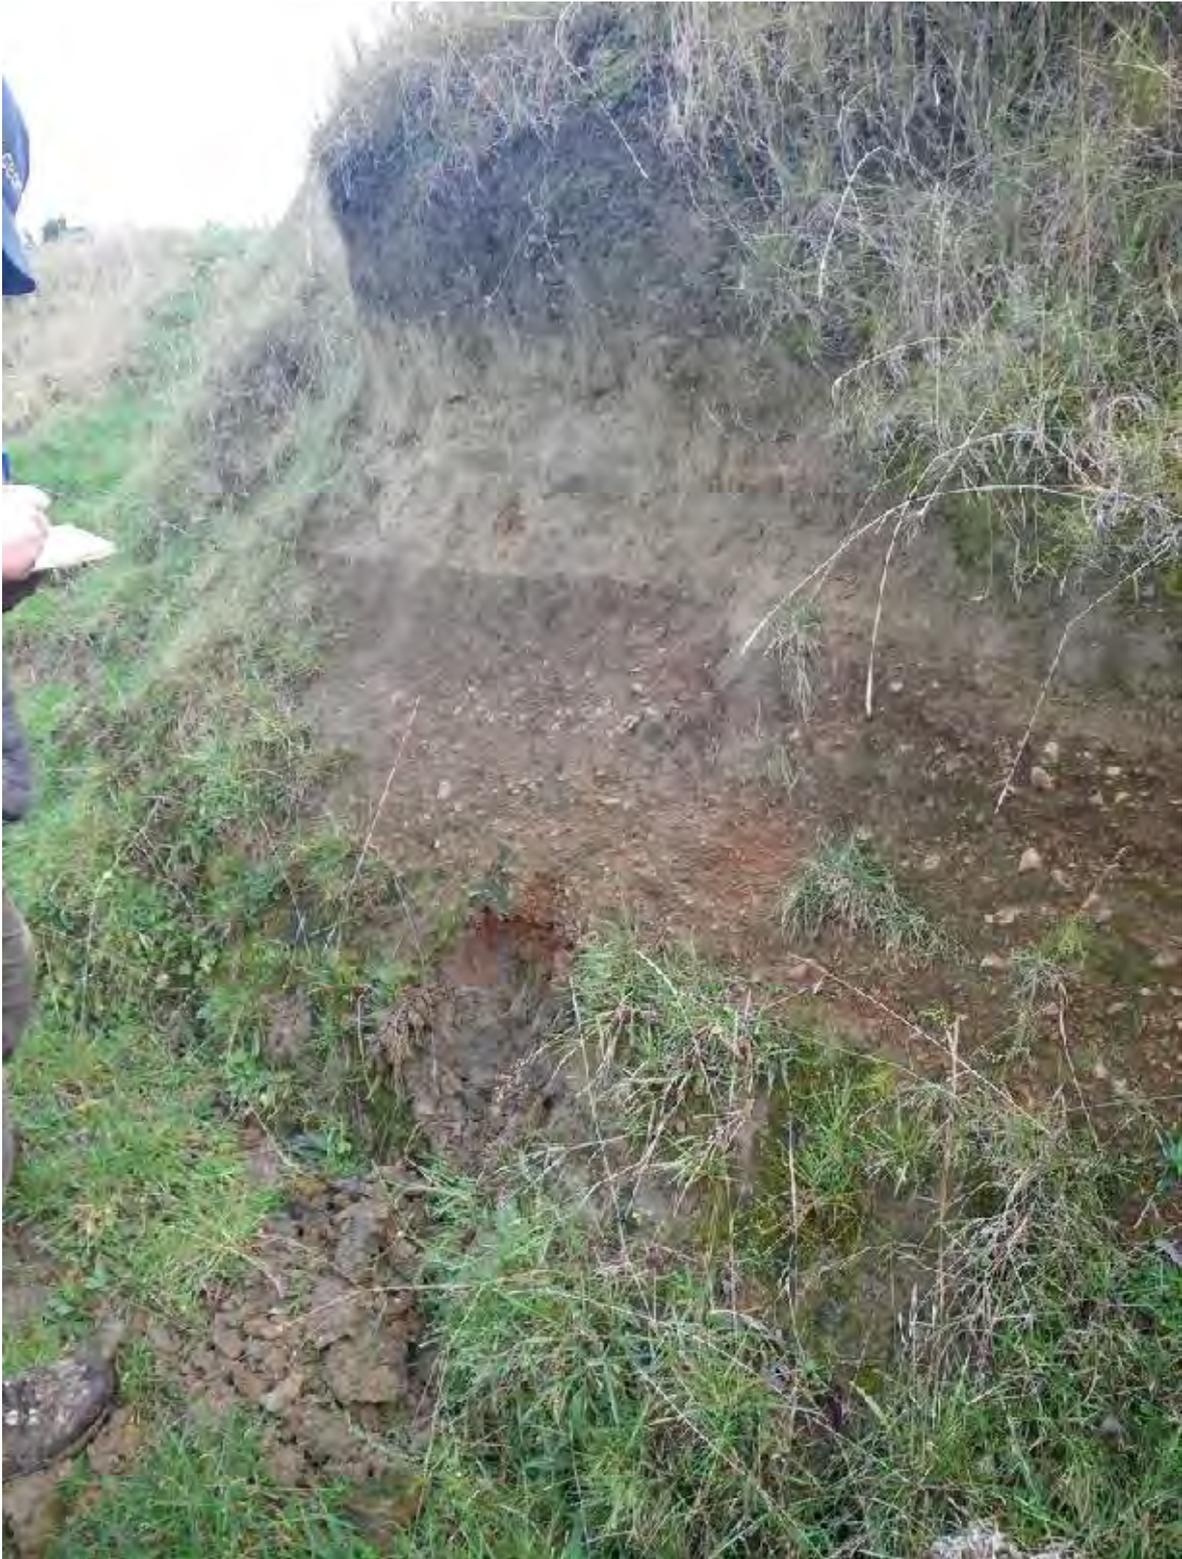
Figure 3-93 In main stream: red metals with seep at base possibly overlying sandstone

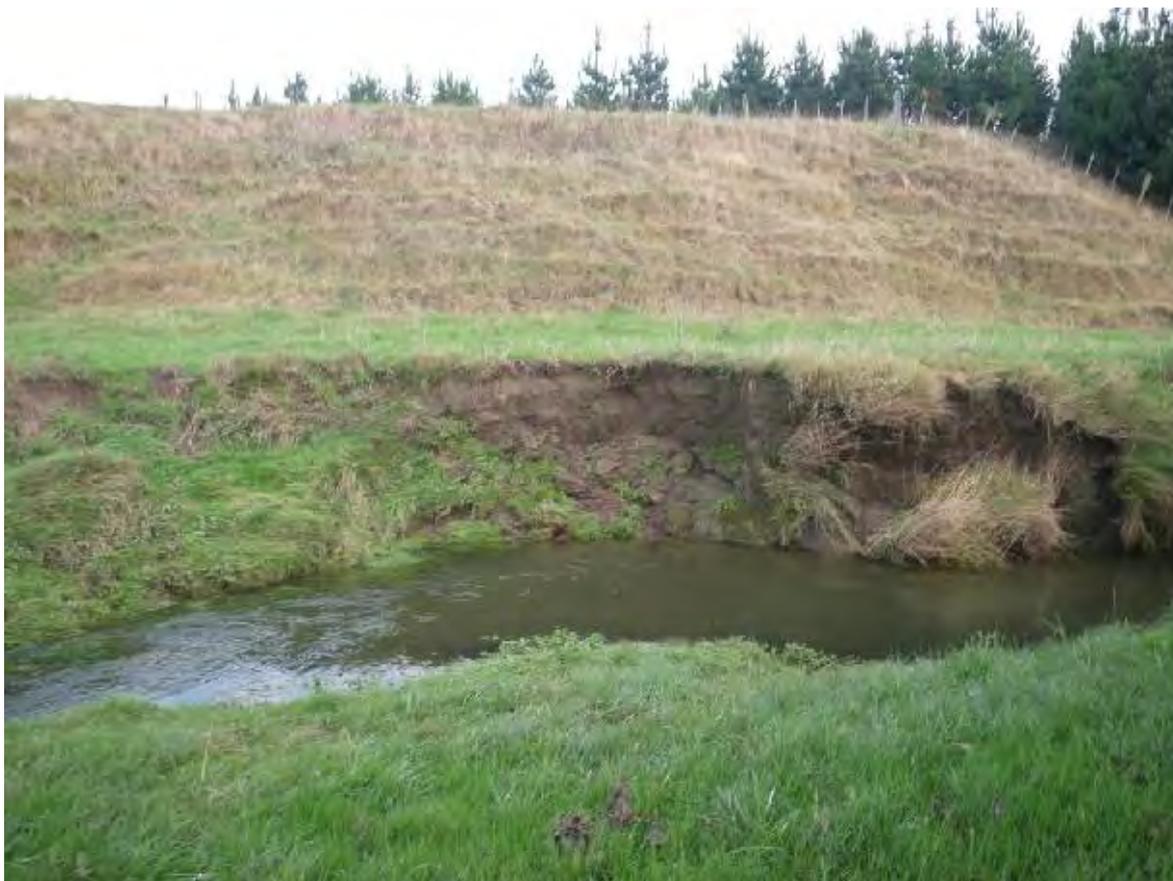
Figure 3-94 Sands and silts in banks of main stream

Minor instability was observed in the most recently deposited sands and silts in the Maharakeke stream banks (refer Figure 3-94). These materials will need to be removed prior to construction of the embankment. However, as discussed below, the requirement for water tightness against seepage under the embankment may necessitate a more significant undercut beneath the dam footprint than required for stability.

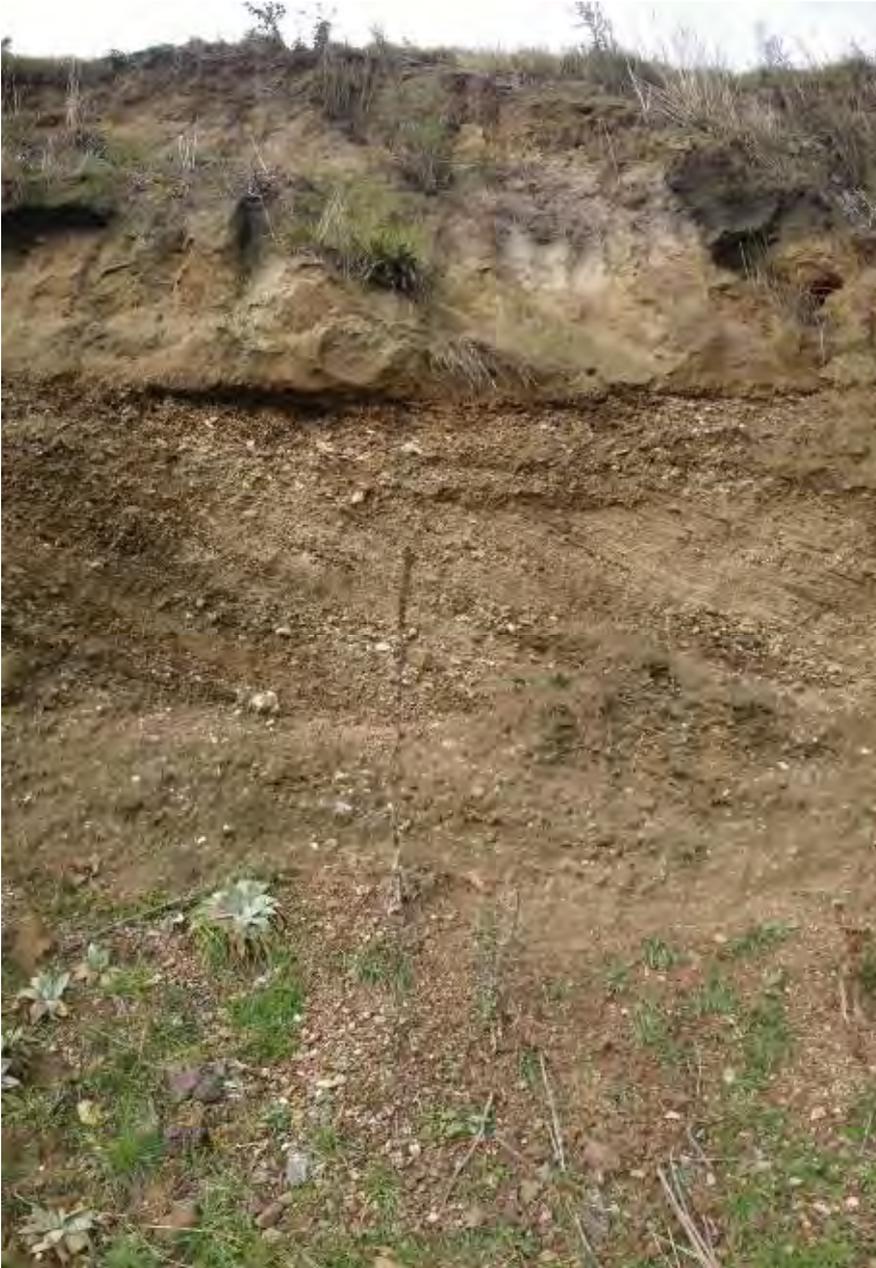
Figure 3-95 Red metals in quarry with high energy foreset bedding, capped by loess

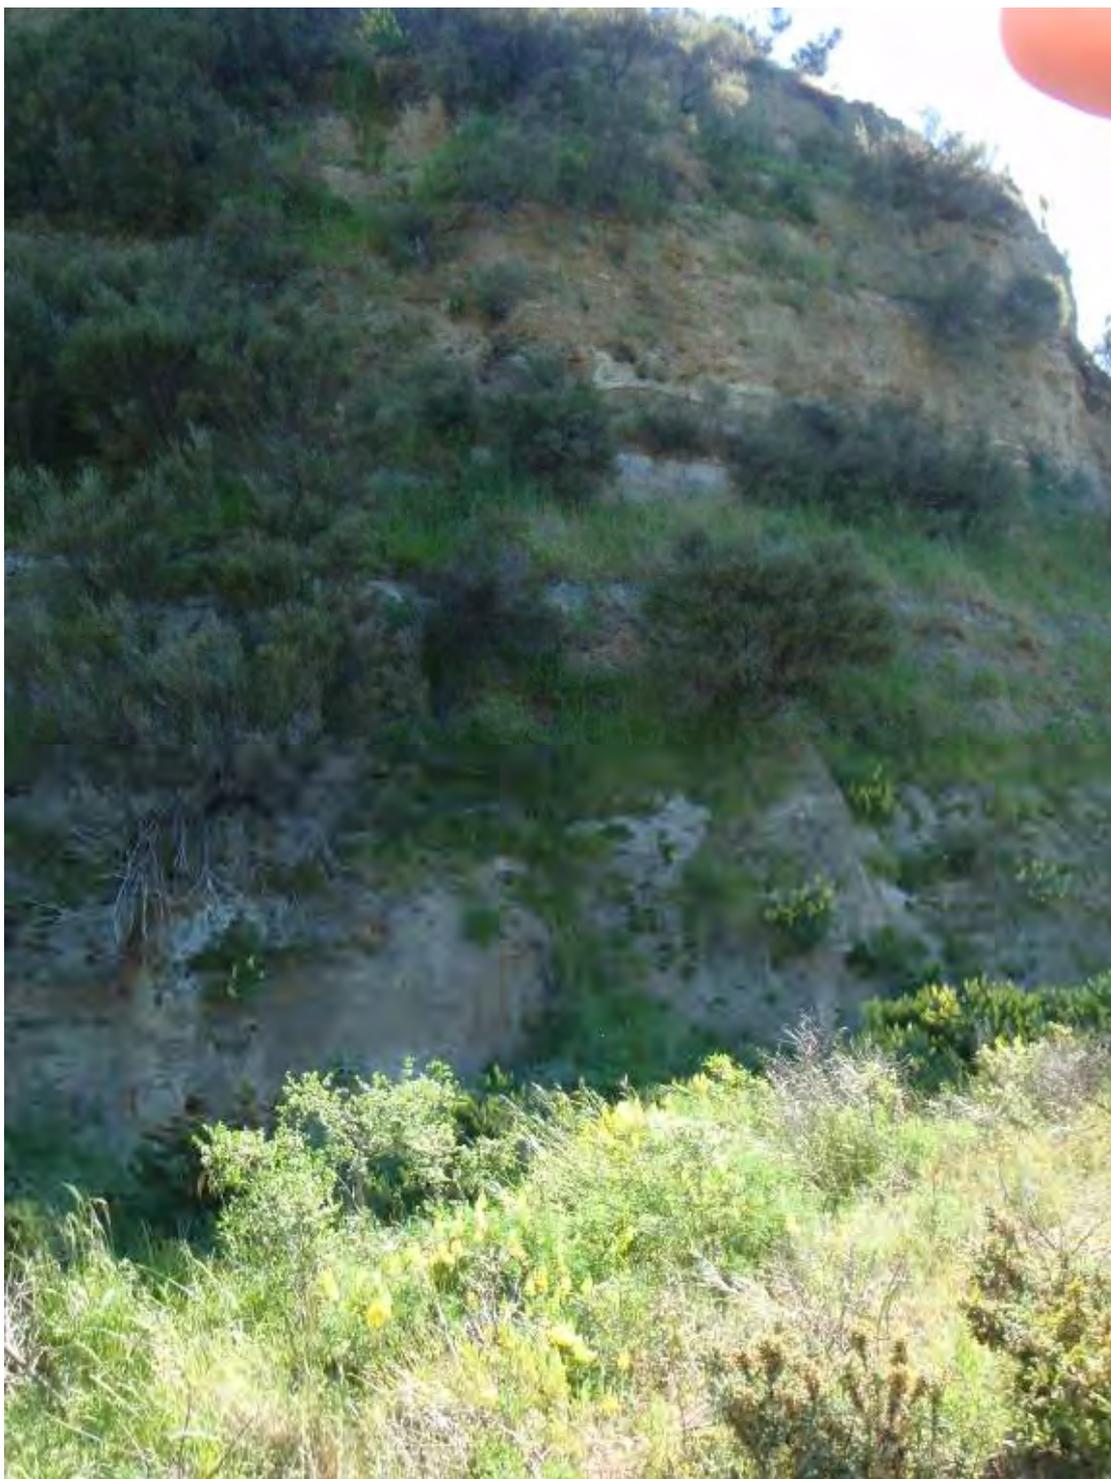
A range of materials are available for dam construction with a limited amount of well graded unweathered greywacke alluvium present within the river bed (exposed due to local gravel-winning operations within the river bed). As discussed above clayey siltstone occurs in up to 10 m thick beds and is overlain by approximately 10 to 15 m of "red metal" (slightly to moderately weathered greywacke terrace gravel) on the valley sides. A thin mantle of loess caps the terrace gravel (Figure 3-96).

Figure 3-96 Profile of gravel deposits exposed upstream of dam

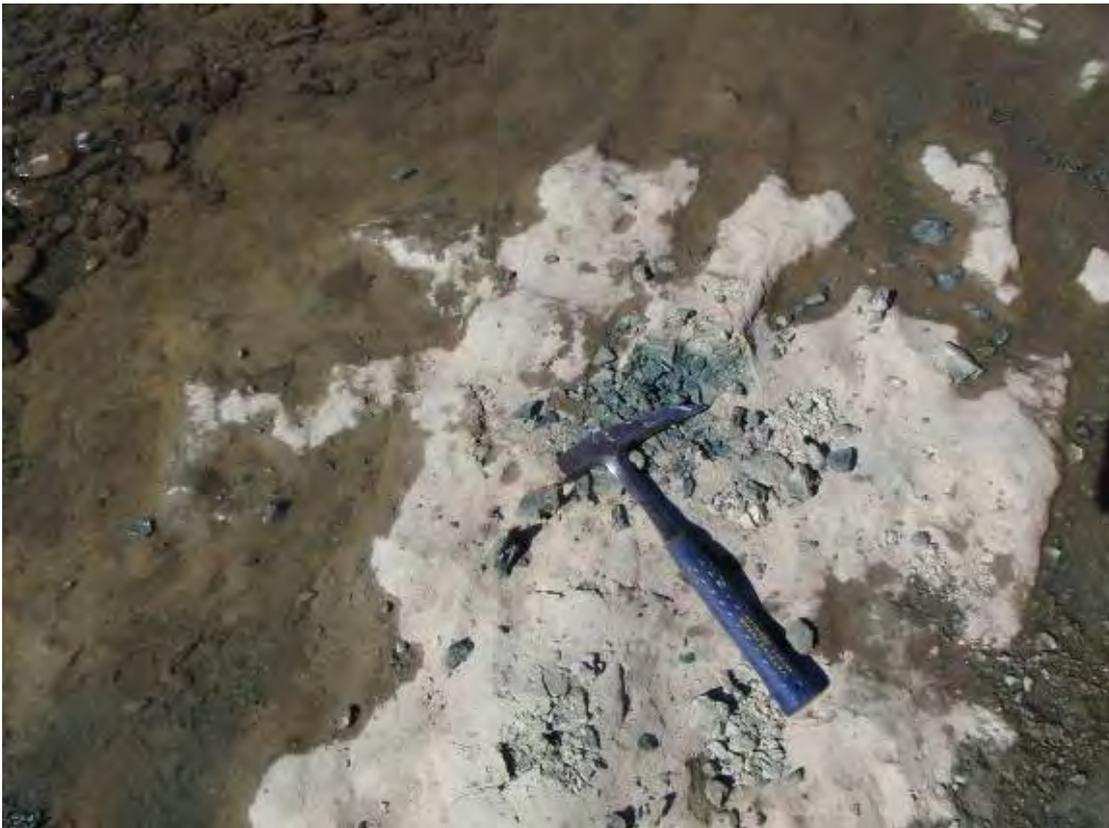
Figure 3-97 Siltstone outcrops in the river bed

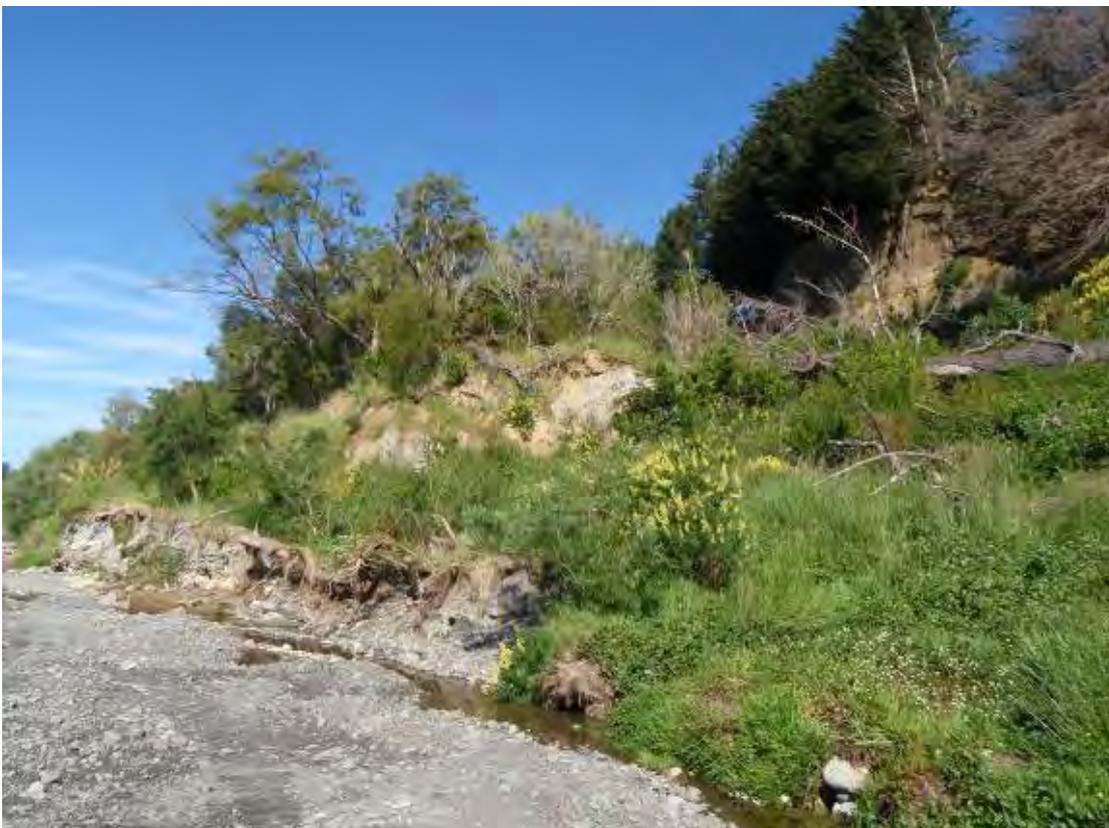
A landslide involving failure of the full cliff height was noted within the proposed dam footprint on the right river bank. The failure appeared to be due to a translational movement on a basal shear surface within the extremely weak clayey siltstone (Figure 3-98).

Figure 3-98 Landslides within reservoir, appear to slide off siltstone contact at river bed

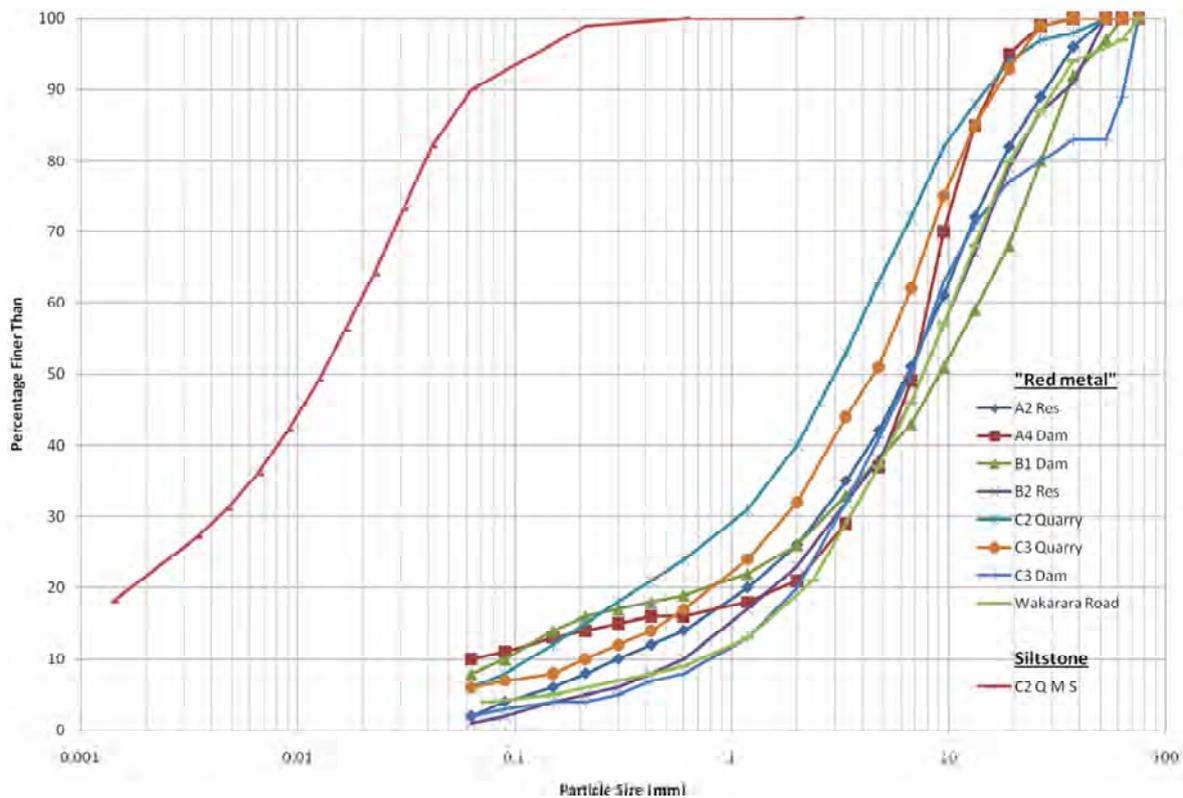
The grading results are summarised in Figure 4-1 and permeability results are presented in Table 4-1 below. The complete test results are included in Appendix E.

Figure 4-1 Particle Size Analysis Results

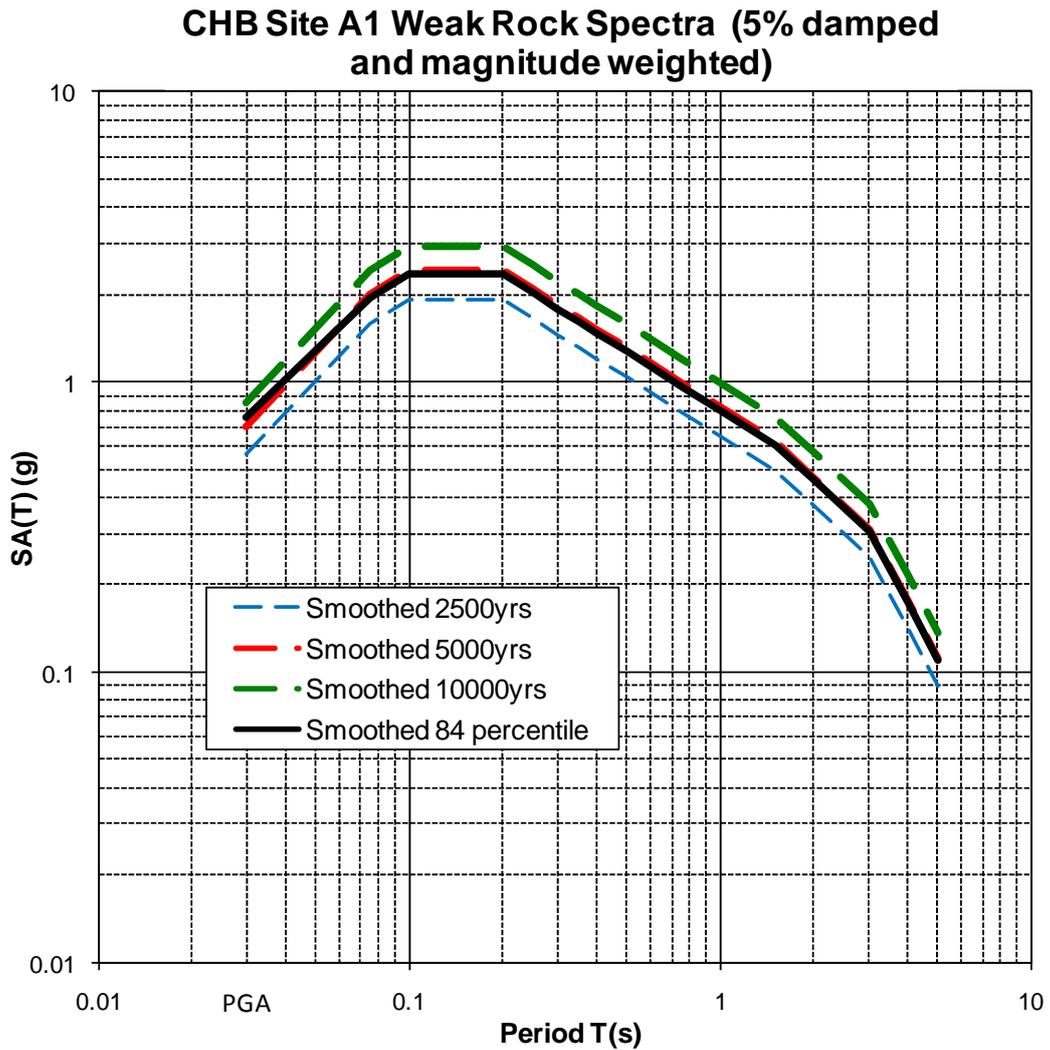
Figure ES1 The smoothed hazard spectra at Site A1 (weak rock) from the standard model, for three return periods, 2500, 5000 and 10,000 years, and the 84-percentile spectrum for a scenario earthquake from the Mohaka South fault. Near-fault factors are added to the scenario spectrum for the final recommended MDE spectrum for Site A1 shown in Figure ES3.

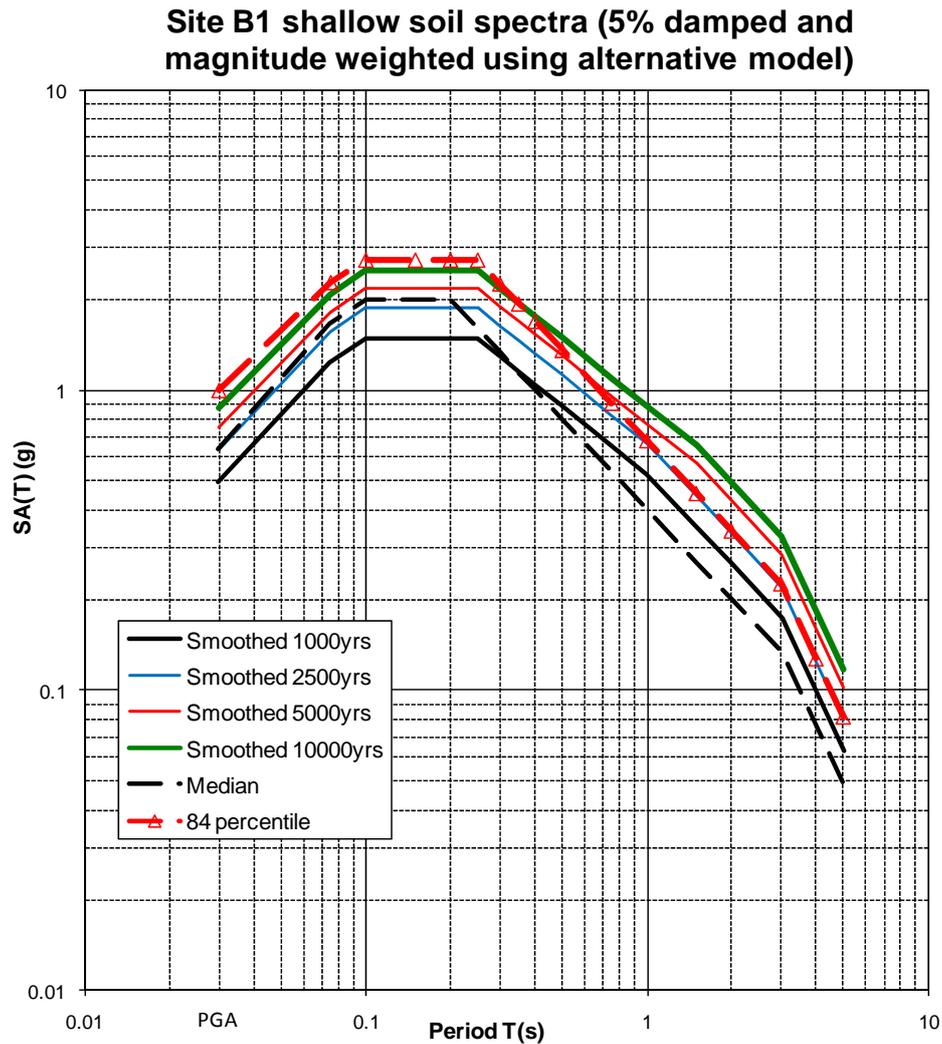
Figure ES2 The smoothed hazard spectra at Site B1 (shallow soil) for the alternative model, for four return periods, 1000, 2500, 5000 and 10,000 years, and median and 84-percentile spectra for a scenario earthquake from the modified Ruataniwha Fault used in the alternative model. PGA is plotted at 0.03s. Near-fault factors are excluded here and in the recommended 10,000-year MDE spectrum for Site B1 shown in Figure ES3.

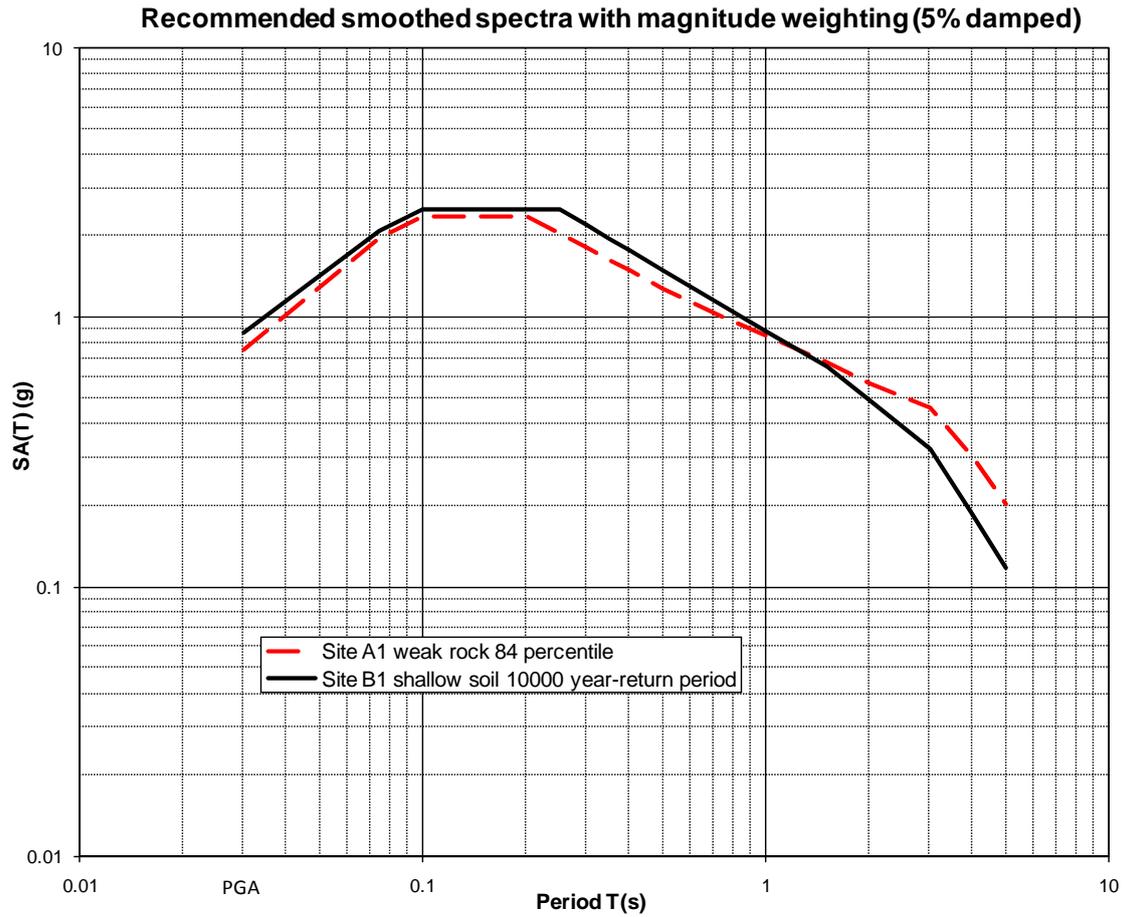
The recommended spectra are presented in Figure ES3 and listed in Table ES2. For Site A1, the recommended spectrum is listed with and without the recommended near-fault factors, to allow application of the NZS1170 factors if these are preferred by the designers. The equations and parameters used to construct the recommended spectra are presented in section 4.2

Figure ES3 Recommended design spectra for MDE motions at Site A1 (weak rock, 84-percentile Mohaka Fault spectrum including 84-percentile near-fault factors) and Site B1 (shallow soil, 10,000-year spectrum with recommended near-fault factors of 1.0). The spectrum recommended for site B1 was derived using the alternative fault model.

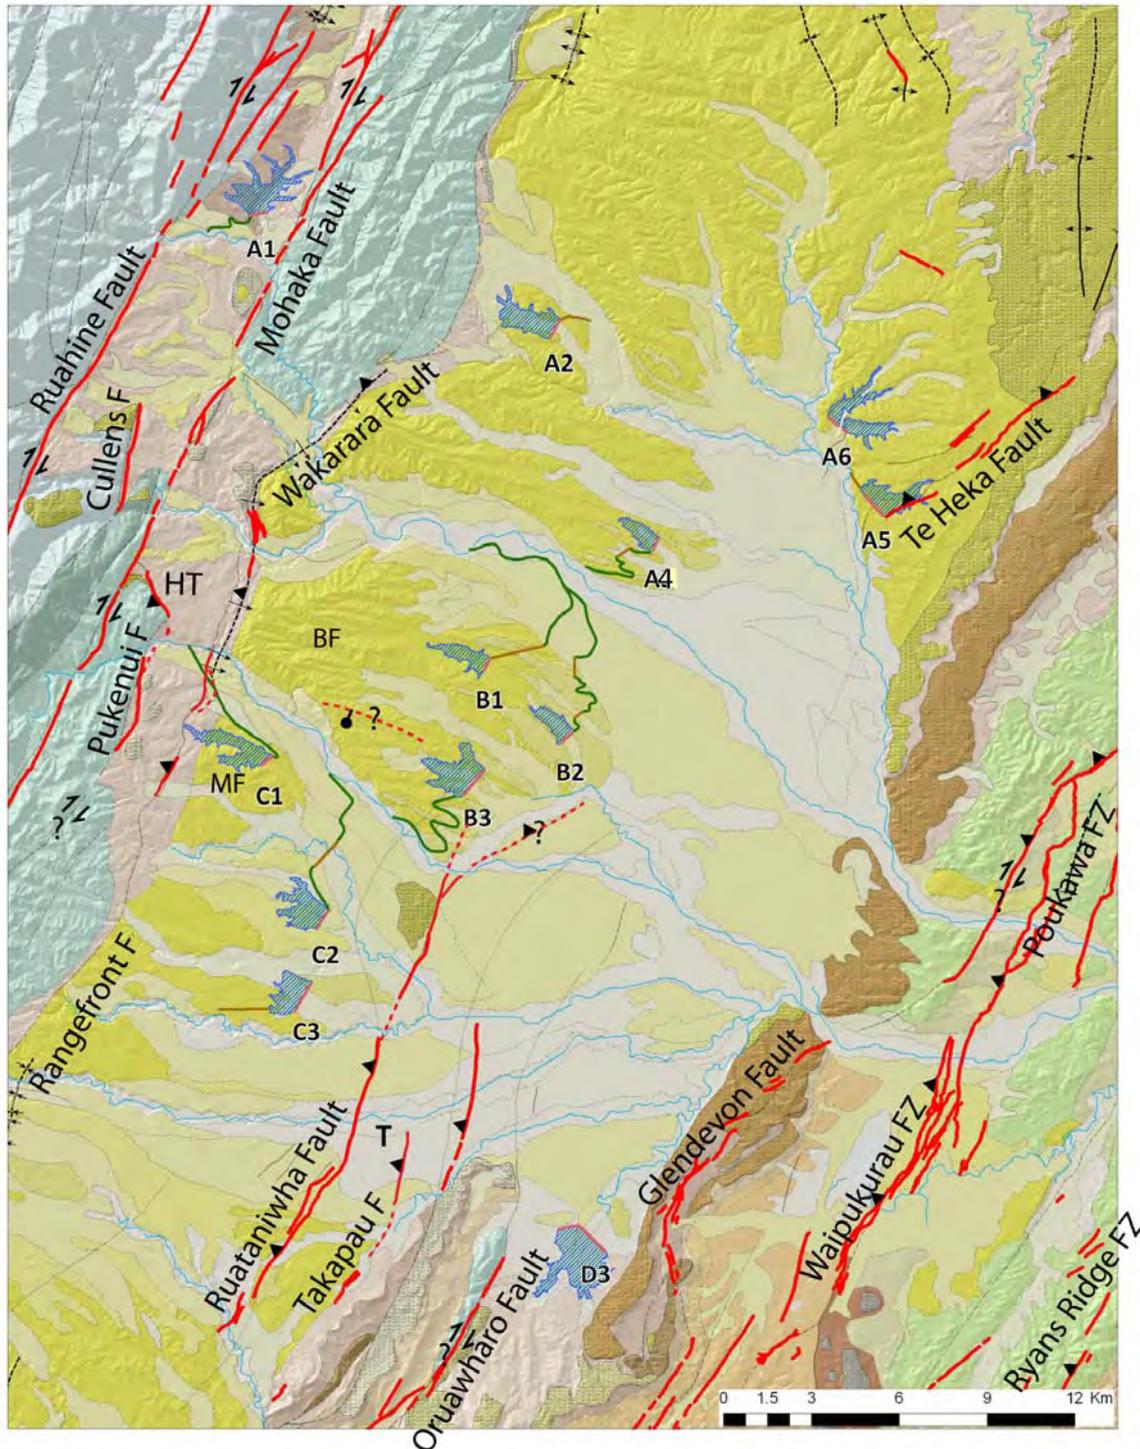
From northwest to southeast, the major faults that are in proximity to the proposed sites are the Ruahine Fault, Mohaka Fault, Wakarara Fault (new to Active Faults database), Rangefront Fault (new), Ruataniwha Fault, Te Heka Fault (new), Oruawharo Fault, and Glendevon Fault (Figure 5). Two additional active faults, the Cullens Fault and Hinerua Thrust (HT), are recognised at the western edge of the study area from Raub et al. (1987). A one-day field reconnaissance was undertaken on 17th June, 2010 to examine the location and activity of a number of these faults for the purposes of the seismic parameters input into the spectral models.

Figure 5 Known active fault (red) and fold traces (black dashed lines) that are in close proximity to the proposed scheme. From 1:250,000 scale geological map of the Hawke's Bay area (Lee et al. in prep; lithologies follow QMap patterns and colours). In addition, possible fault (red dashed lines) and fold (thin black lines) locations are also included. Teeth, strike-slip and tick/ball symbols indicate fault style. Proposed embankment dams are labelled A1 through D3. New faults, e.g. the Te Heka, Takapau, Wakarara and Rangefront faults, have been defined as part of this study. HT marks the Hinerua Thrust, and BF and MF refer to the Blackburn and Makaretu alluvial fan complexes. T marks the proximity to Takapau and Tikokino junction.

Distances shown in Table 1 vary from several kilometres to less than 500 m. In terms of surface deformation and fault rupture, distances of >500 m from the currently mapped traces of folds and faults are probably insignificant in terms of hazard from fault (or fold) displacement during large earthquakes. Values in Table 1 that are <500 m are probably sufficiently close to mapped and potential (unmapped/ projected) structures that further fault location work may be justified. For example, it is noted that Embankment A5 is sited c. 200 m from the Te Heka Fault and may even intercept the projection of fault and fold structures related to the Te Heka Fault (Figure 5). As a second example, a race proposed for Embankment C1 crosses the trace of the Rangefront Fault near the south bank of the Tukituki River.

Other additional unmapped faults and folds may exist near the reservoir dam structures that are currently not shown on the GNS Science Active Faults database or from the published literature. Additional mapping near the proposed dam sites should be undertaken to assess the possibility of further faults and folds that could cause surface displacements. For example, Kingma (1962) and Lee et al. (in prep.) show several faults with SE-striking traces across young geologic surfaces that emanate from the Axial Ranges, e.g. the Blackburn Fault Zone, which cuts the Blackburn alluvial fan (Figure 5; Table 1).

Some broad generalisations regarding the location and style of deformation of some of the traces depicted in Figure 5 can be made (Table 1). Future single-event earthquake surface-ruptures of the Mohaka and Ruahine faults are expected to be several metres in size (3-5 m), and predominantly right-lateral in sense, with a subordinate vertical component. Slip rate estimates for these faults are c. 3-4 mm/yr, and c. 1-2 mm/yr, respectively (Beanland 1995; Beanland & Berryman, 1987; Raub et al. 1987; Langridge et al., unpublished data). Using the Ministry for the Environment's (MfE) classification for active fault recurrence (Kerr et al., 2003; Van Dissen et al., 2003), the Mohaka and Ruahine faults are Class I (2000 yr) and Class II (2000-3500 yr) recurrence interval faults. More definitive values of earthquake recurrence are given in Table 2 and used in the estimation of ground motion spectra.

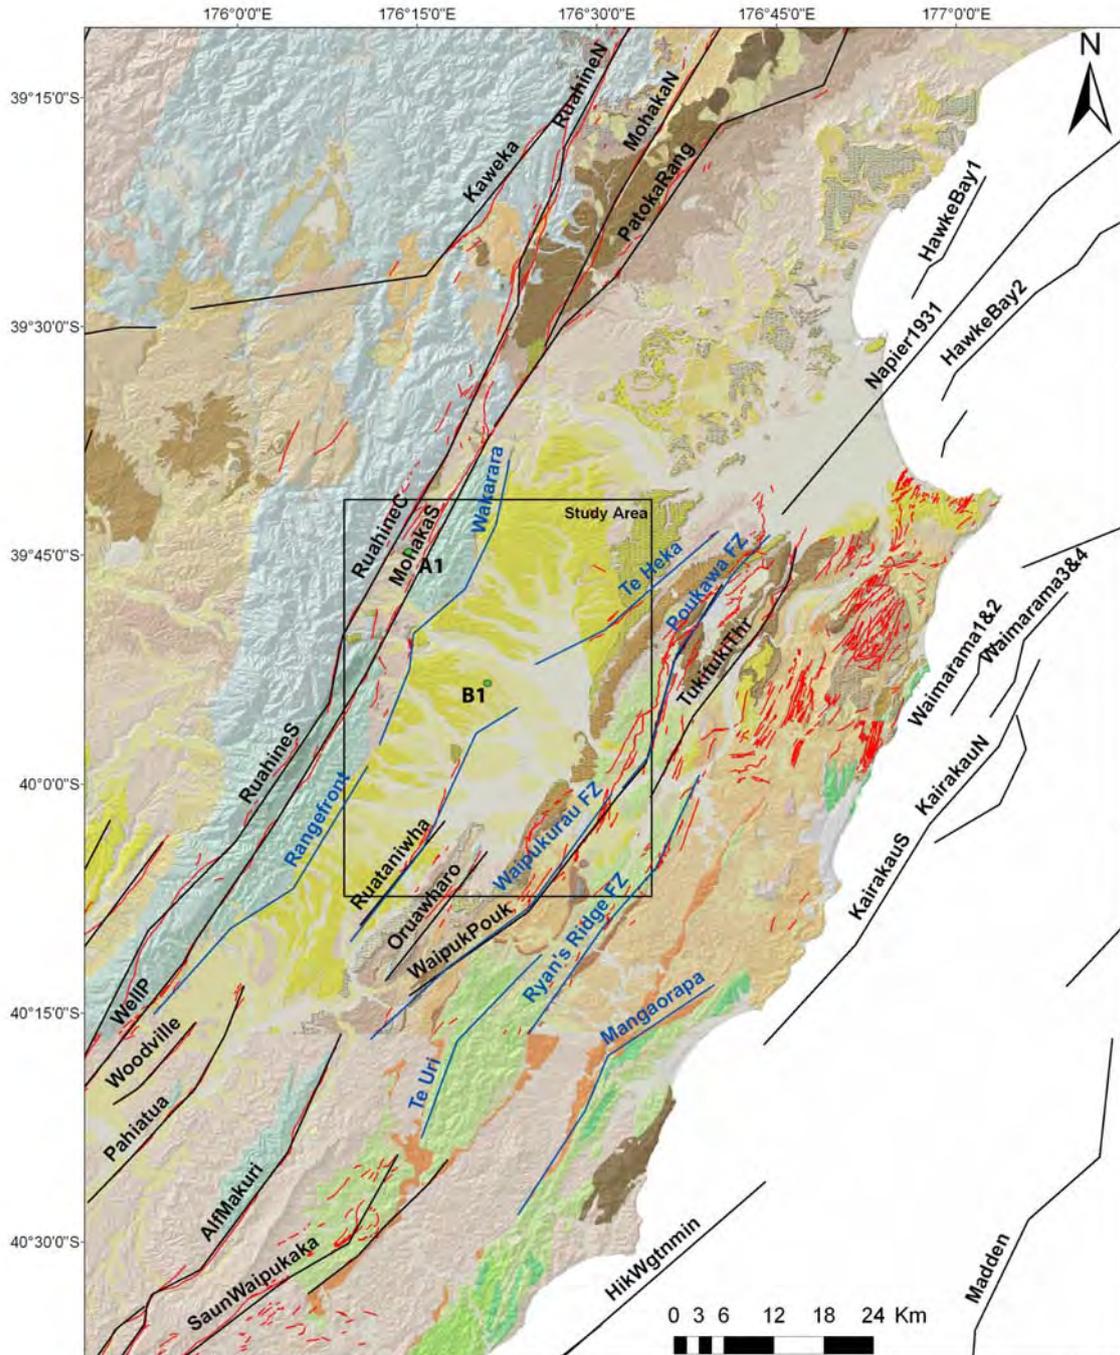
Figure 6 Active fault earthquake source model(s) encompassing the Central Hawke's Bay area. The base map for the figure is from QMap geology (e.g. Lee and Begg 2002, Lee et al. in prep). The red lines represent visible evidence of faulting, represented in the NSHM by earthquake sources shown by the blue and black lines. The blue lines are the new and modified sources developed in this study (see Table 1). The black lines represent the active fault source as they are in the 2010 version of NSHM (many have abbreviated names). The positions of sites A1 and B1 are shown by green dots.

Figure 6 shows the alternative source model used in this study. The blue lines represent sources that are new or have been redefined in this study, e.g. Te Uri, the northward continuation of the Saunders-Waipukaka source (i.e. the 1934 Pahiatua earthquake source). The black lines represent NSHM sources that have been used unaltered in this study. They include the Mohaka South segment (MohakaS), Oruawhara and Wellington-Pahiatua (WellIP)

Figure 6 and Table 2b define several new active fault earthquake sources (Te Heka, Wakarara, Rangefront, Te Uri, and Mangaorapa) that have been appended to the 2010 version of the NSHM, for the alternative fault model. It also includes the re-definition of the location, length, and/or segmentation of several existing NSHM sources. For example, the WaipukPoukawa source has been split into two sources and modified. These new or modified representations are the result of the active fault and fold mapping portrayed on the QMap Hawke's Bay sheet (Lee et al., in prep) and the Wairarapa sheet (Lee and Begg 2002), and through confirmation based on field reconnaissance. The Takapau and Glendevon faults are not entertained as new seismic sources in this study. The latter is considered as a flexural-slip fault that can only generate earthquakes of up to c. M 5.7 (Van Dissen et al. 1989).
