Hawkes Bay Regional Council

Ruataniwha Water Augmentation
Scheme

Advanced Prefeasibility Geotechnical
Investigation Report

T&T Ref: 27195/V04

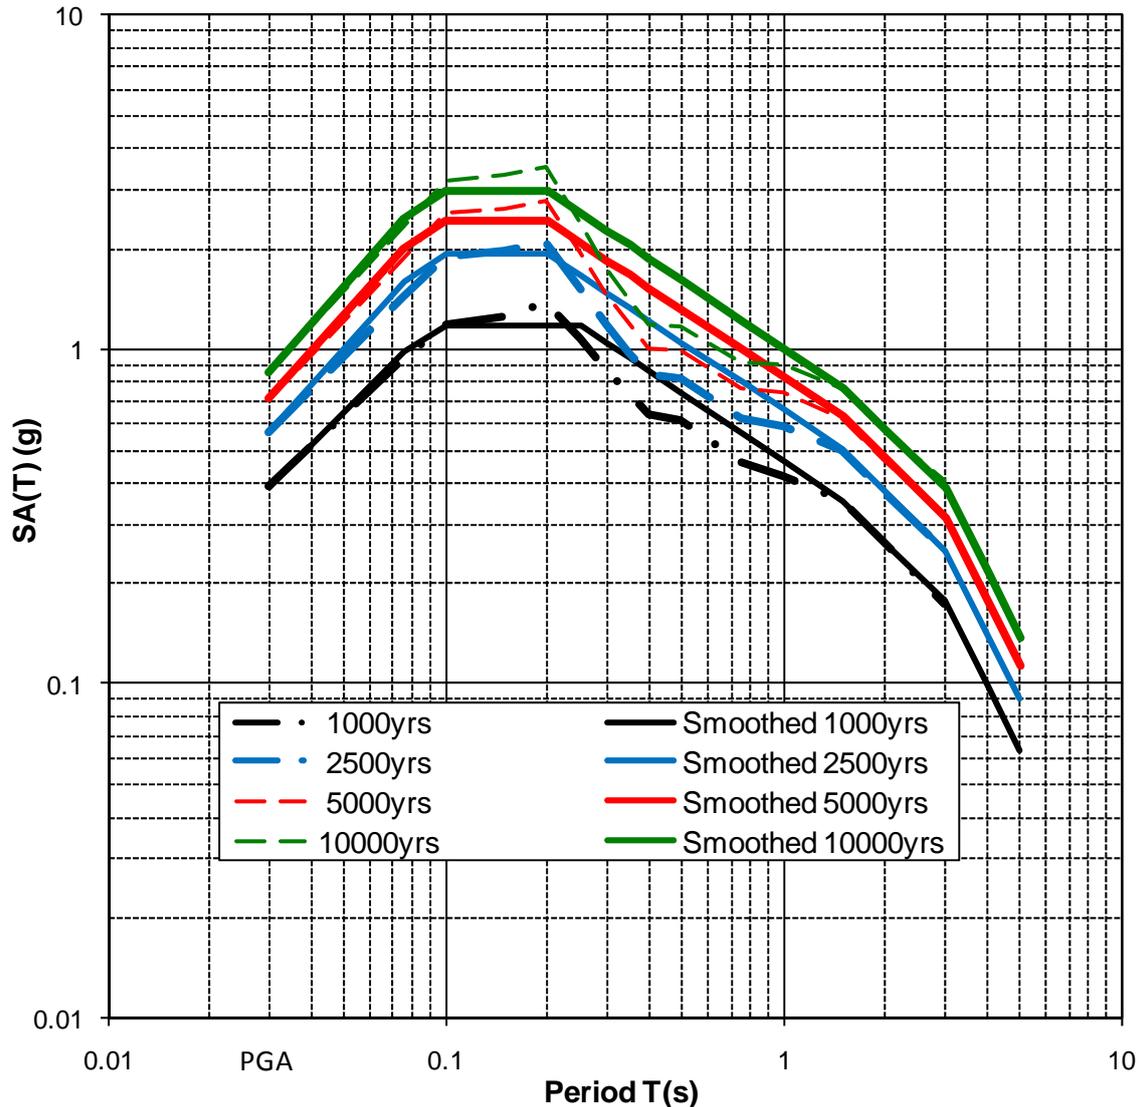
CHB Site A1 Weak Rock Spectra using standard model (5% damped and magnitude weighted)

Figure 7 compares the smoothed spectra (without near-source factors) with the raw spectra derived from the probabilistic seismic hazard analysis using the standard model. A common feature for the smoothed spectra for all return periods is the truncation of the peaks of the hazard spectra that occur around 0.2s period. This truncation is intended to offset the effect that hazard spectra calculated using the New Zealand attenuation model by McVerry et al. (2006) tend to over-estimate the recorded spectra at 0.2s period. Similar truncation of the peaks of the spectra was applied in deriving the NZS1170 spectral shape factors. In the spectral period range of 0.3s-1.0s, the raw hazard spectra are considerably smaller than the smoothed spectra at site A1, with the largest differences at 0.4s spectral period. For the 10,000-year return period, the raw hazard spectrum is about 64% the value of the smoothed spectrum. The large difference is likely caused by the “un-smoothness” of the spectrum predicted by the McVerry et al. (2006) attenuation model, especially at short distances. The effect of “un-smoothness” is exacerbated by the dominant contribution to the hazard spectra from the Mohaka South fault at a distance of only 1.5 km from the site. At spectral periods over 1s, the smoothed spectra are nearly identical to the raw hazard spectra.

Figure 7 Unsmoothed and smoothed magnitude-weighted rock spectra for site A1 using the standard fault model. PGA is plotted at 0.03s.

The changes to the standard model in the alternative fault model presented in Table 2b have virtually no effect on the estimated hazard spectra for site A1, and the results presented for this site were derived by using the standard fault model.
